Canterbury earthquake  
(magnitude 7.1),  
Darfield-Christchurch  
Sept 4, 2010

A photographic account from a visit on  
Sept 8, 2010

By: P. Marinos, R. Rodogianni, G. Tsiambaos, N.  
Sabatakakis & B. Christaras

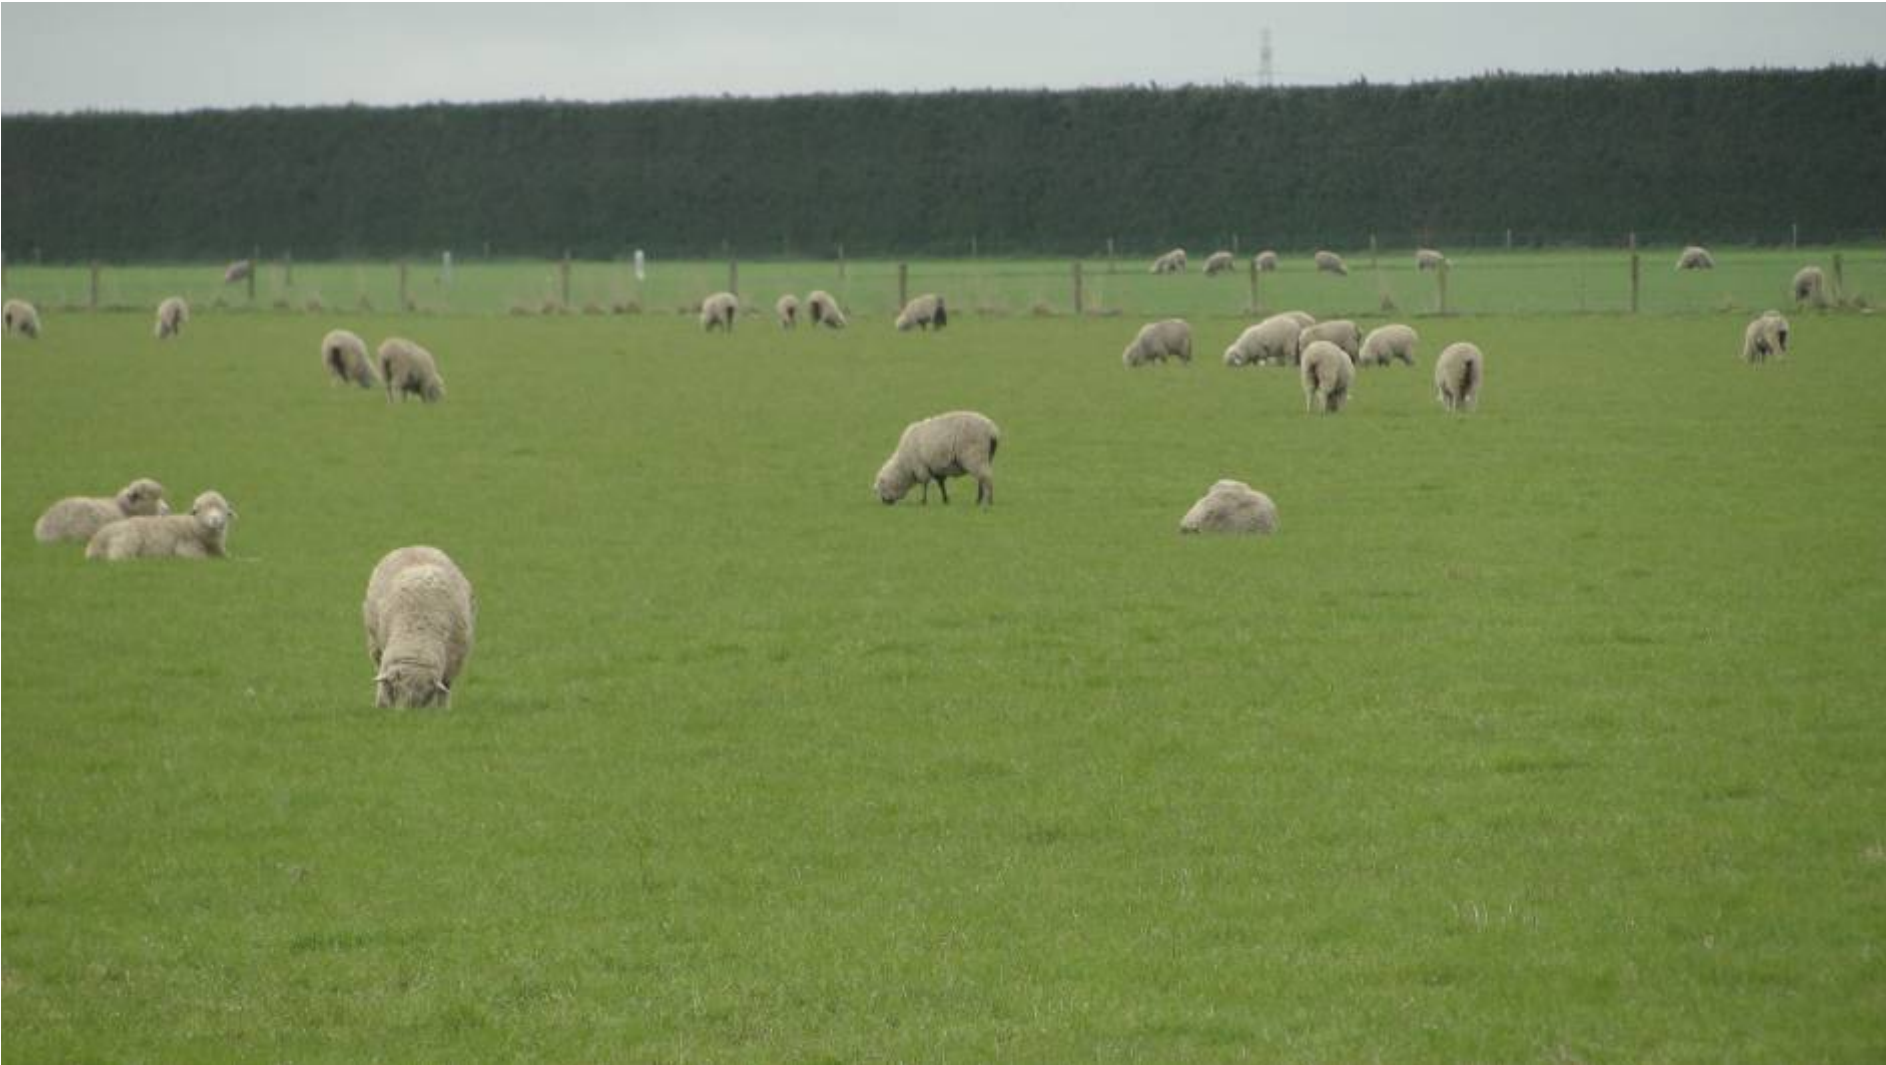
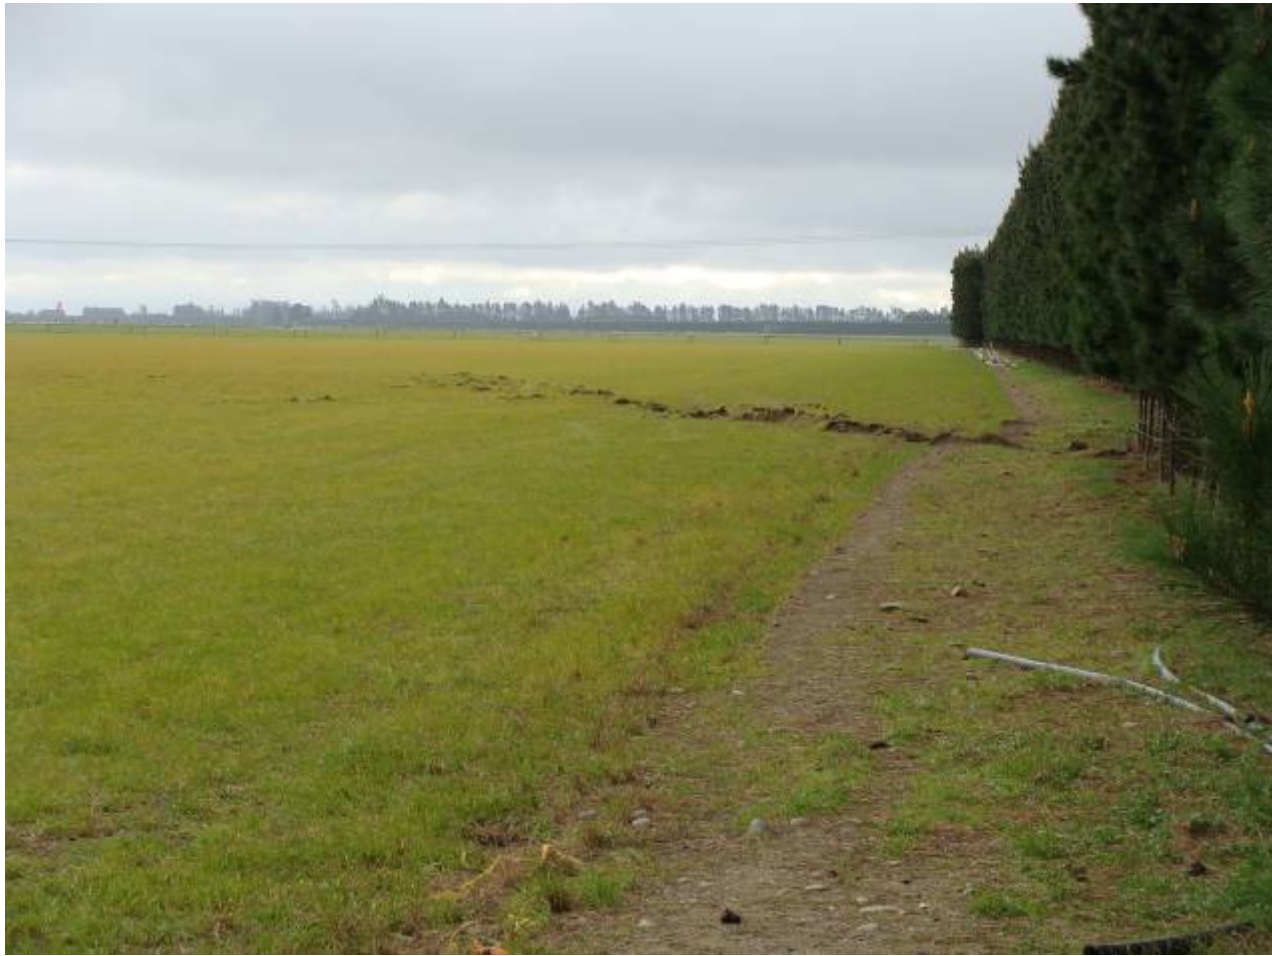
Strike slip right lateral about 3 m horizontal offset. En  
echelon. Observed length 13km

Vertical displacement of about few 10s of cm,

Small inverse component.

Width of zone of deformations 10-30m

Surface rupture on Glaciation surface 18000 old

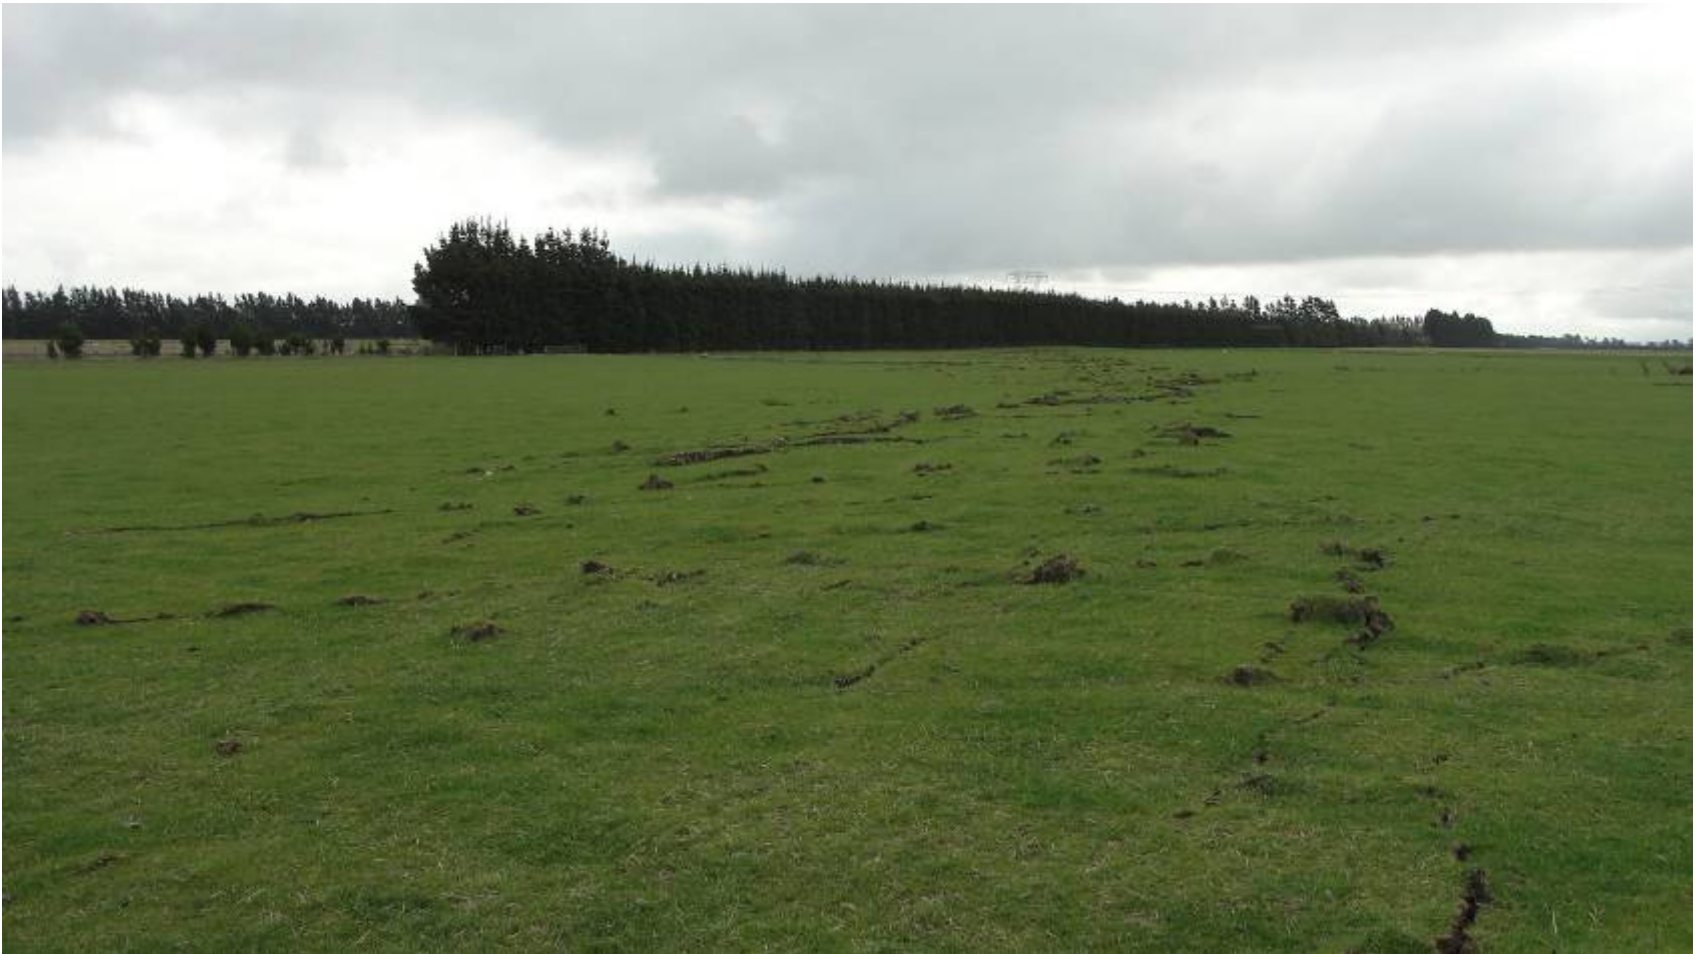
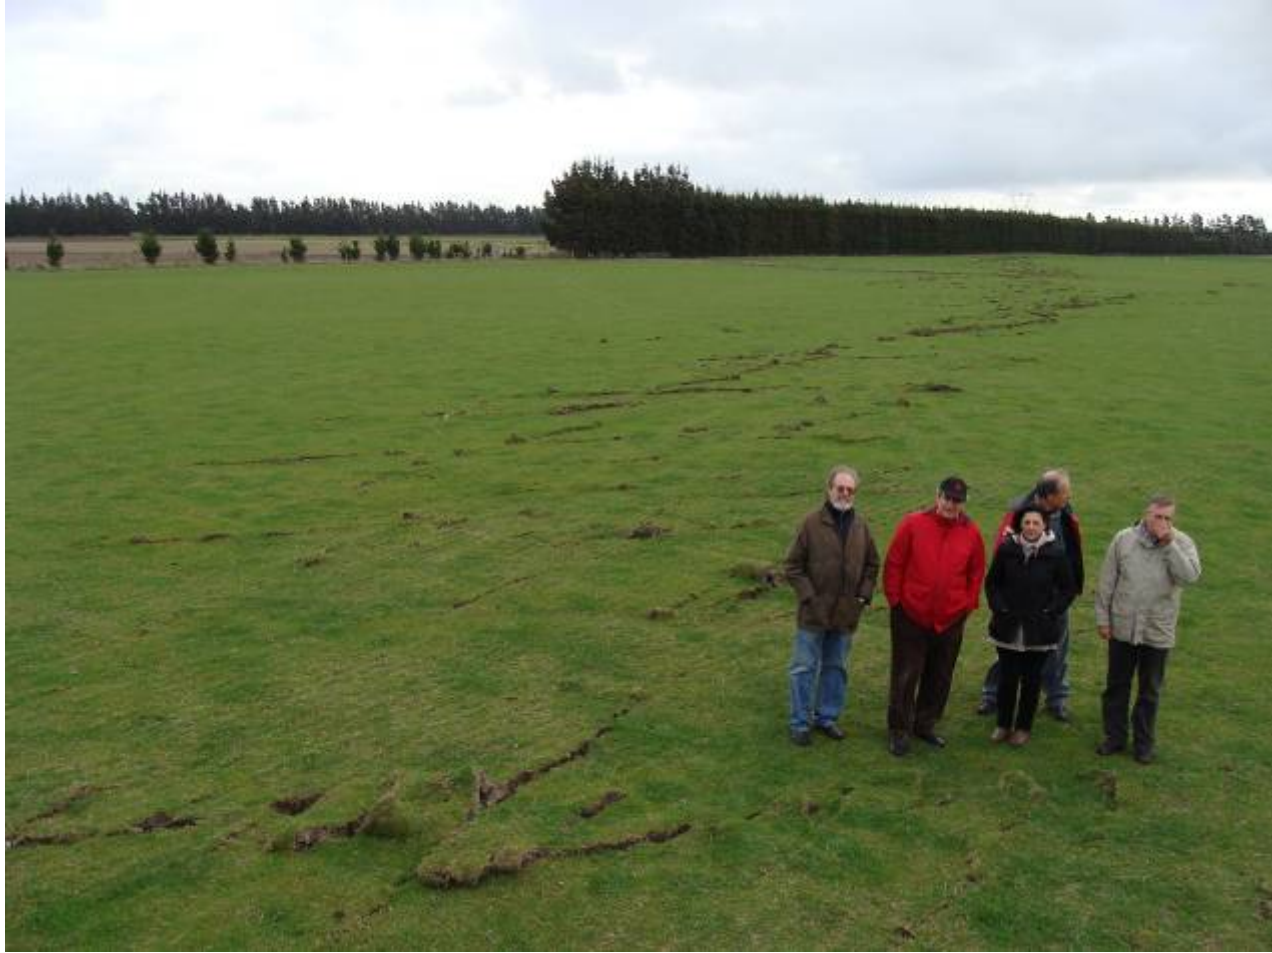
The width of deformations associated with the en echelon development of the fault rupture

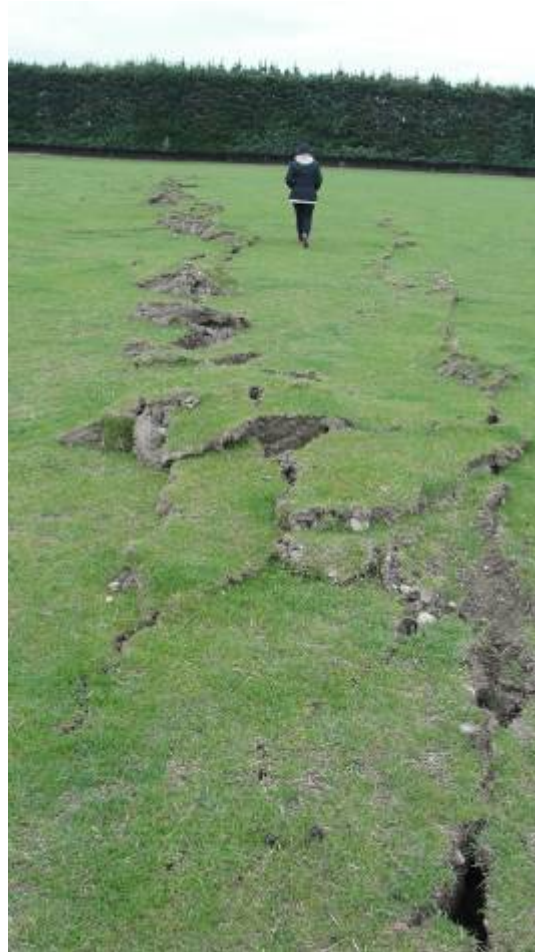
# Signs of the local inverse component

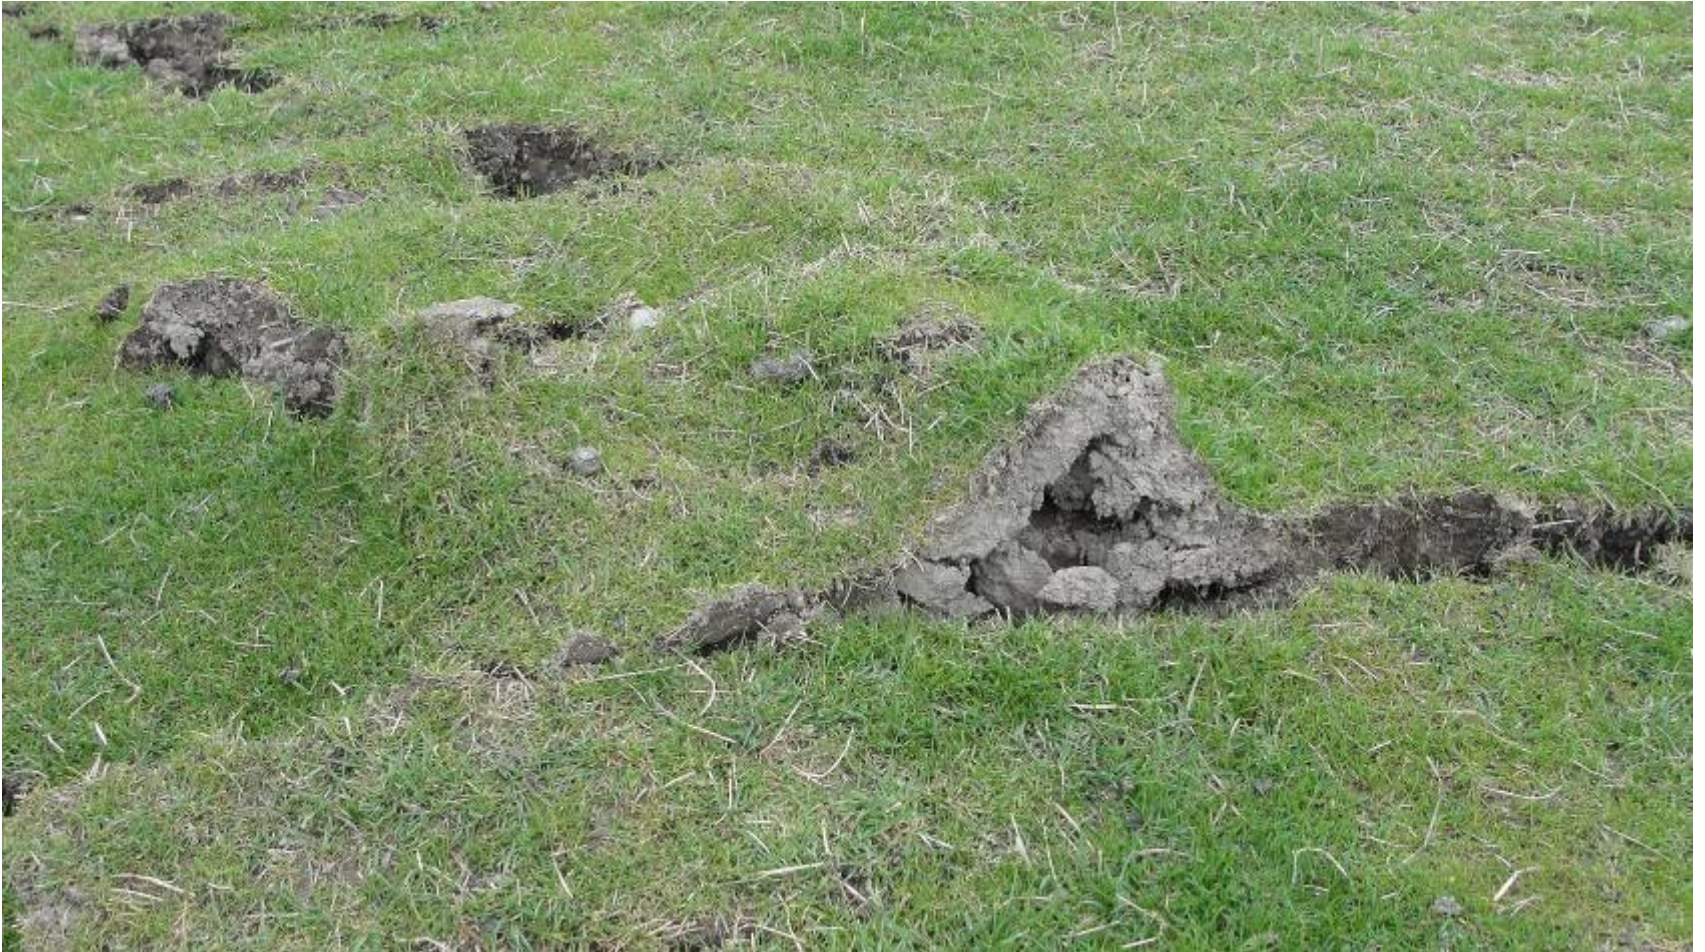
# Signs of the local inverse component

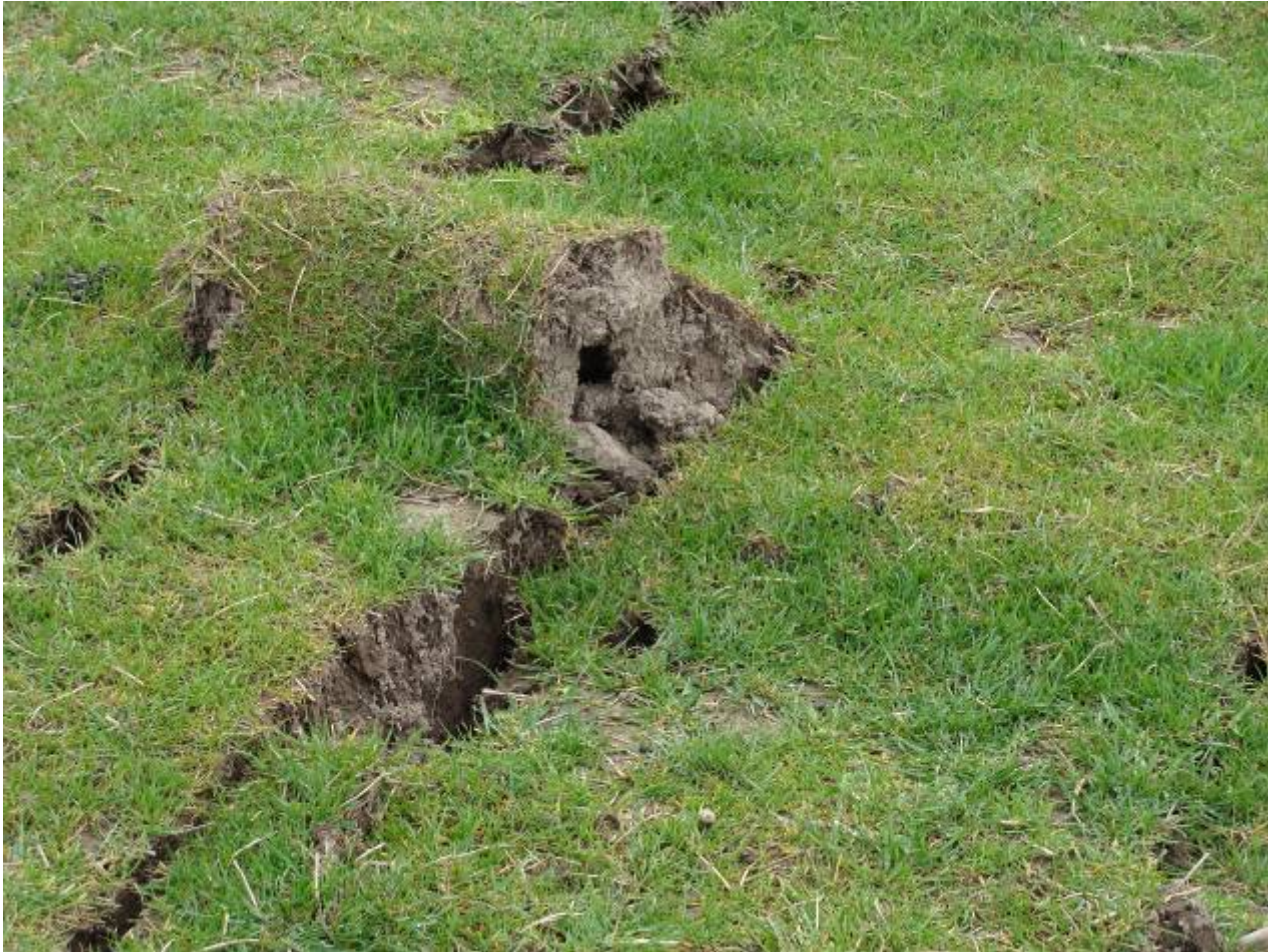
# Signs of the local inverse component

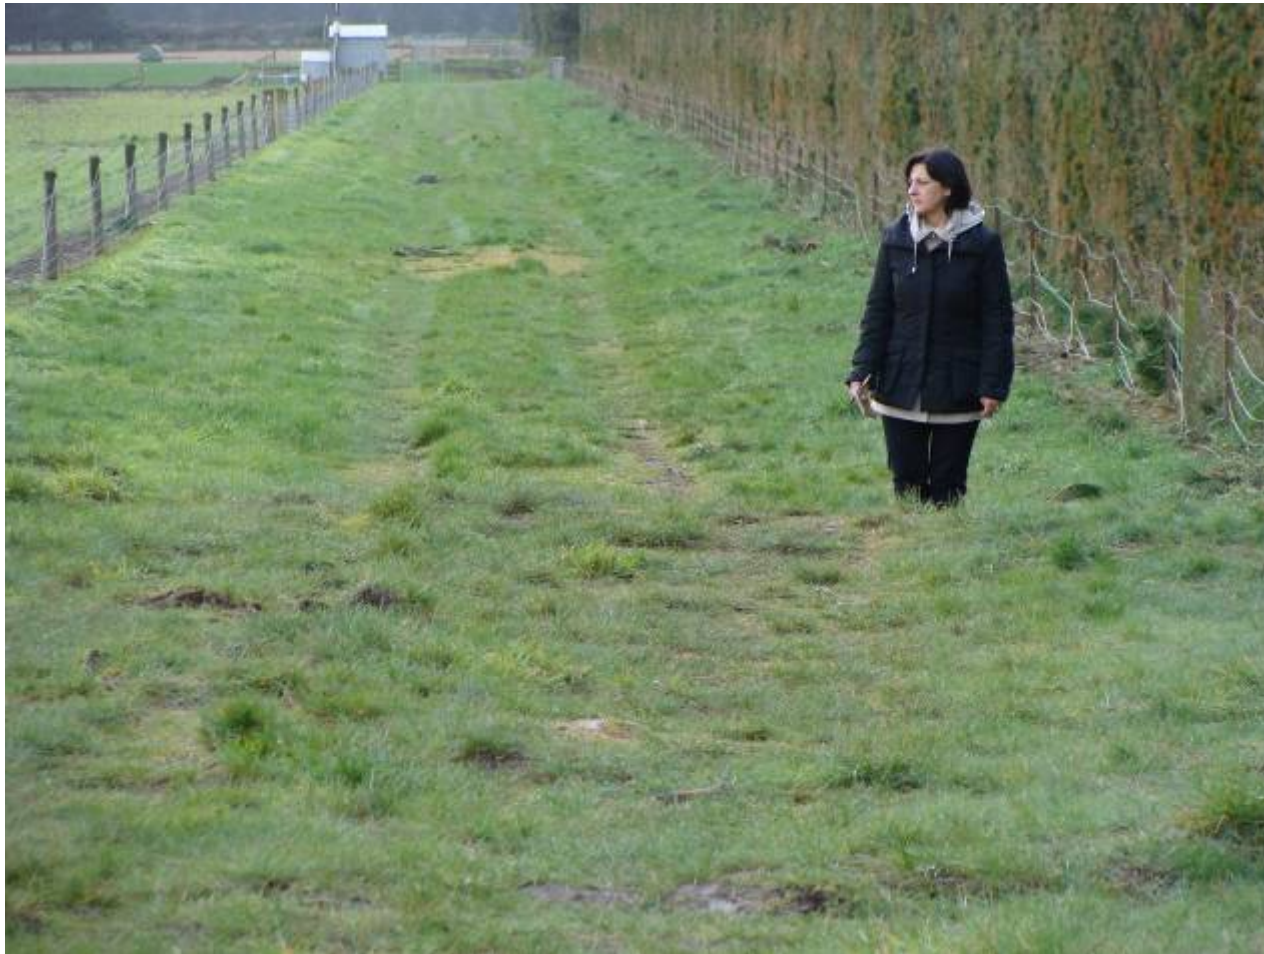
One of the bigger vertical displacement in the fault zone

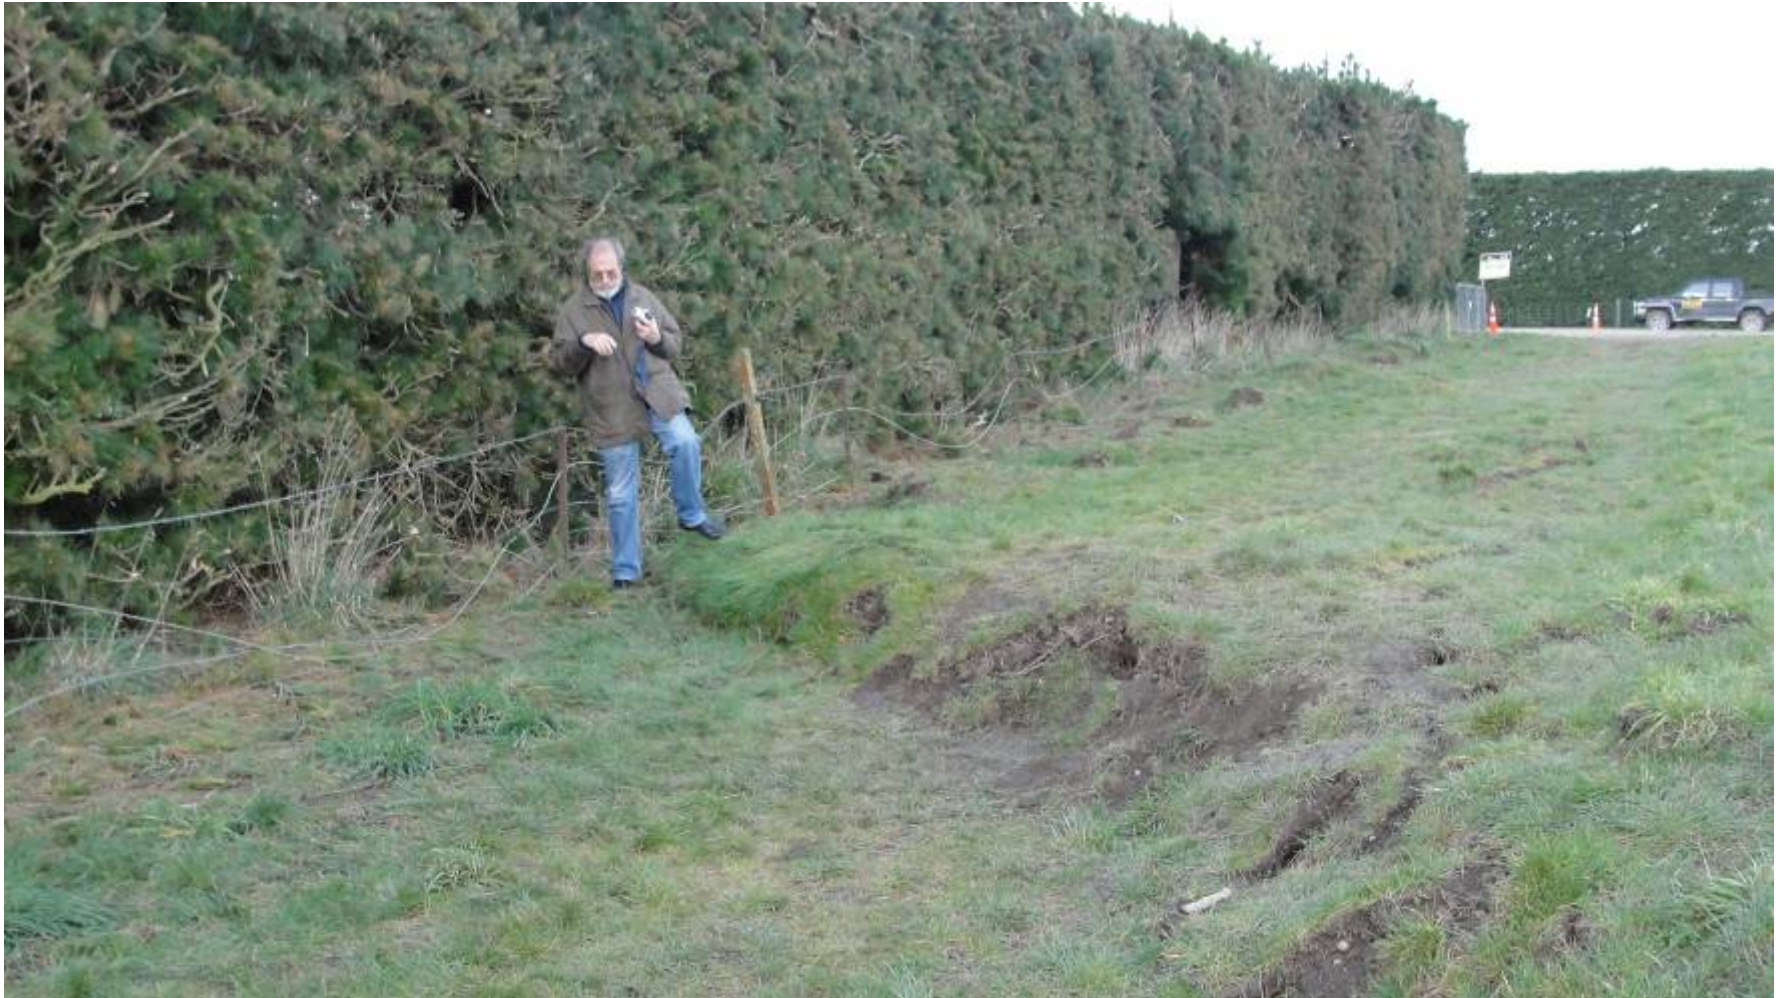
One of the bigger vertical displacement in the fault zone

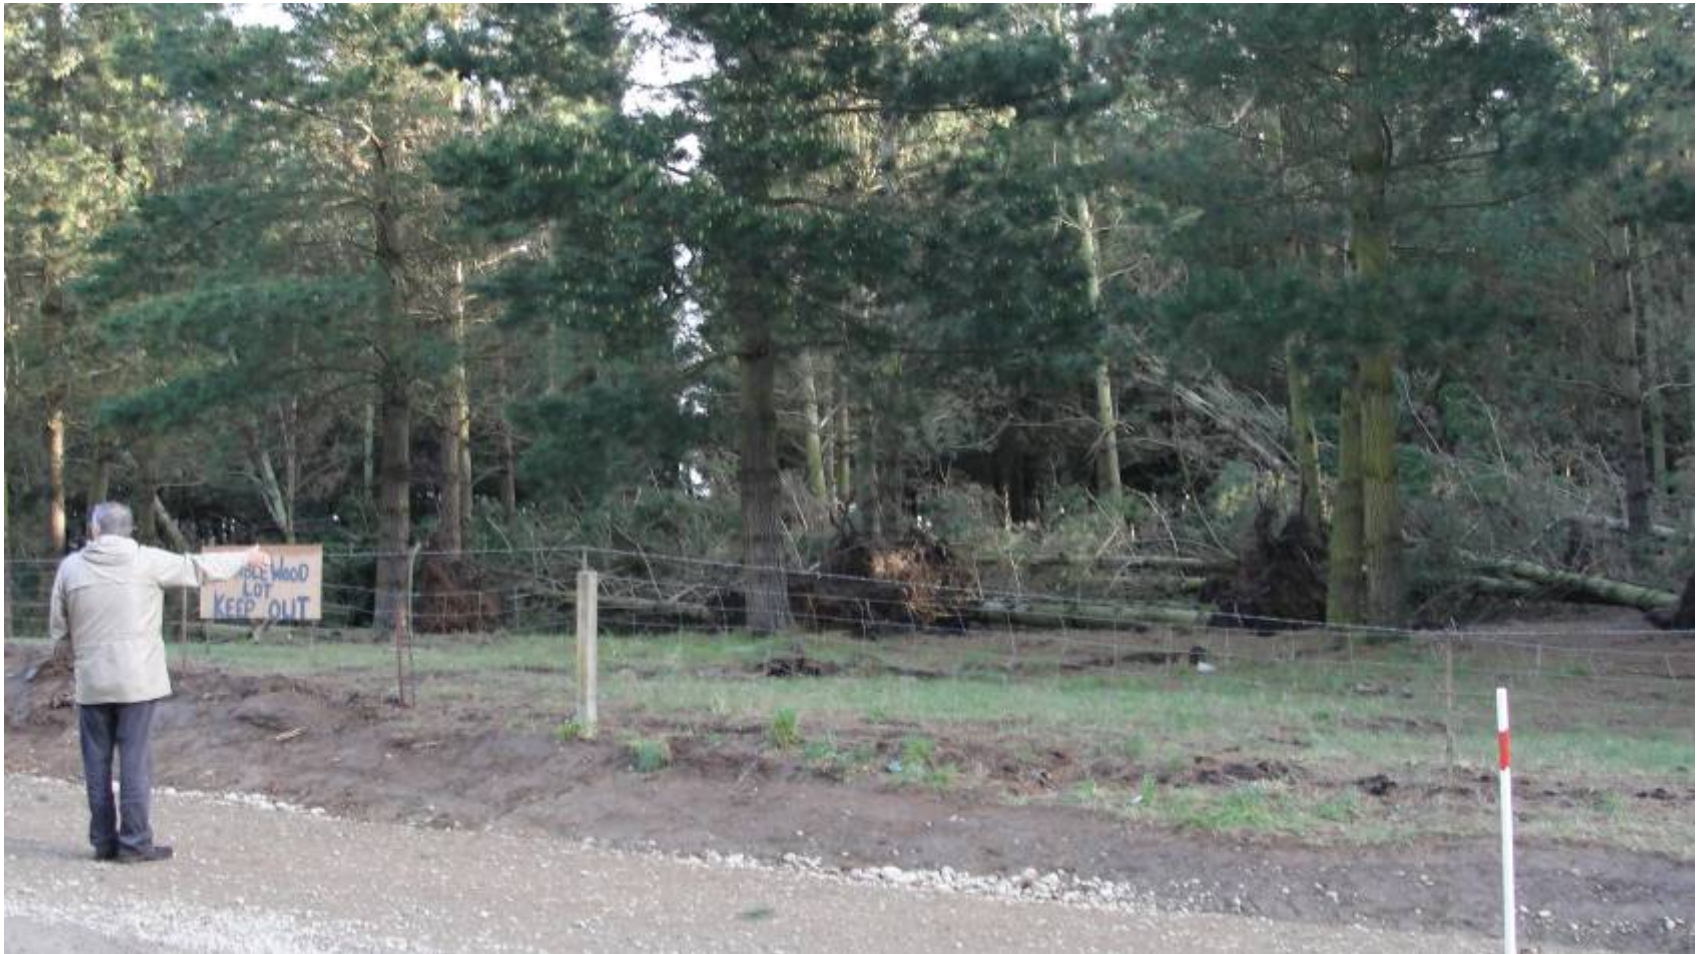
# Trees unrooted in the course of the fault

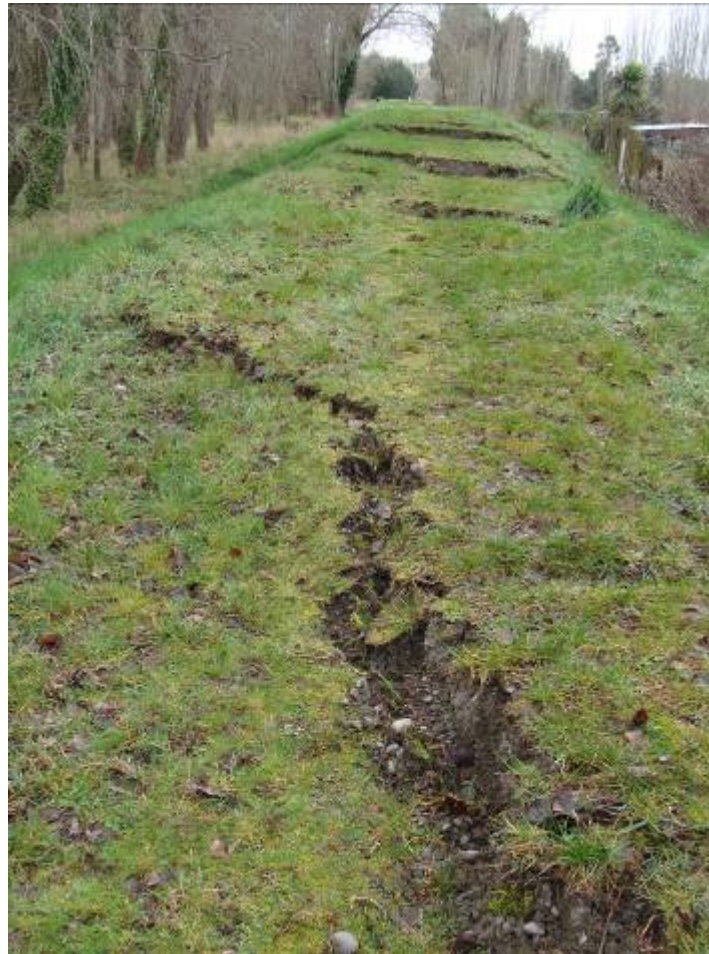
# Failure of embankment of Waimakariri river due to liquefaction of its surroundings. Lateral spreading assisted

The river is just at the left side of photo.

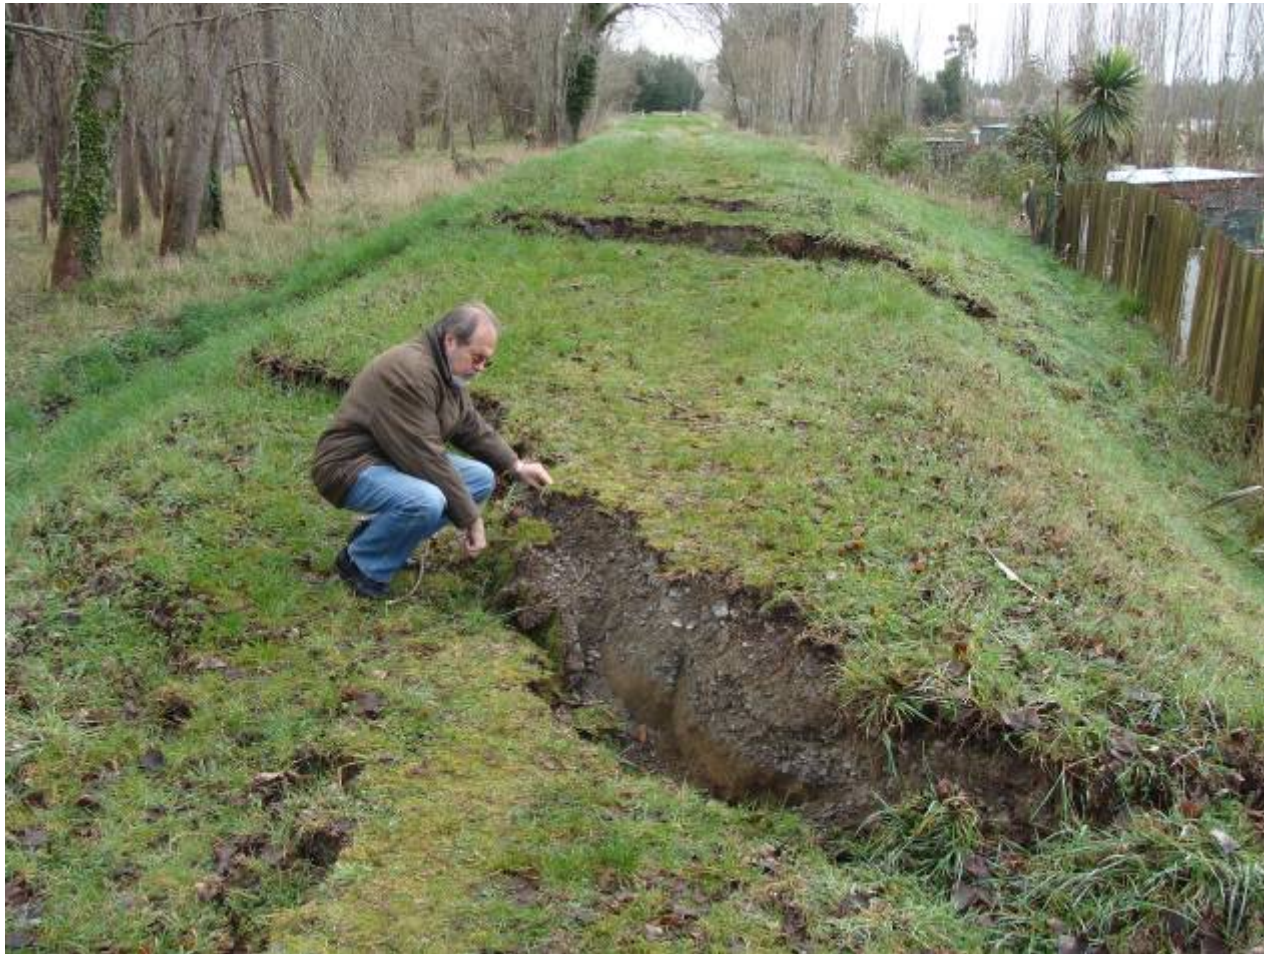
Failure of embankment of Waimakariri river due to liquefaction of its surroundings. Lateral spreading assisted  
The river is just at the left side of photo.

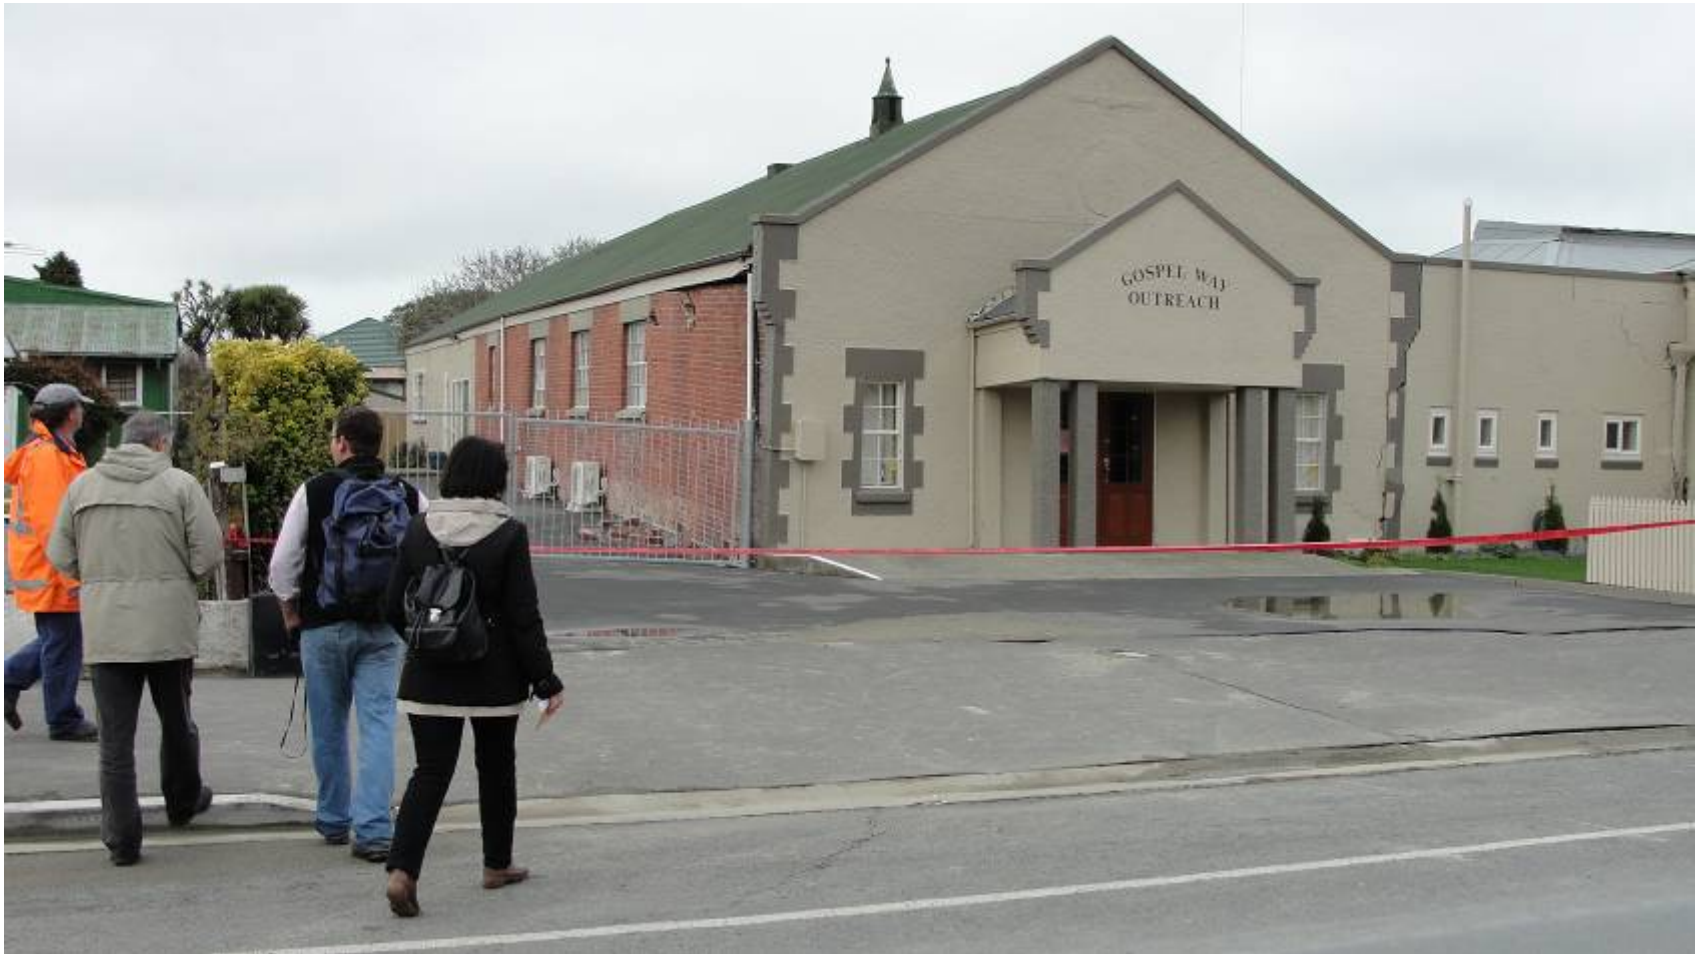
# Subsidence of the frontal part of the house, Kaiapoi

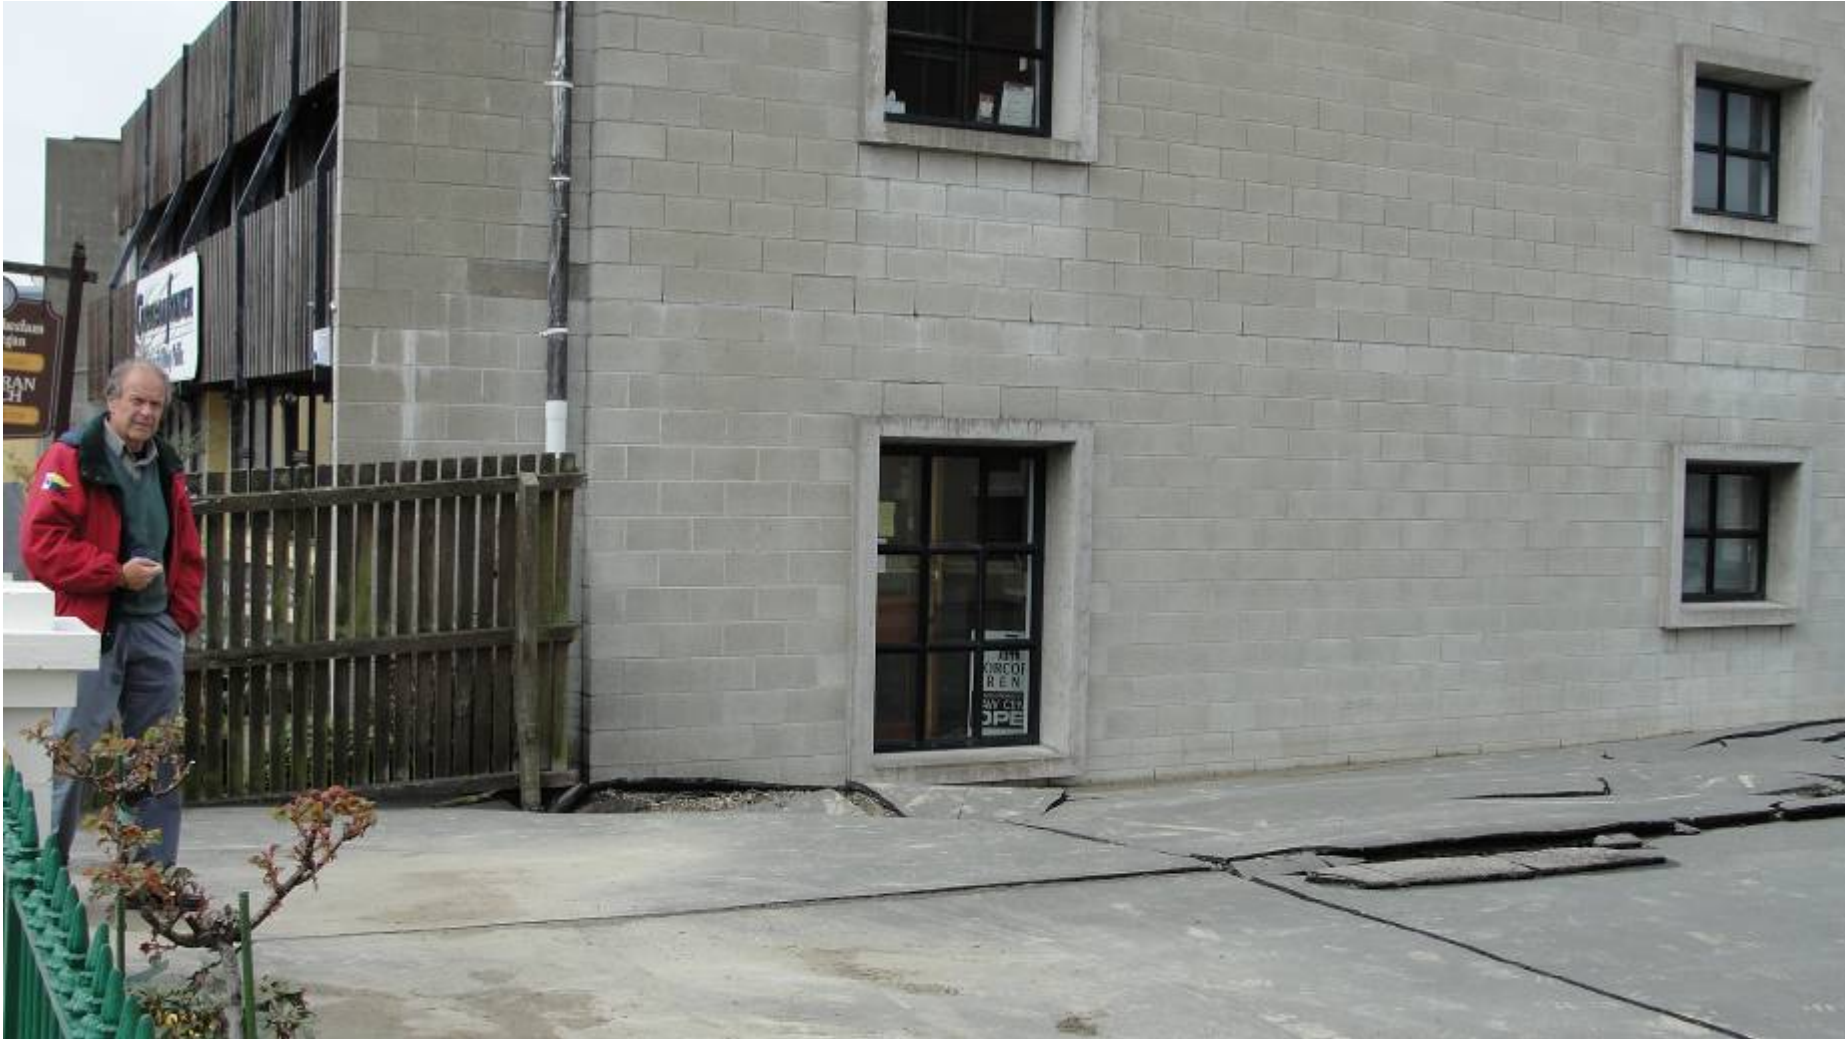
# Subsidence due to liquefaction, Kaiapoi

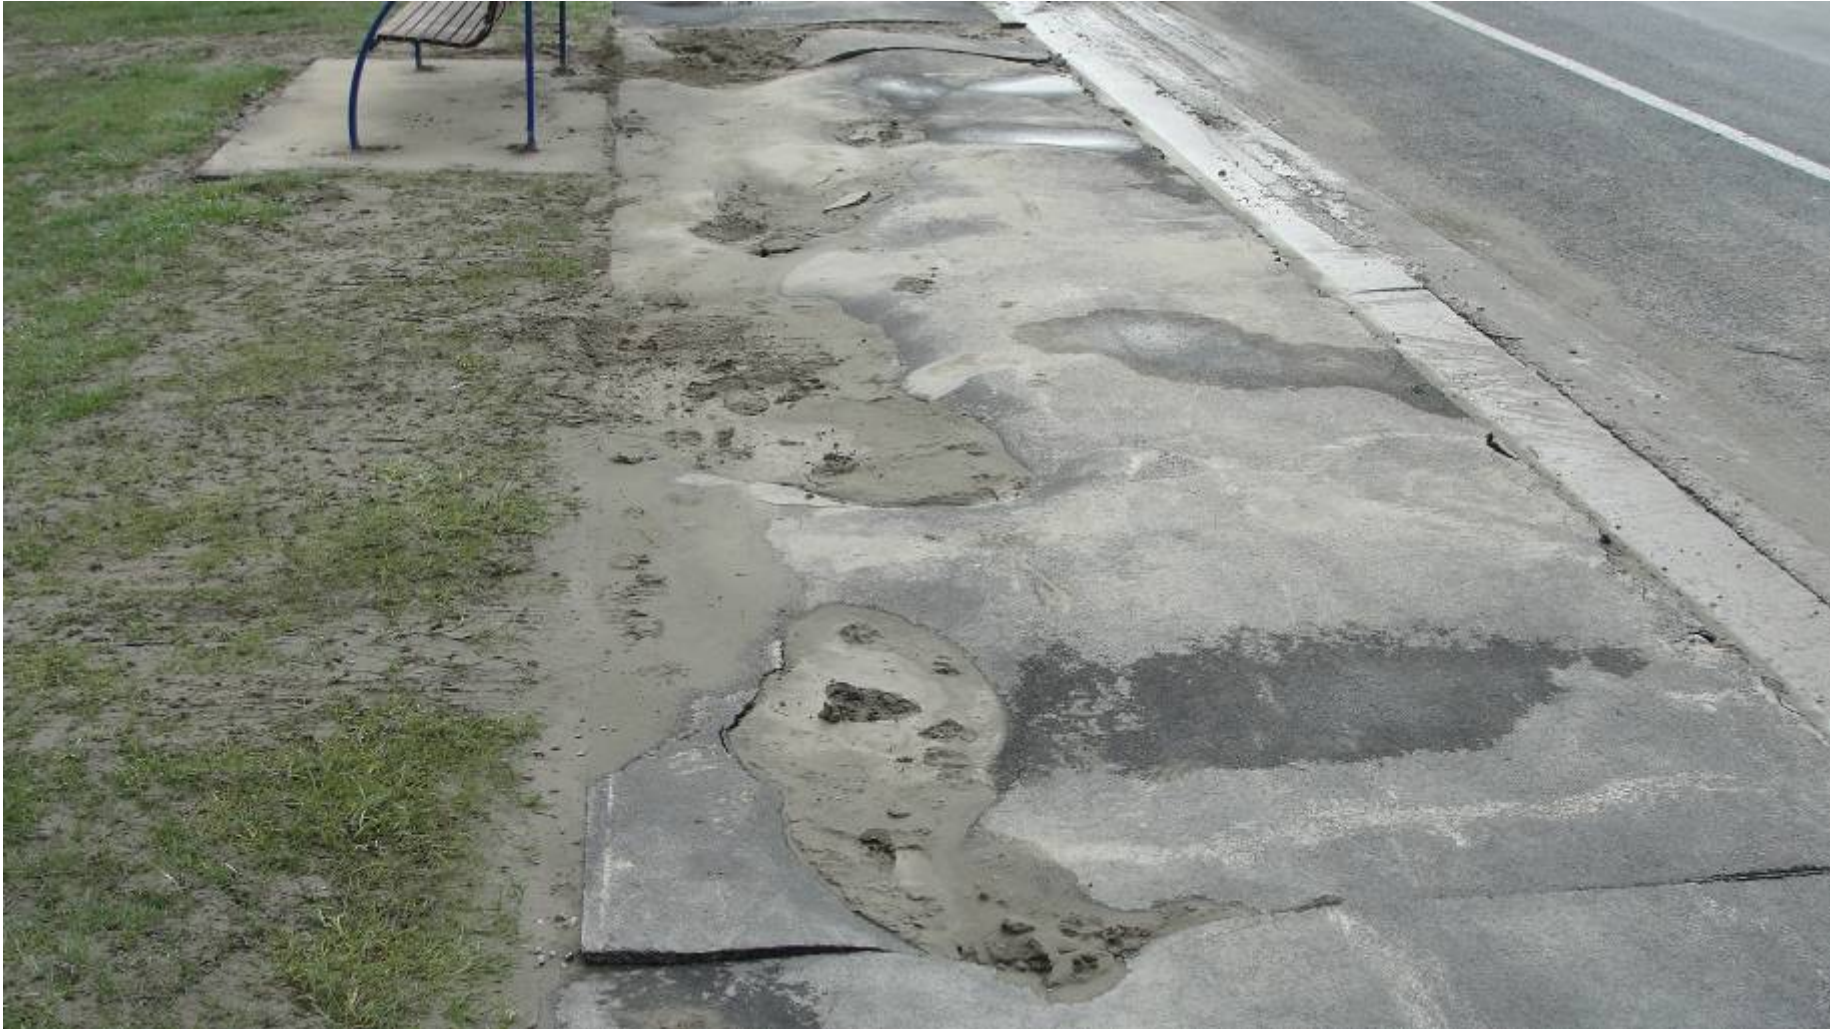
# Liquefaction affected pavements and streets

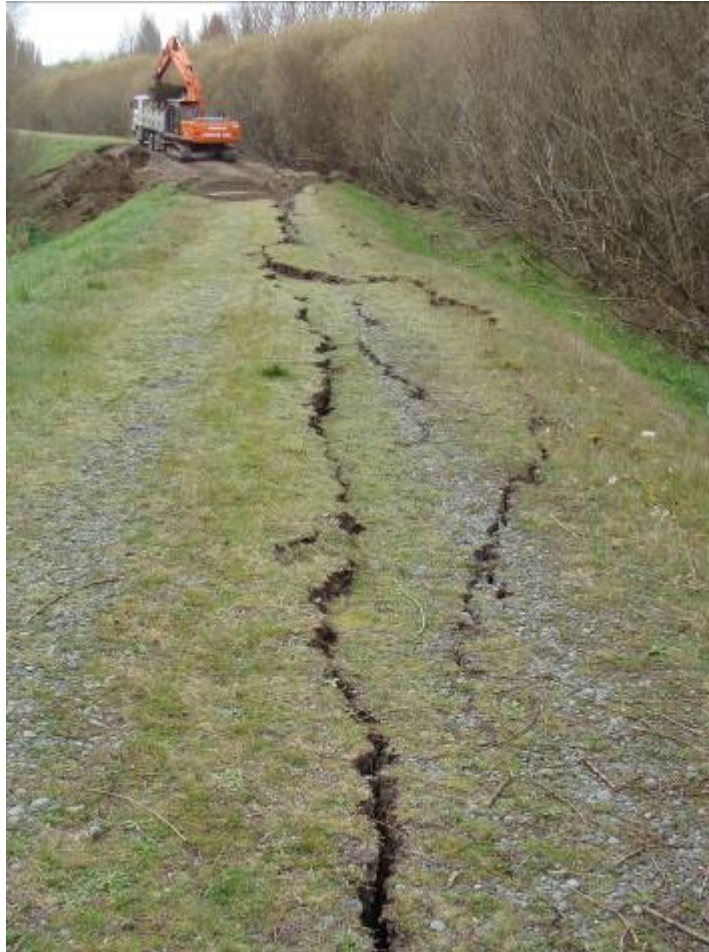
Failure of embankment of Waimakariri river due to lateral spreading. Liquefaction affected its environment.  
The river is just at the left side of photo.
