Canterbury earthquake  
(magnitude 7.1),  
Darfield-Christchurch  
Sept 4, 2010

A photographic account from a visit on  
Sept 8, 2010

By: P. Marinos, R. Rodogianni, G. Tsiambaos, N.  
Sabatakakis & B. Christaras

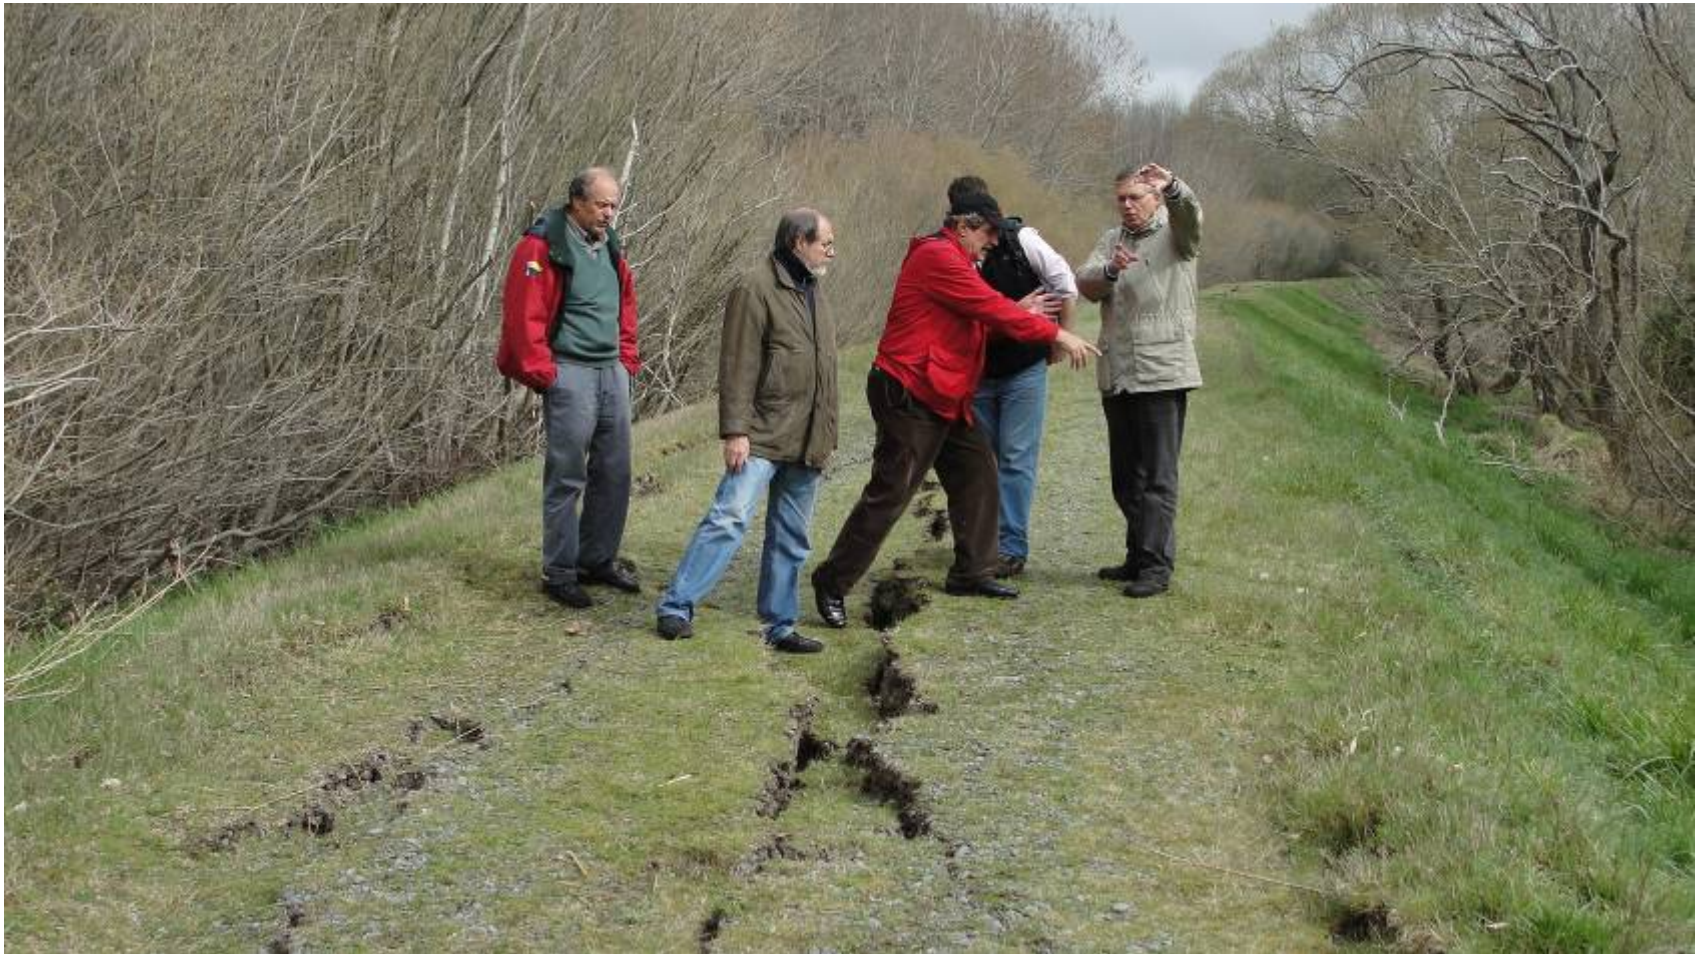
Failure of embankment of Waimakariri river due to lateral spreading. Liquefaction affected its environment.  
The river is just at the left side of photo.

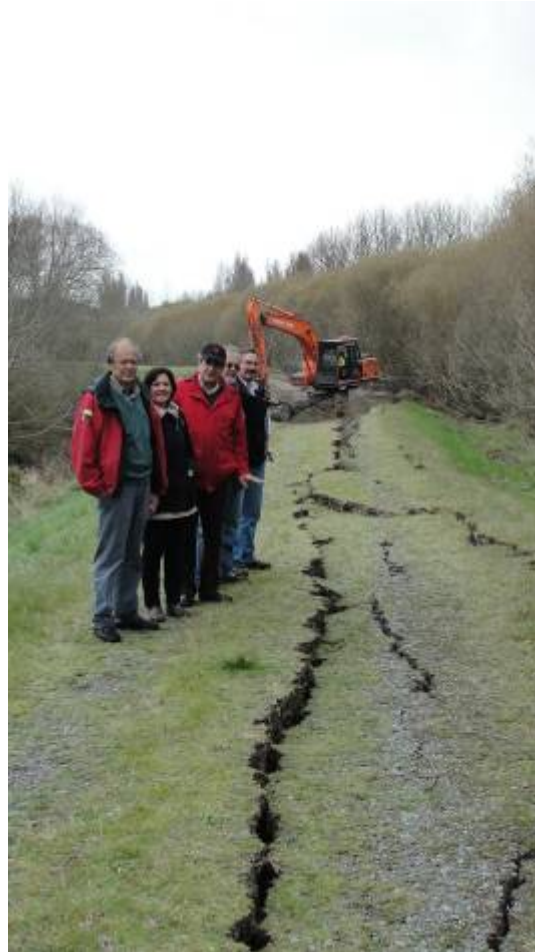
Failure of embankment of Waimakariri river due to lateral spreading. Liquefaction affected its environment.  
The river is just at the right side of photo.

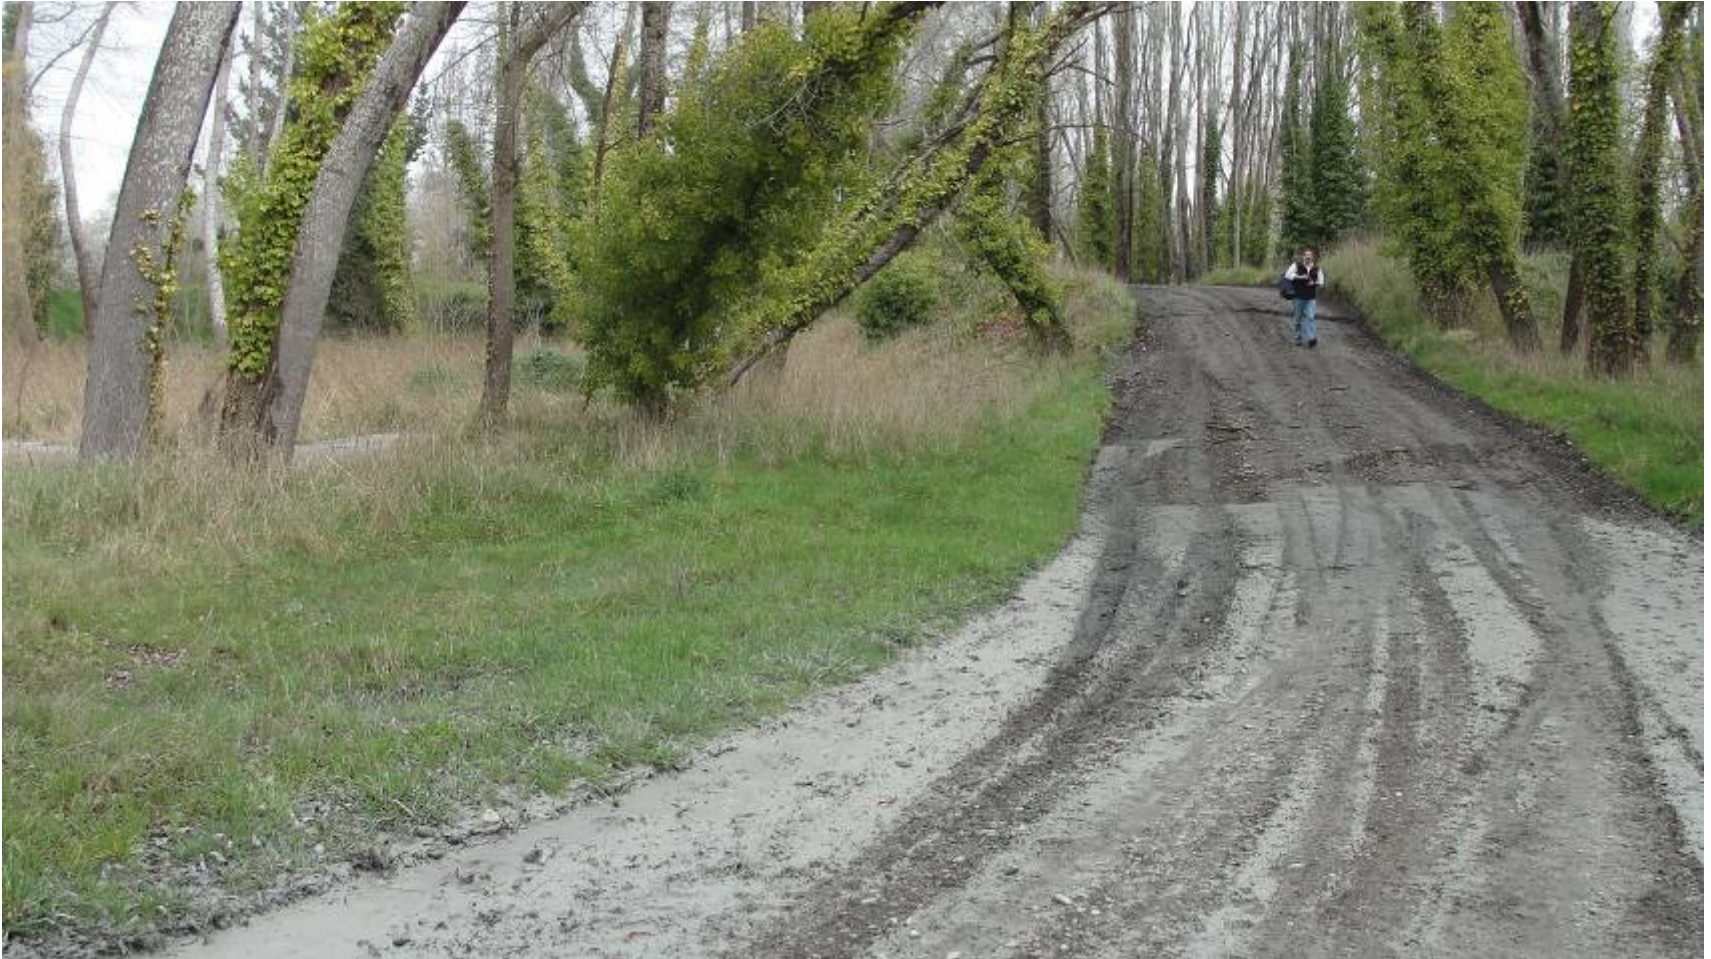
# Fissures from lateral spreading

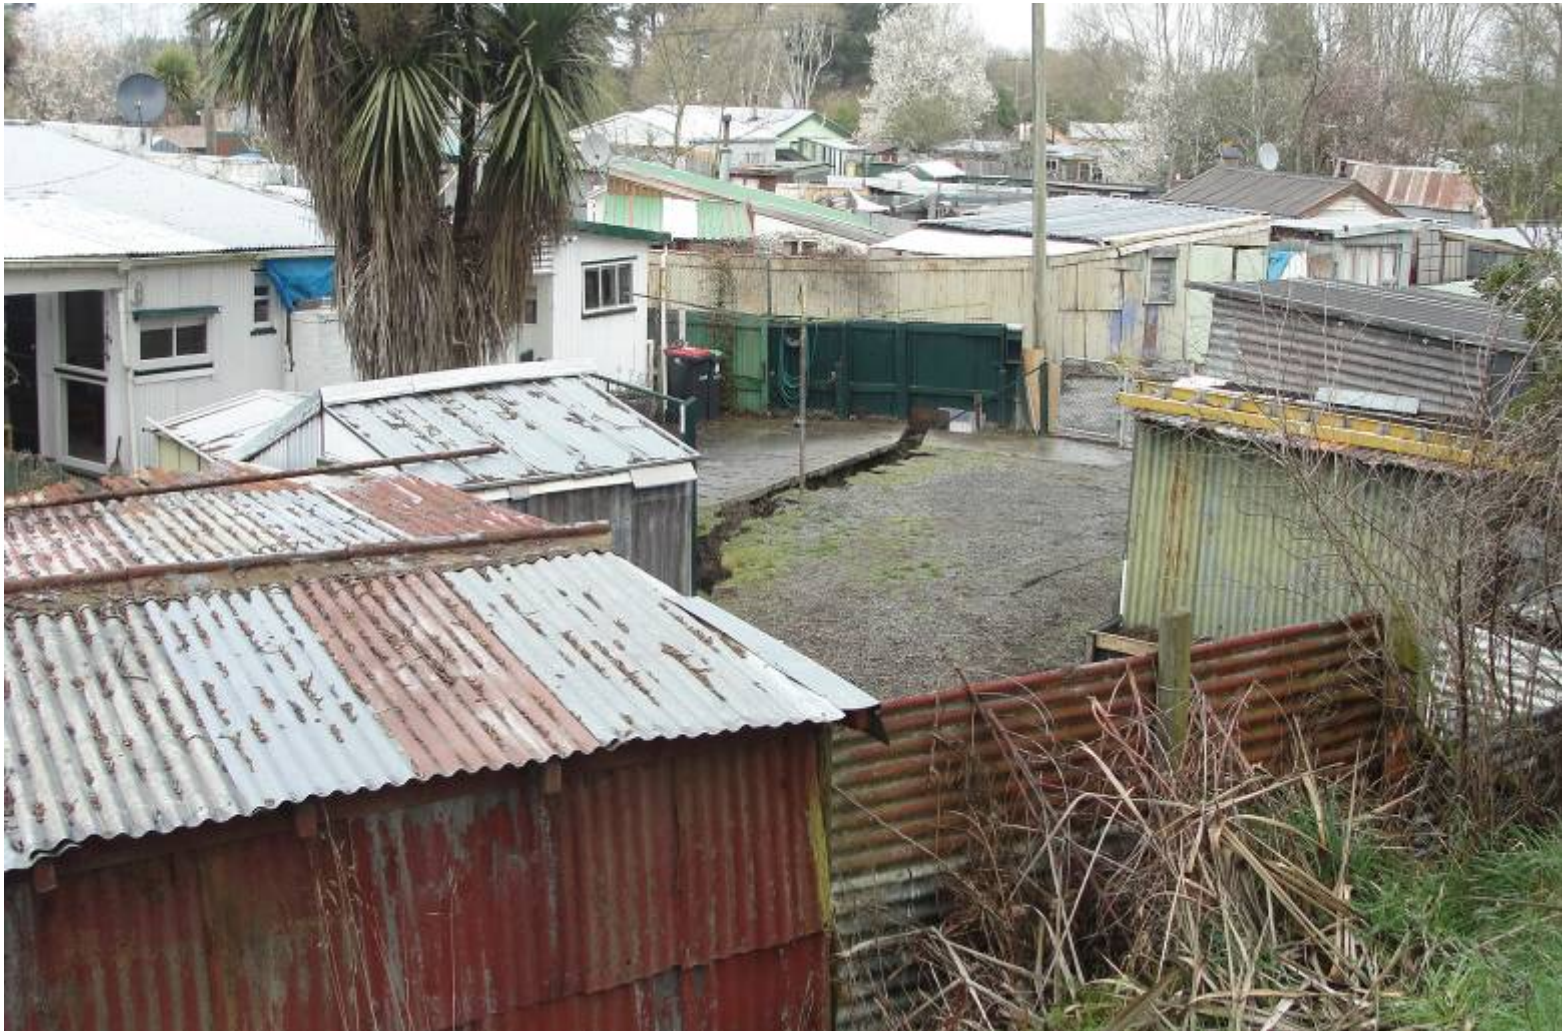
Fissure from lateral spreading. The river bank is at the right, in a distance of about 150m

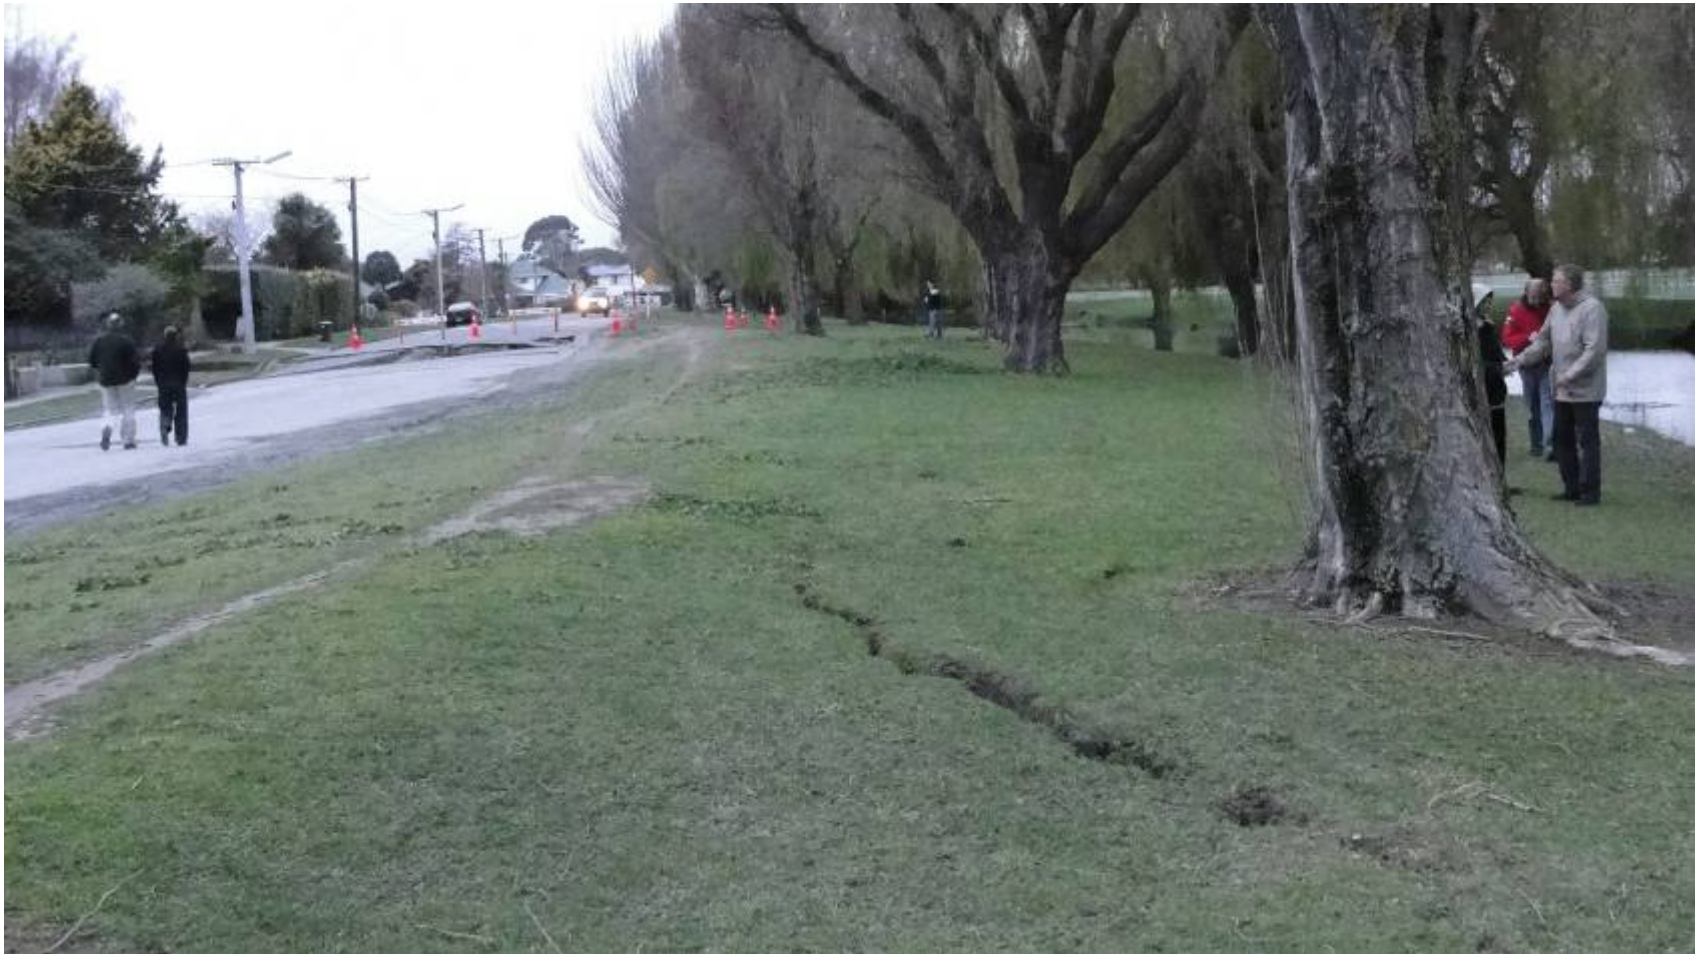
Lateral spreading. A canal can be seen on the right

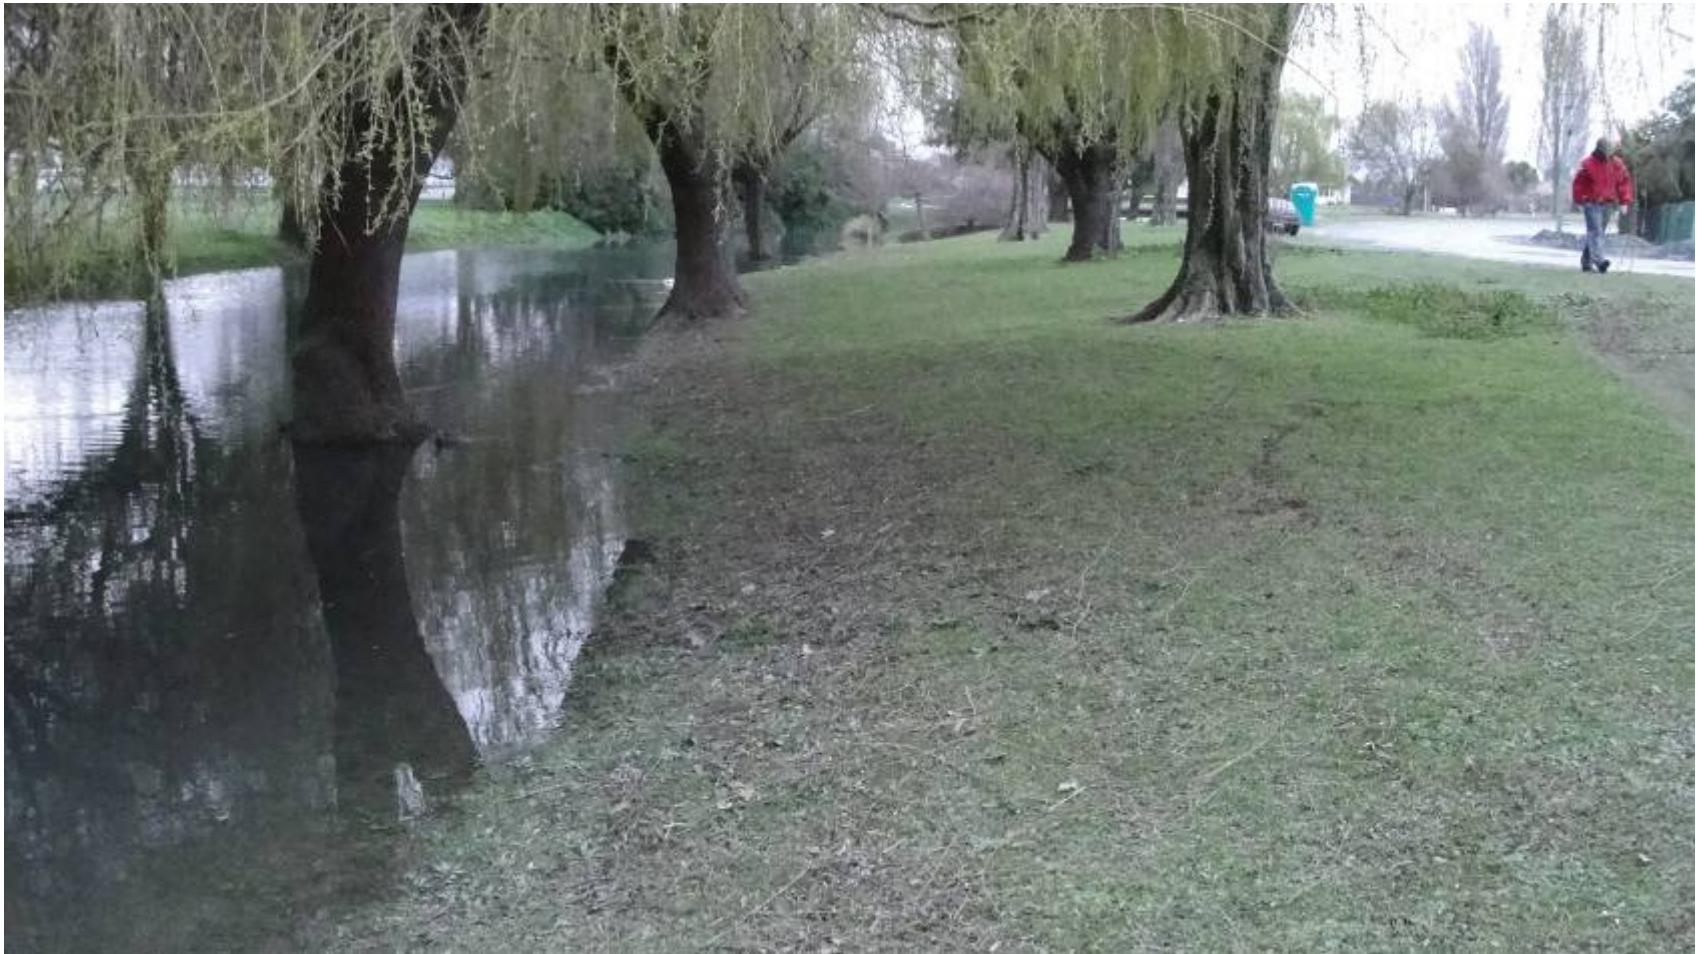
Lateral spreading. Due to the provoked subsidence the banks got new position, covering the trunks of trees

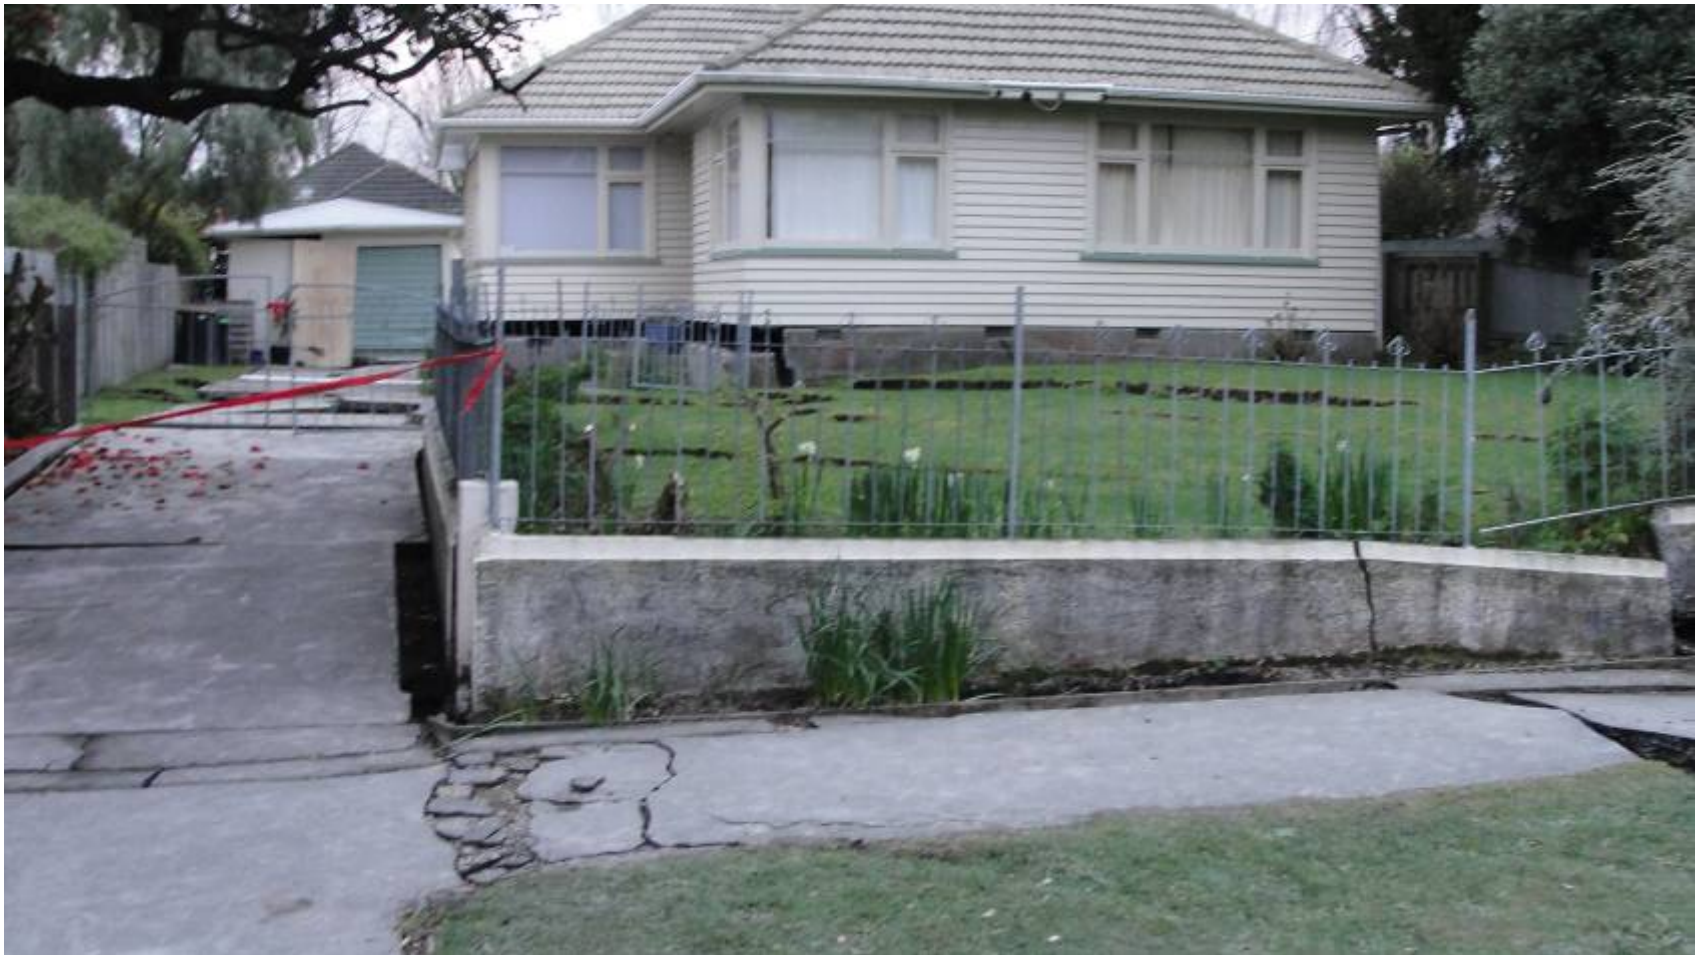
Lateral spreading towards the canal which is in front of the undermined house, in a distance of about 50m

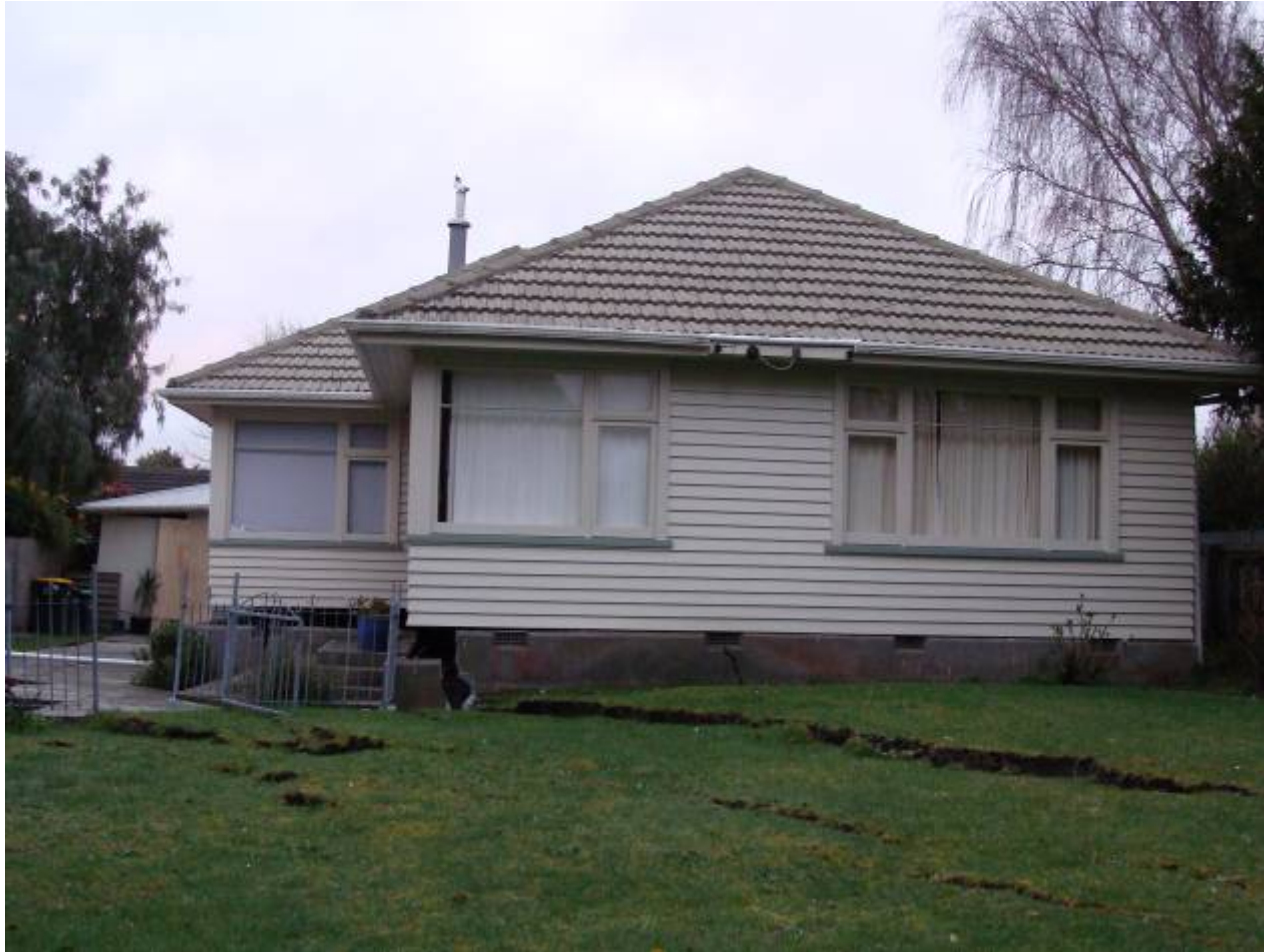
Lateral spreading that reached and undermined the house  
(with this simple, laying on ground, foundation)
