# The Nicoll Highway Collapse

D. W. Hight  
T.O. Henderson + A.R. Pickles  
S. Marchand

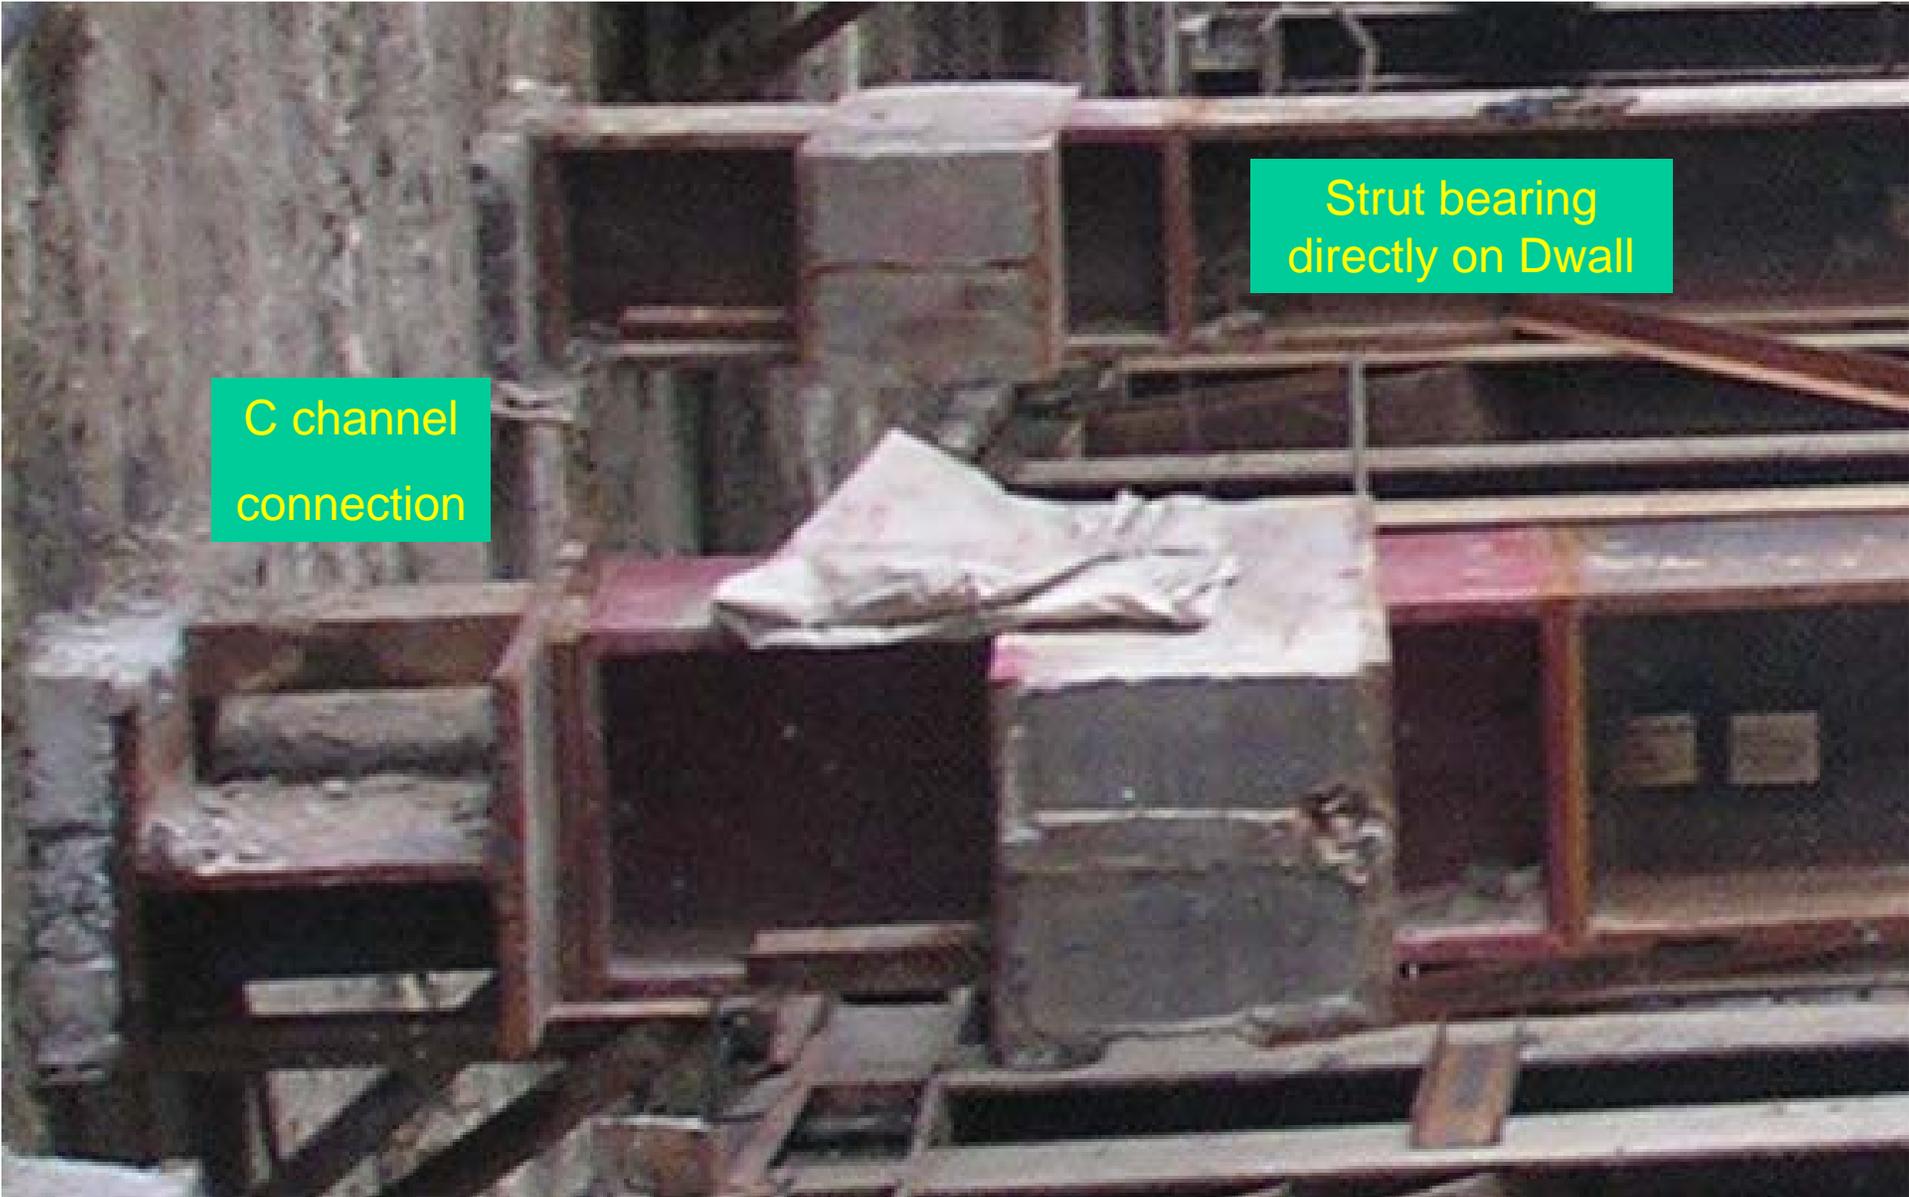
Strut bearing  
directly on Dwall

C channel  
connection

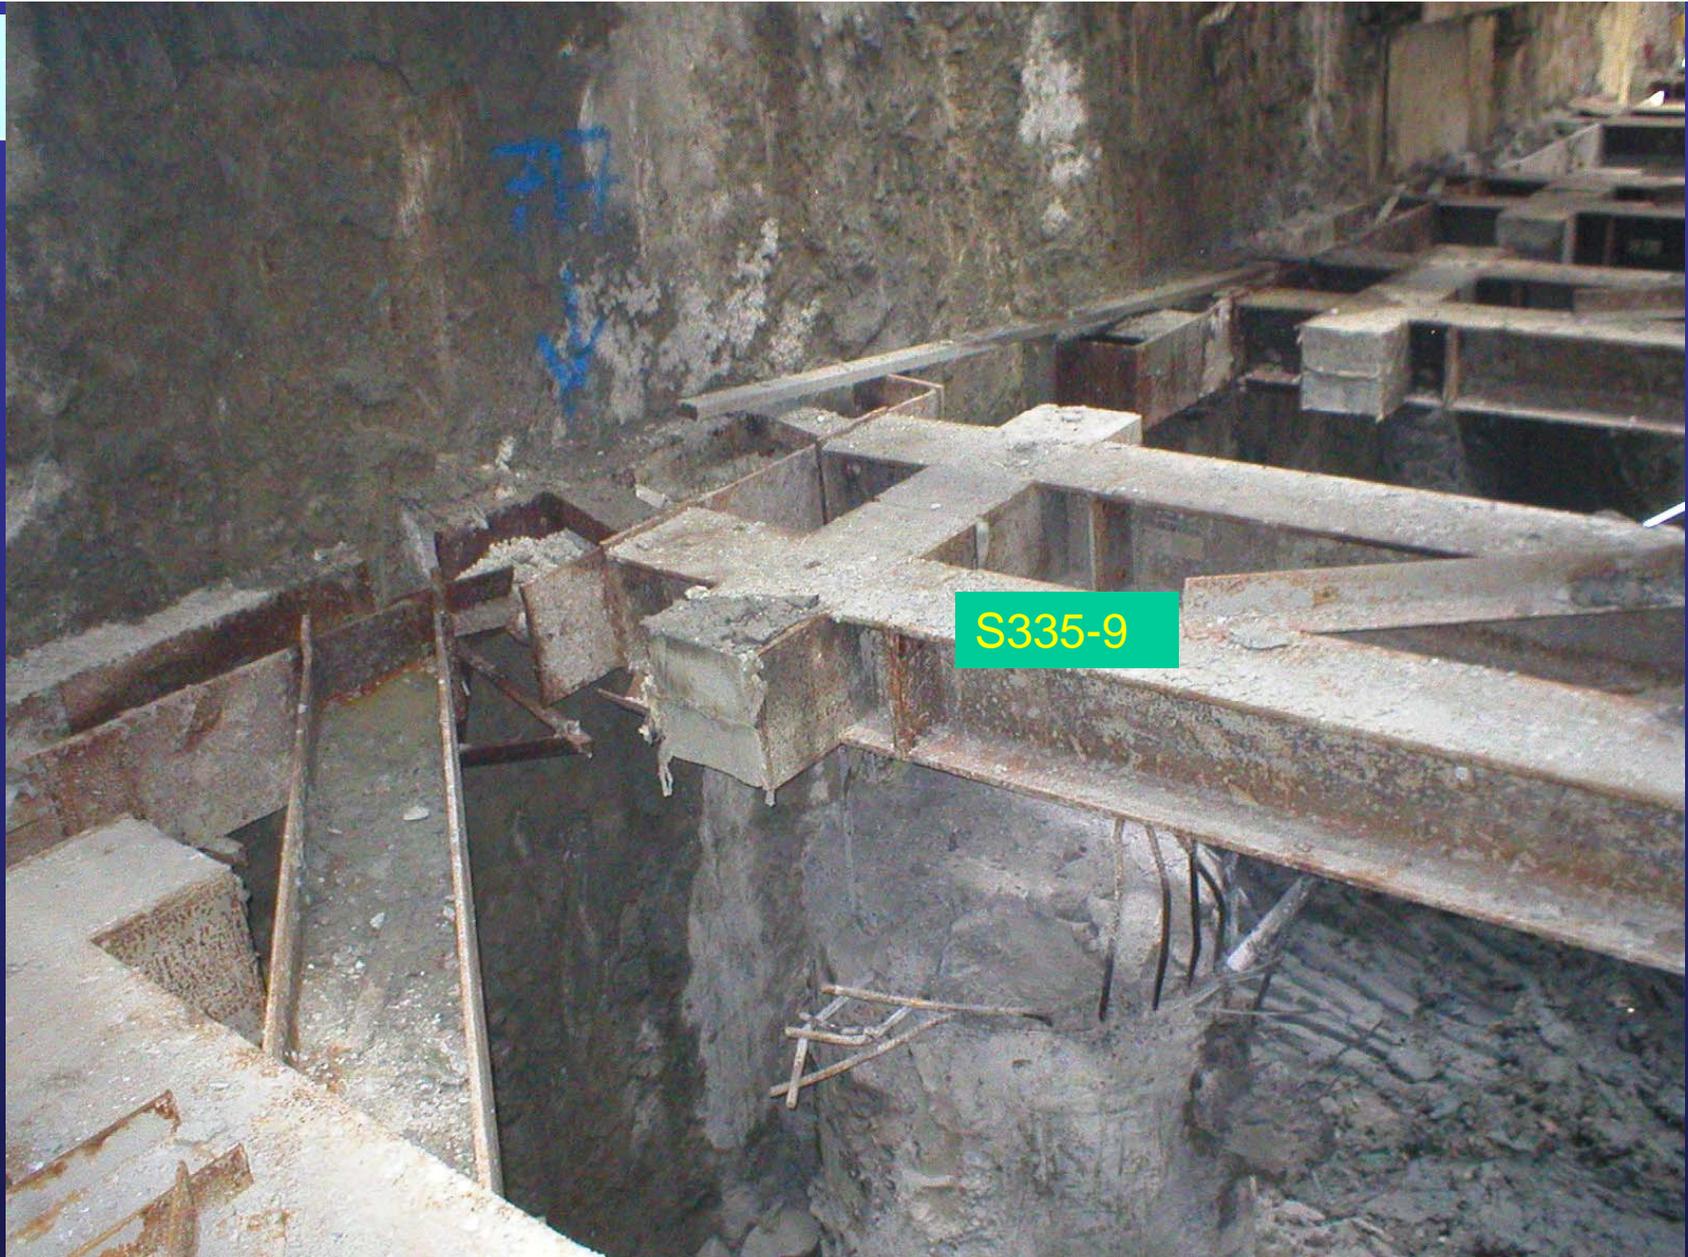
*Strut 335-9 south wall*

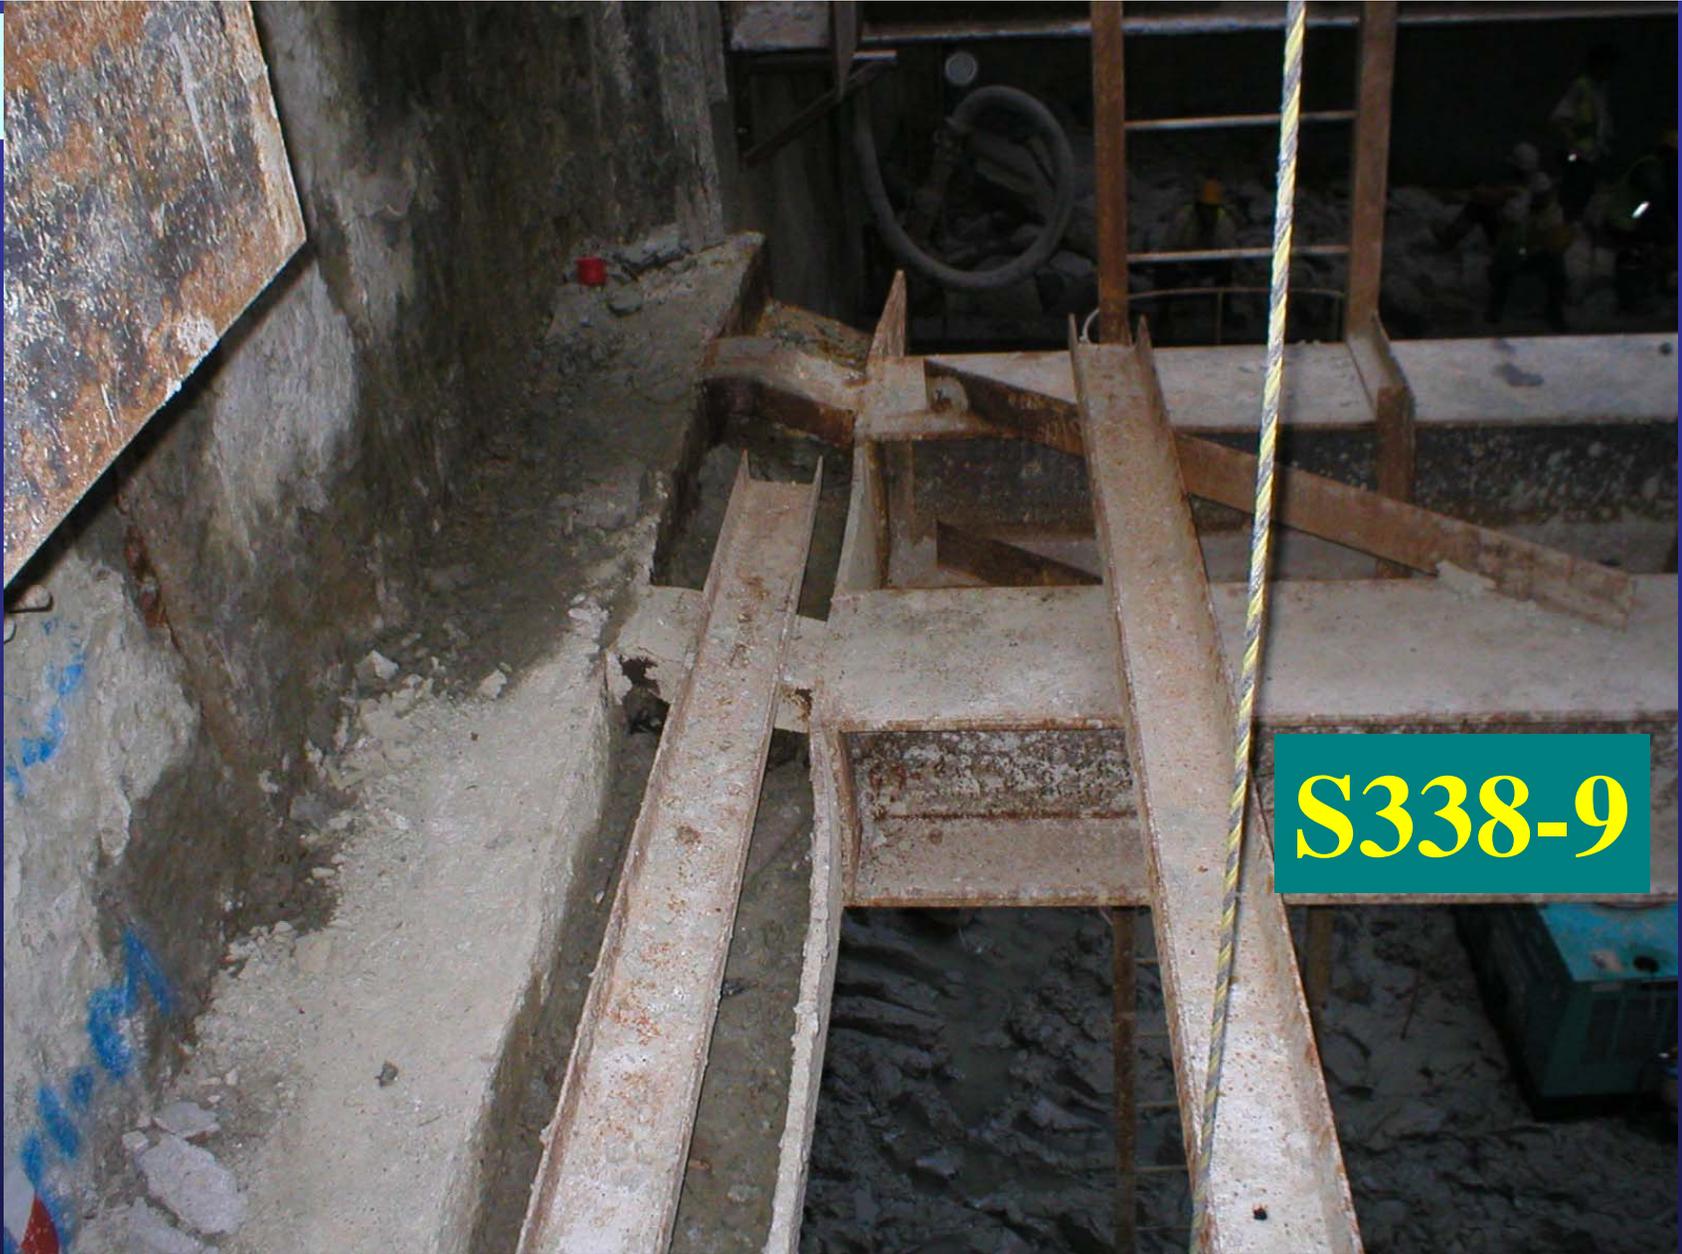
S338-9

*Strut 338-9 north wall*

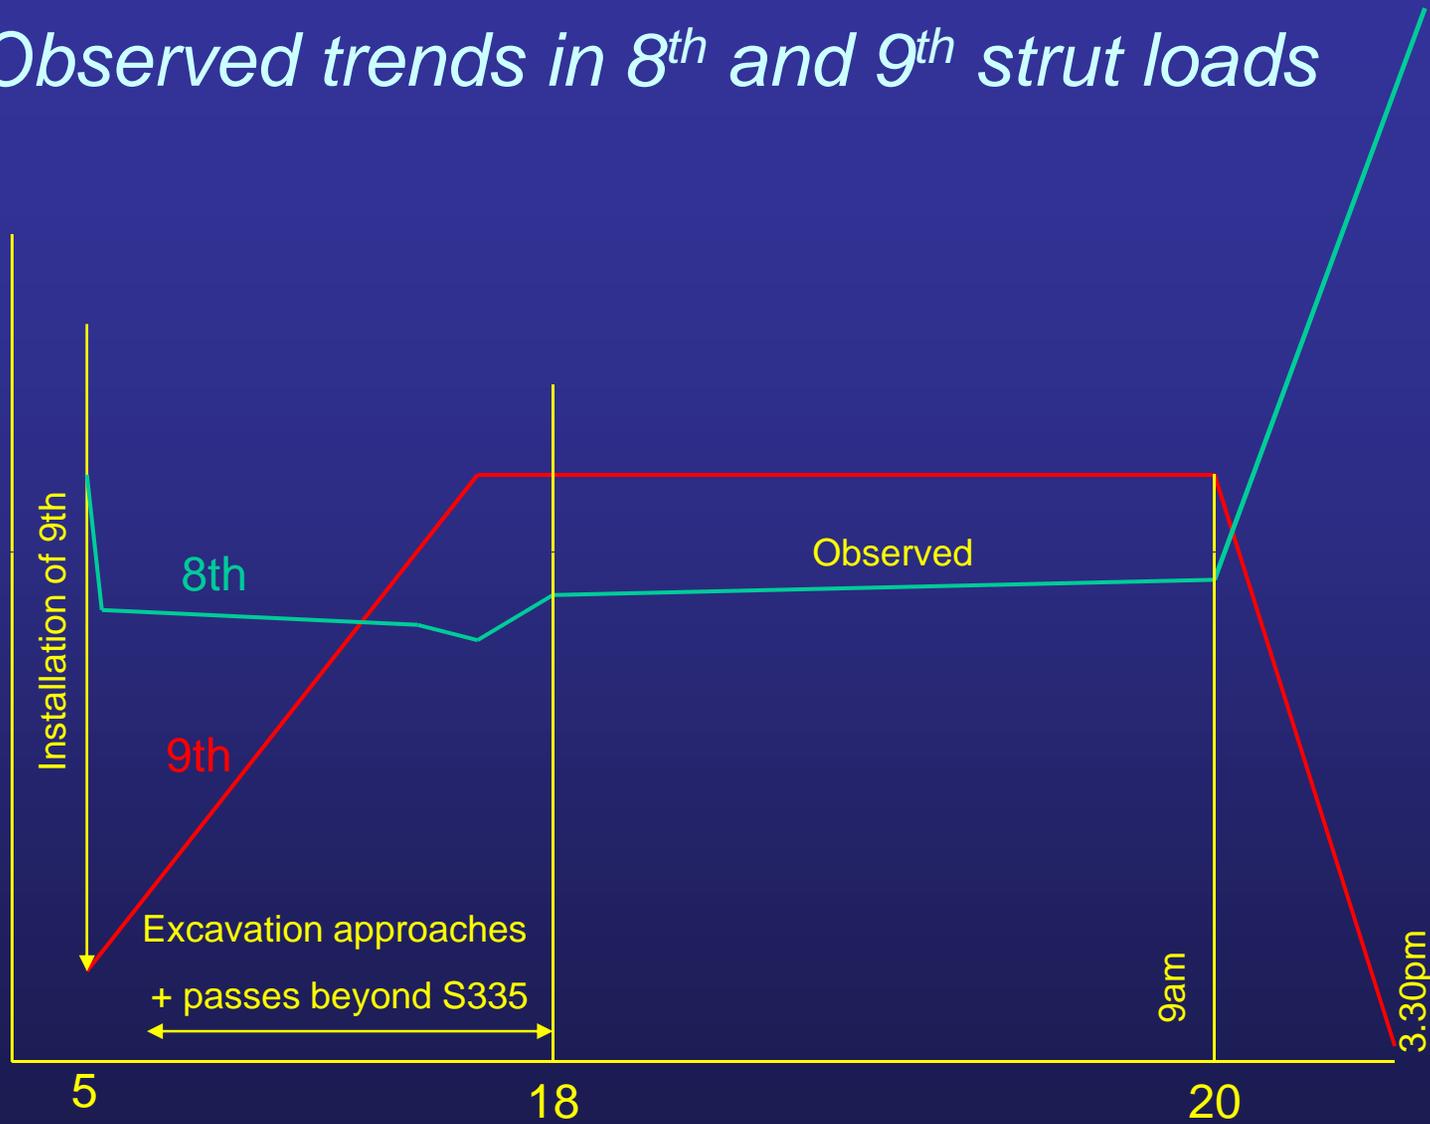
# Observed trends in 8<sup>th</sup> and 9<sup>th</sup> strut loads

The trends were consistent with there being yielding of the 9<sup>th</sup> level strut-waler connection when the excavation passed beneath but with no further significant changes in load in either the 9<sup>th</sup> or 8<sup>th</sup> level struts until the collapse was initiated

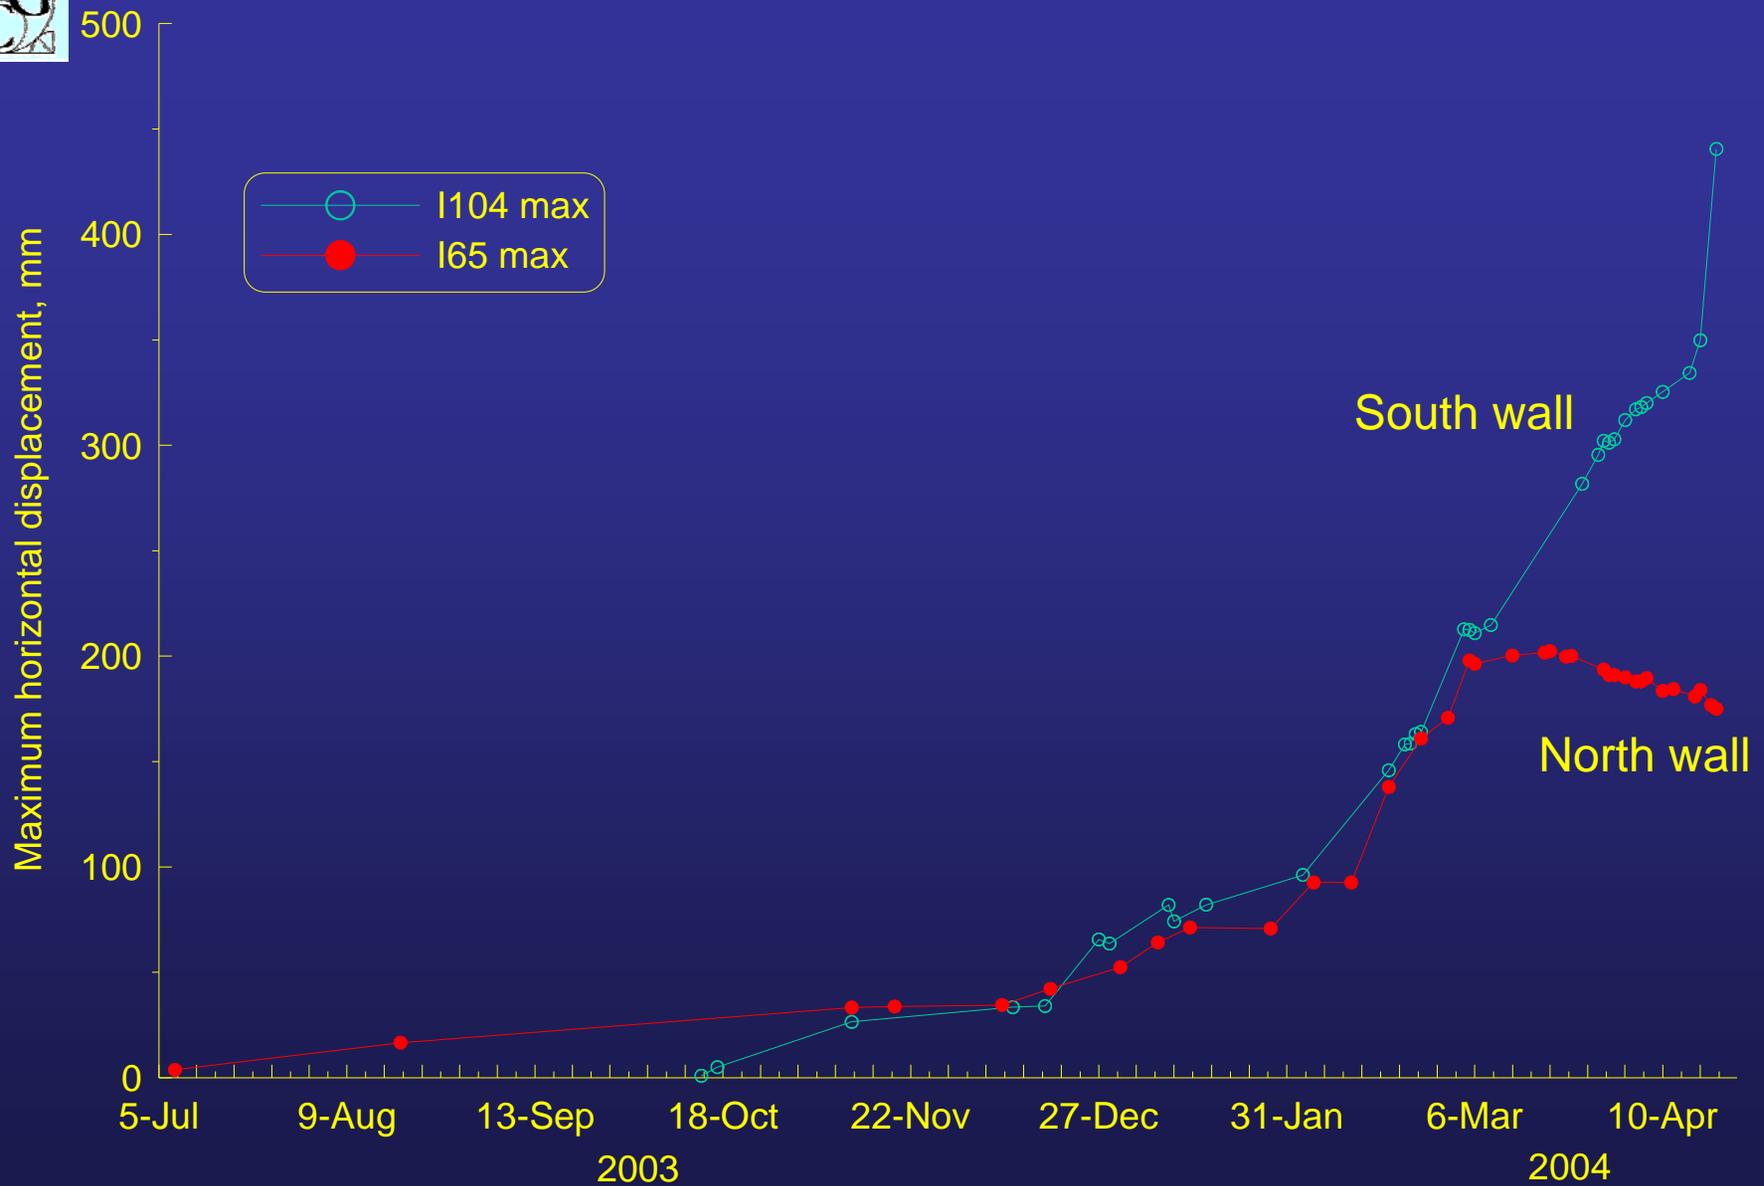
*Comparison of inclinometer readings I65 and I104*

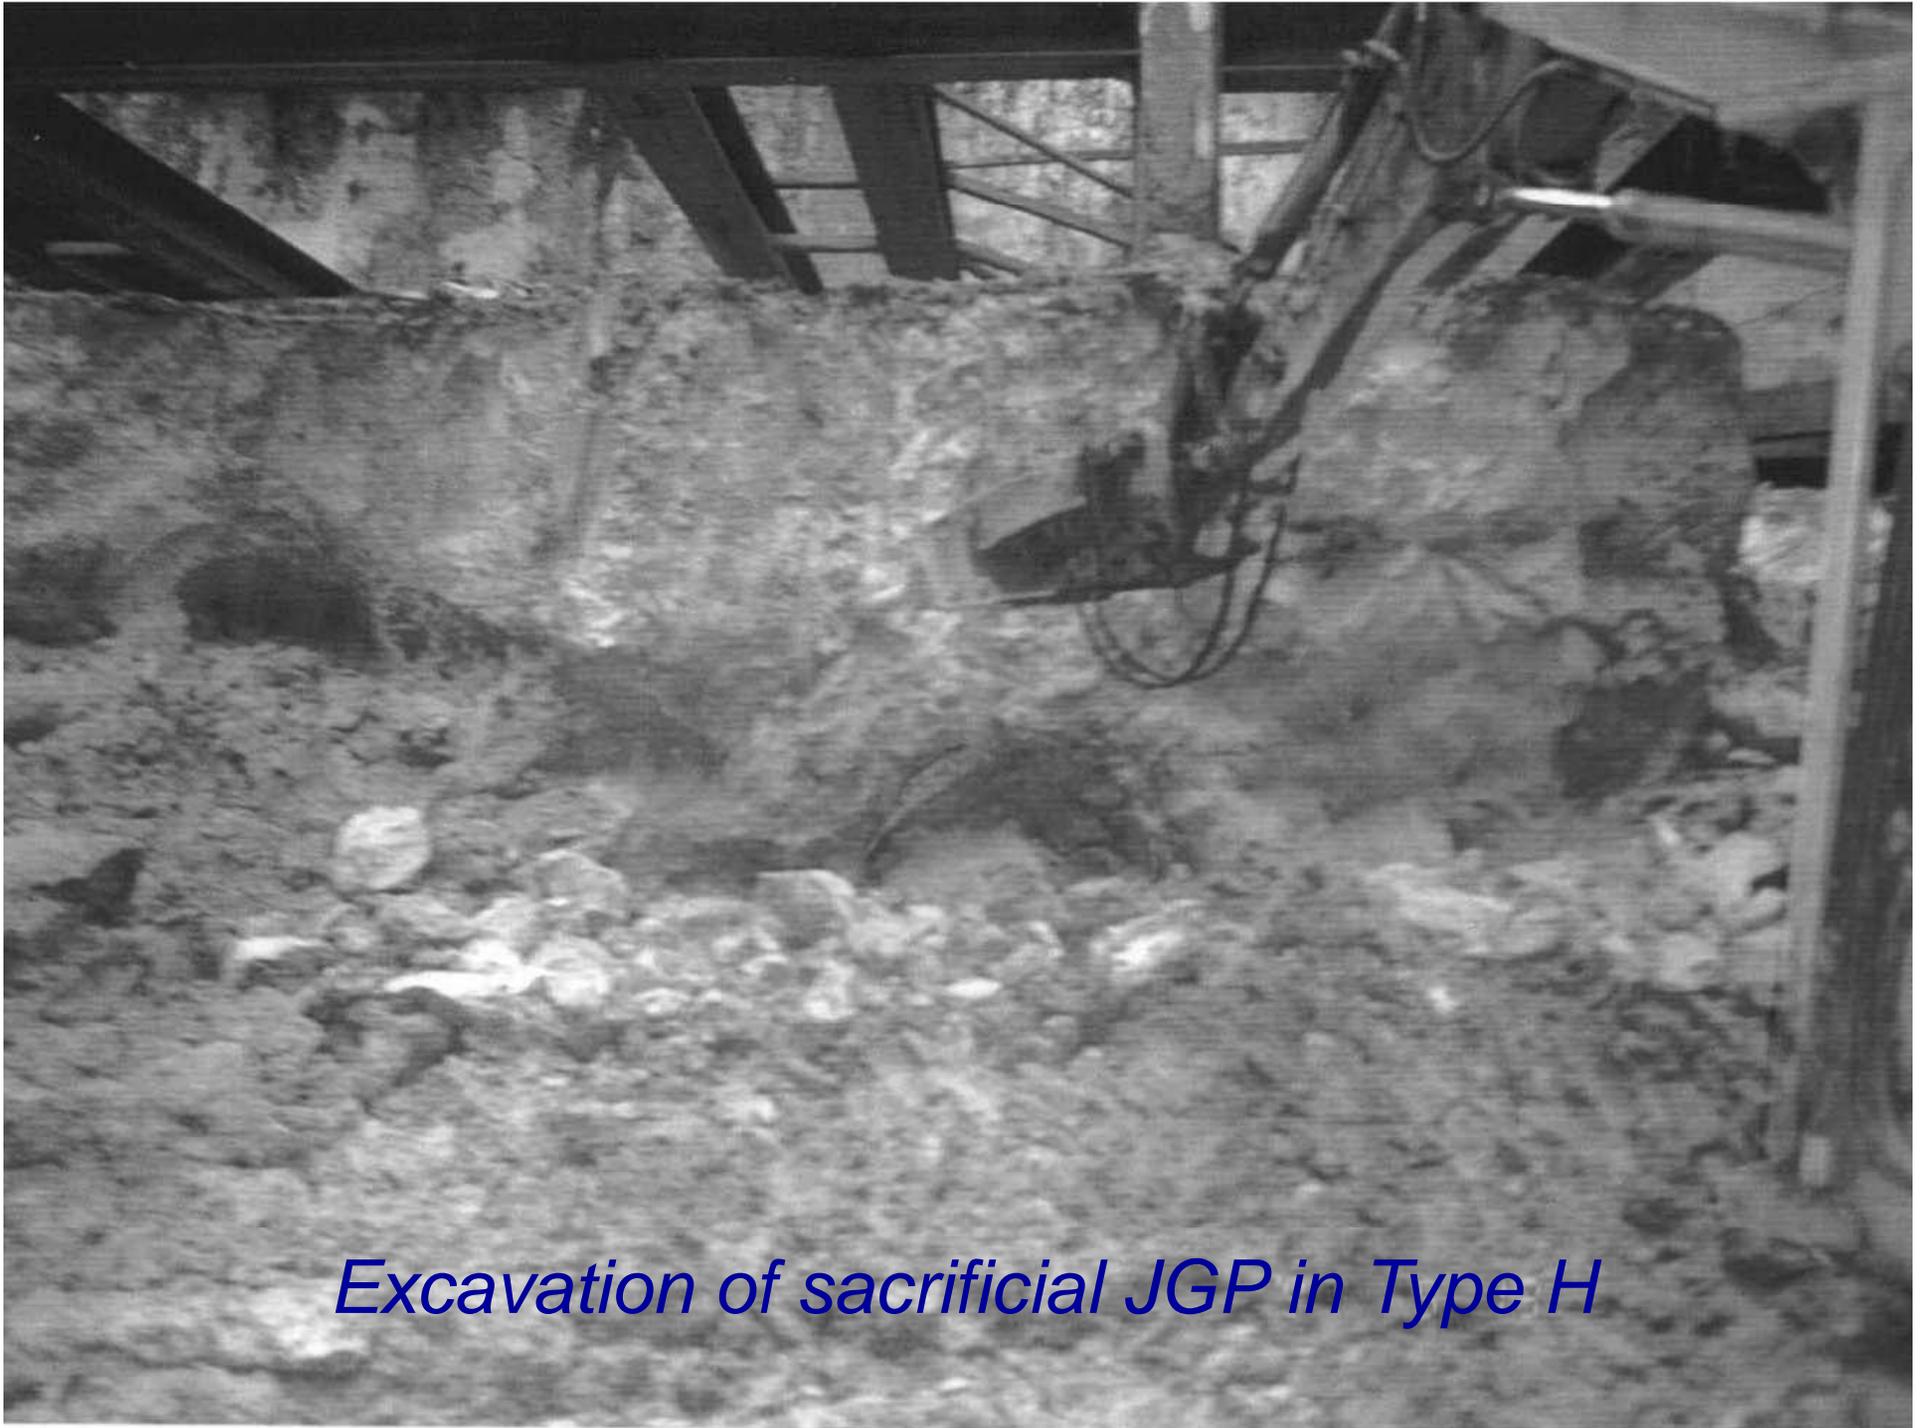
*Excavation of sacrificial JGP in Type H*

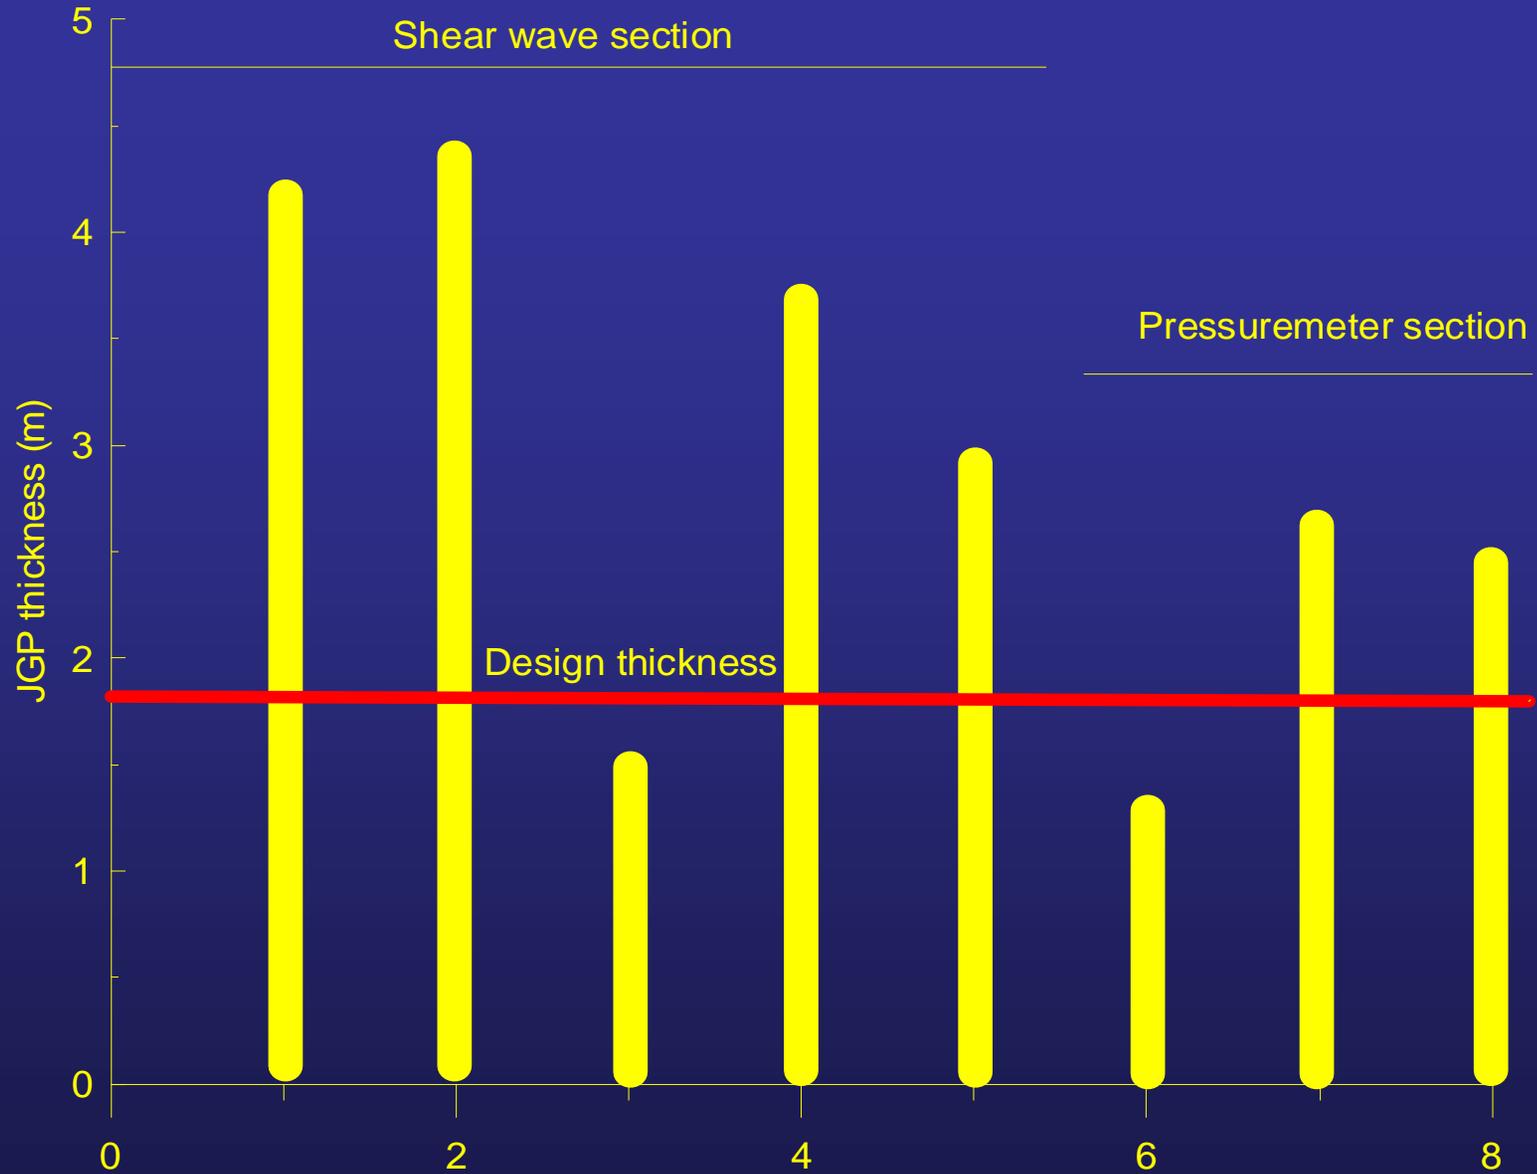
*Thicknesses of JGP in Type K*

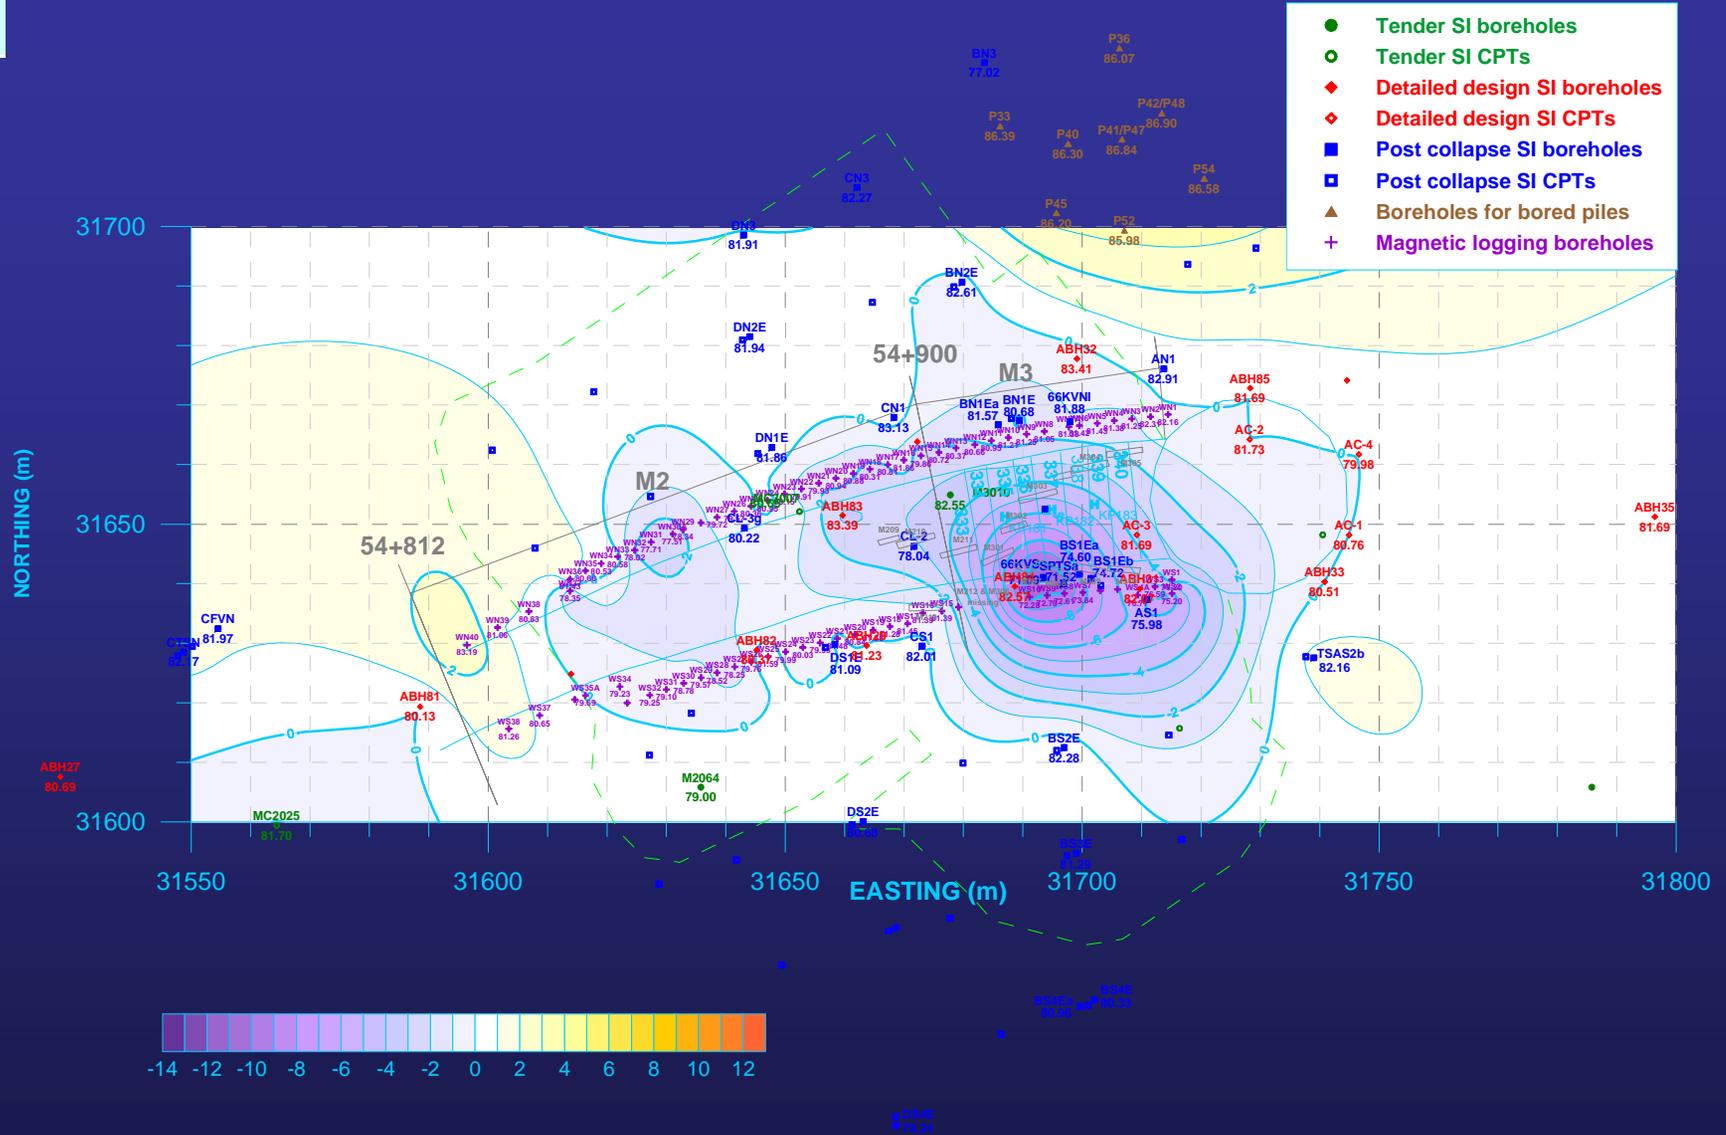
*Distortion to upper F2 layer caused by the collapse*

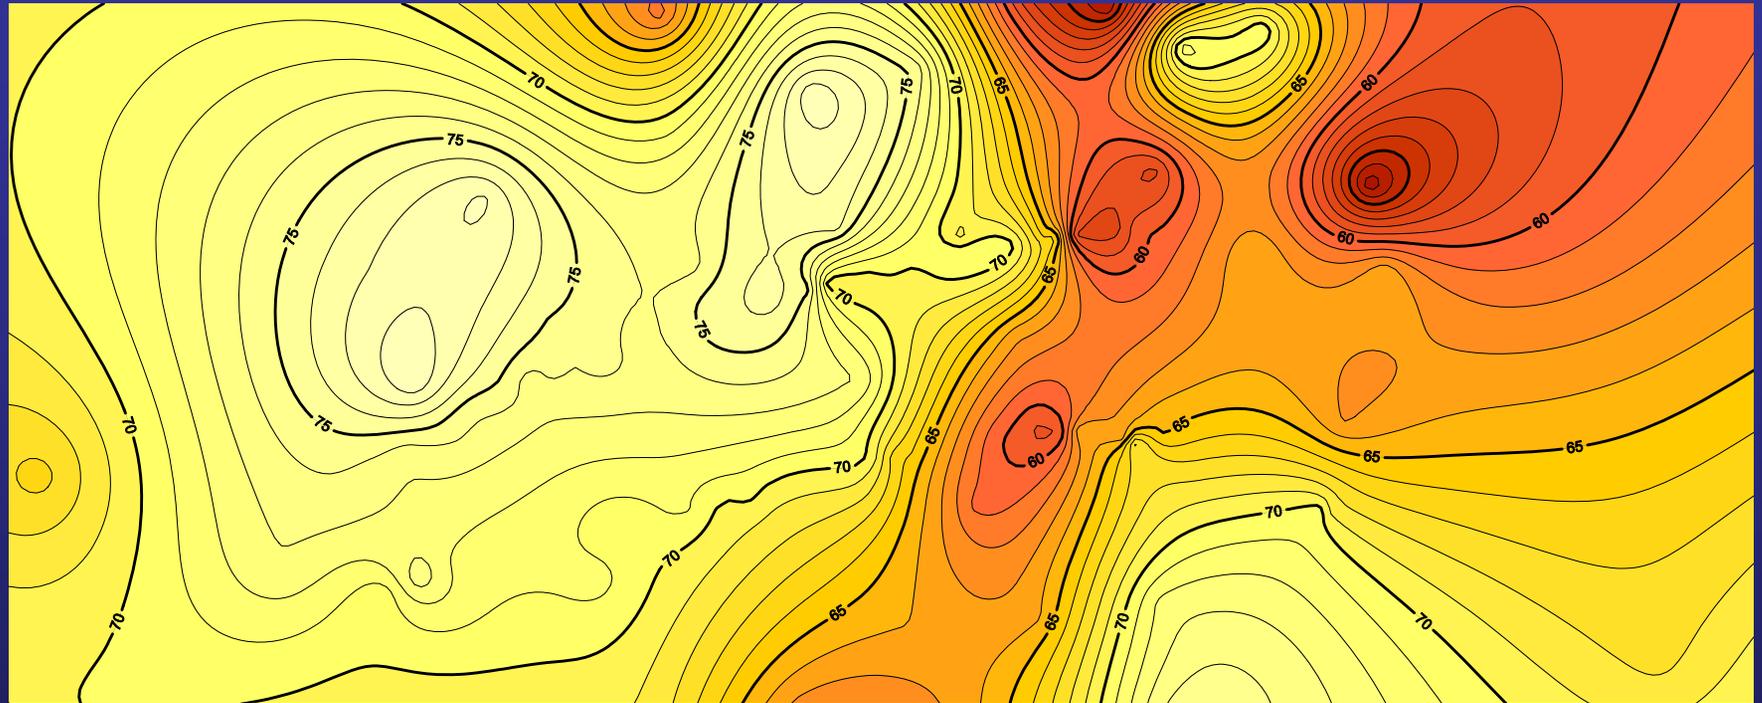
*Buried valley in the Old Alluvium*

- There was a buried valley crossing the site of the collapse diagonally from south-west to north-east
- The presence and setting of the buried valley explain the asymmetric conditions and the different collapse on the north and south sides
- The buried valley coincides with the major ground distortion on the south side and was clearly influential in the collapse
- Below the Lower Marine Clay the buried valley was infilled with estuarine organic clays on the south side and fluvial clays on the north side
- Gas exsolution almost certainly occurred in the deep organic clays as a result of stress relief, reducing their strength further

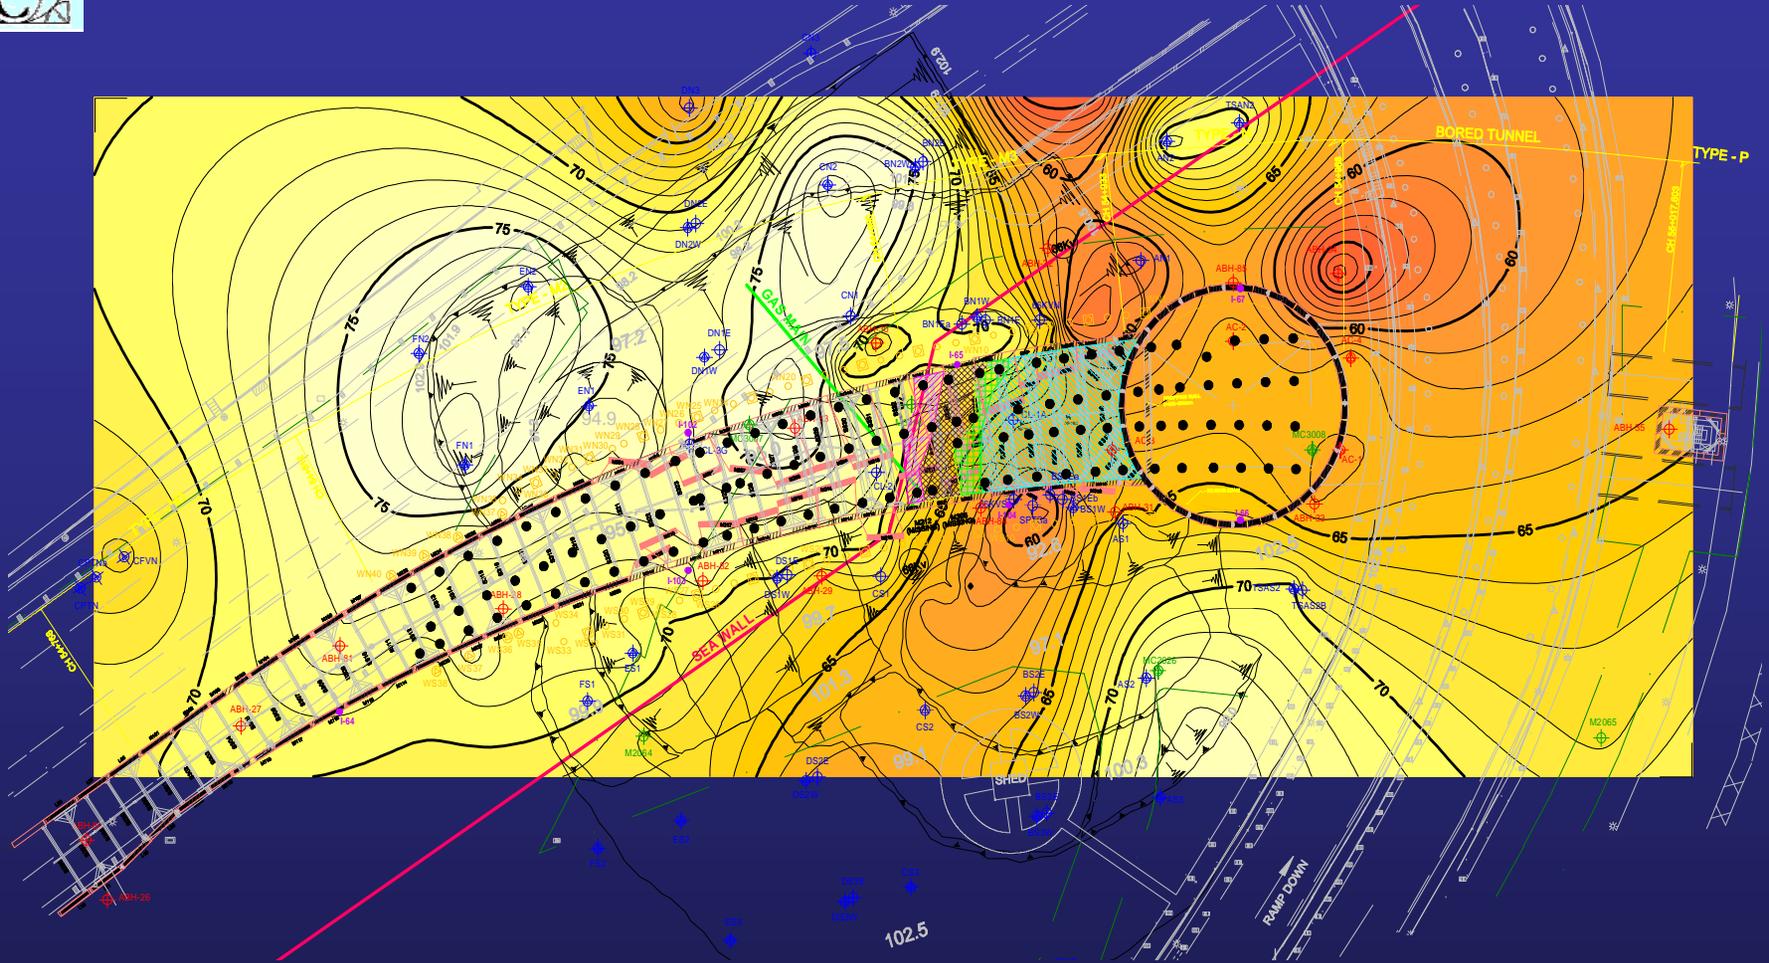
*Post-collapse geometry and sequence of excavation superimposed on buried valley*

- **The buried valley was crossed without collapse developing**
- Strut forces would have been a maximum in the buried valley and would have varied across the valley
- The collapse was not, therefore, inevitable
- An external influence (trigger) is required to explain the timing of the collapse and why it occurred after crossing the buried valley

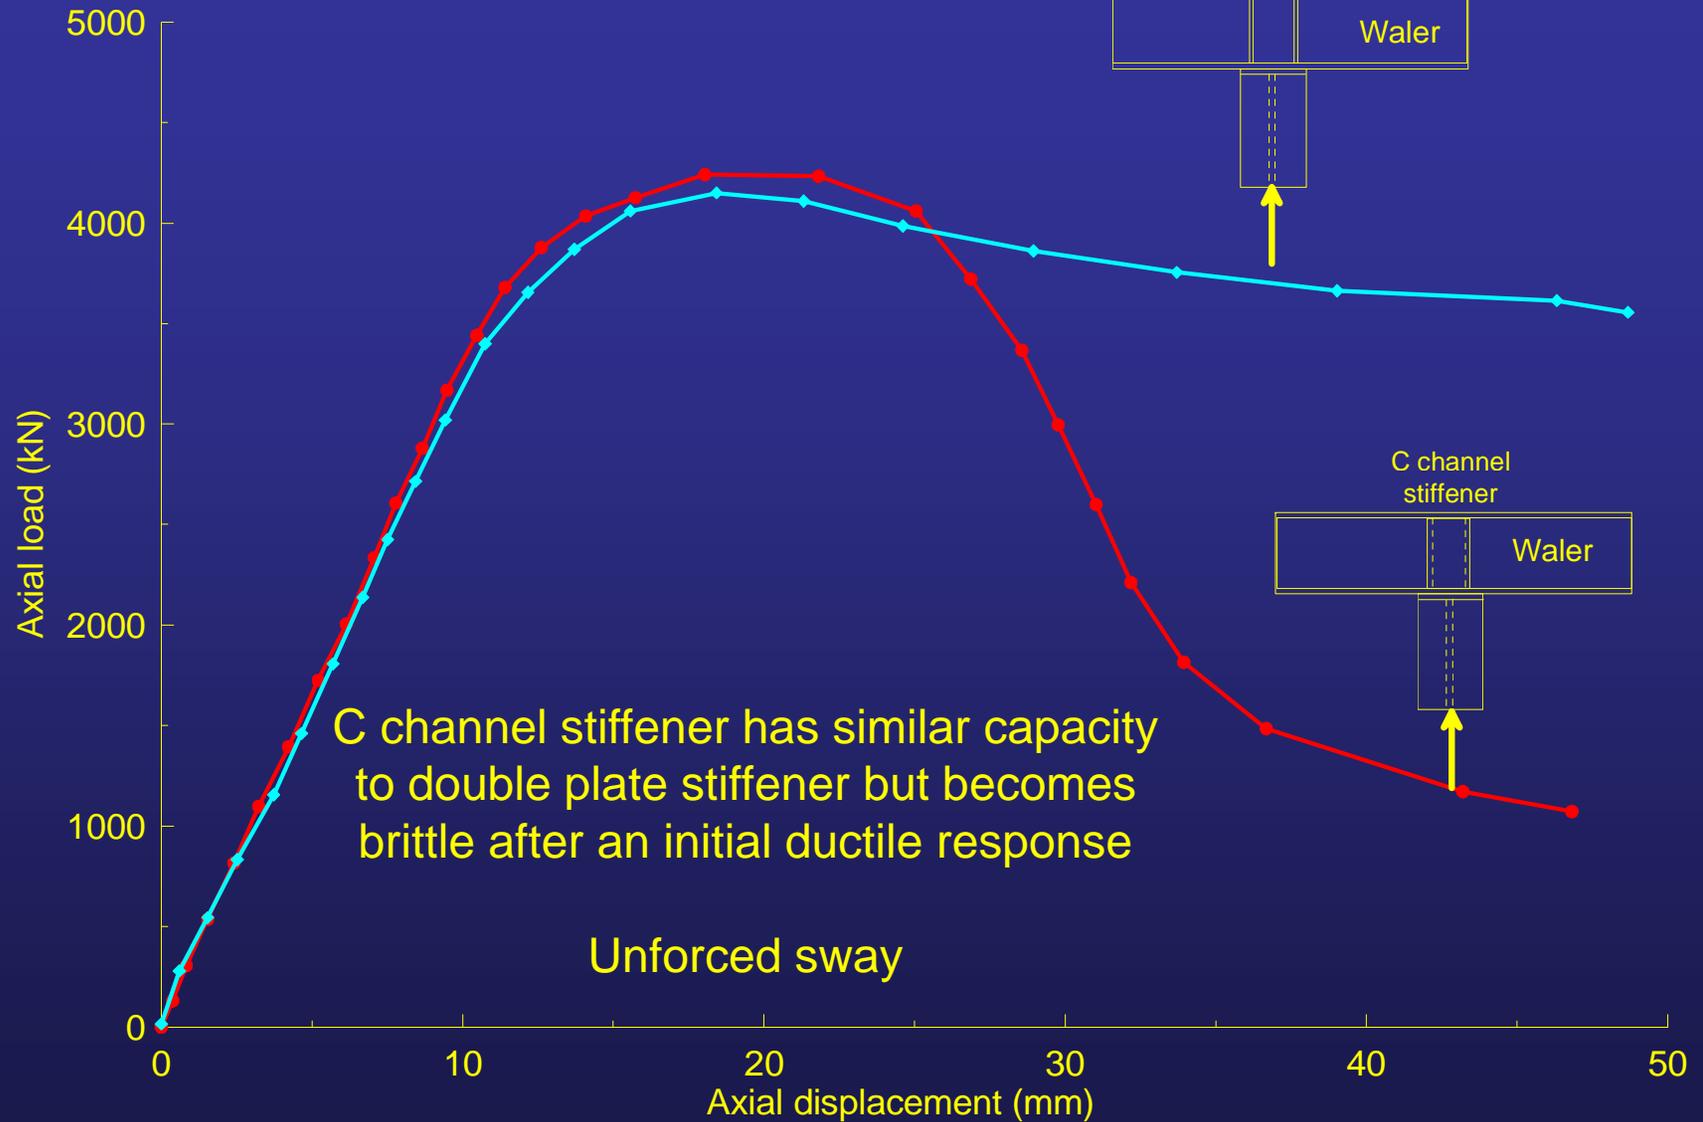
C channel stiffener has similar capacity to double plate stiffener but becomes brittle after an initial ductile response
