# The Nicoll Highway Collapse

D. W. Hight  
T.O. Henderson + A.R. Pickles  
S. Marchand

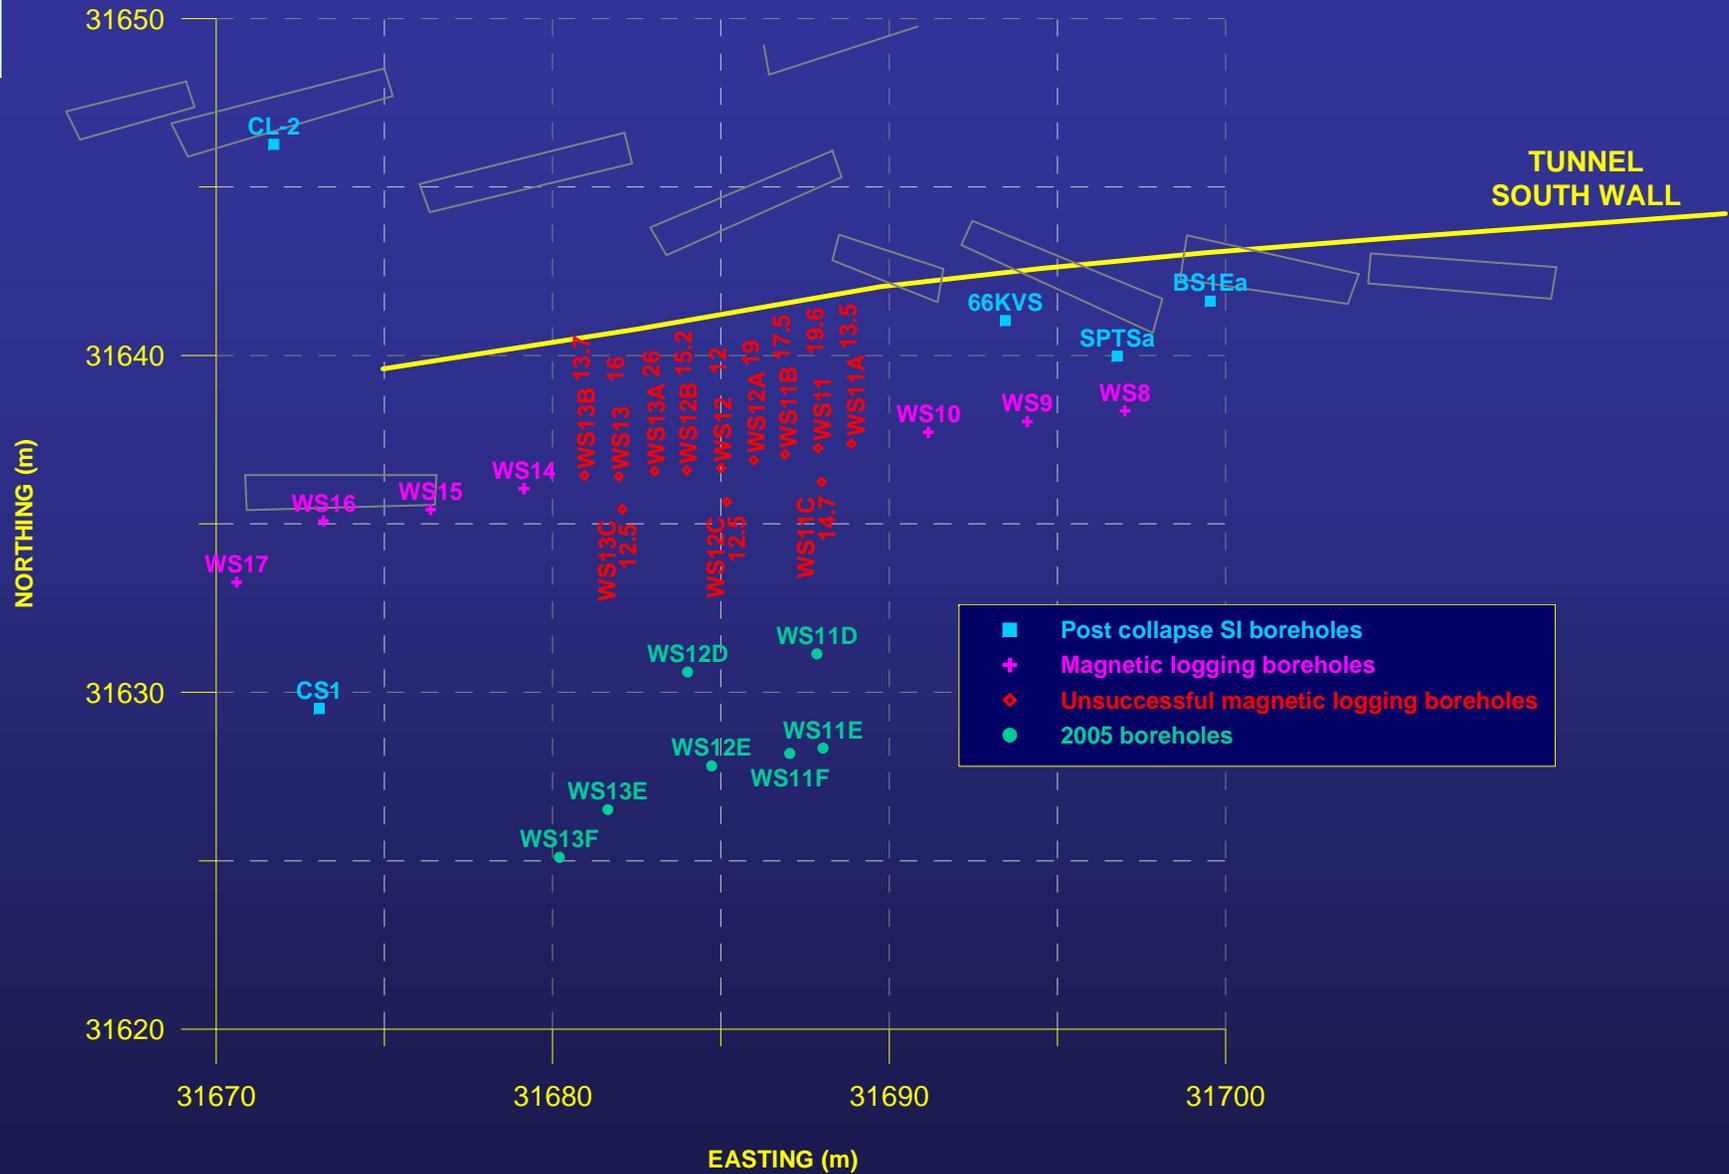
*Coincidence between inability to advance boreholes and missing Dwall panels*

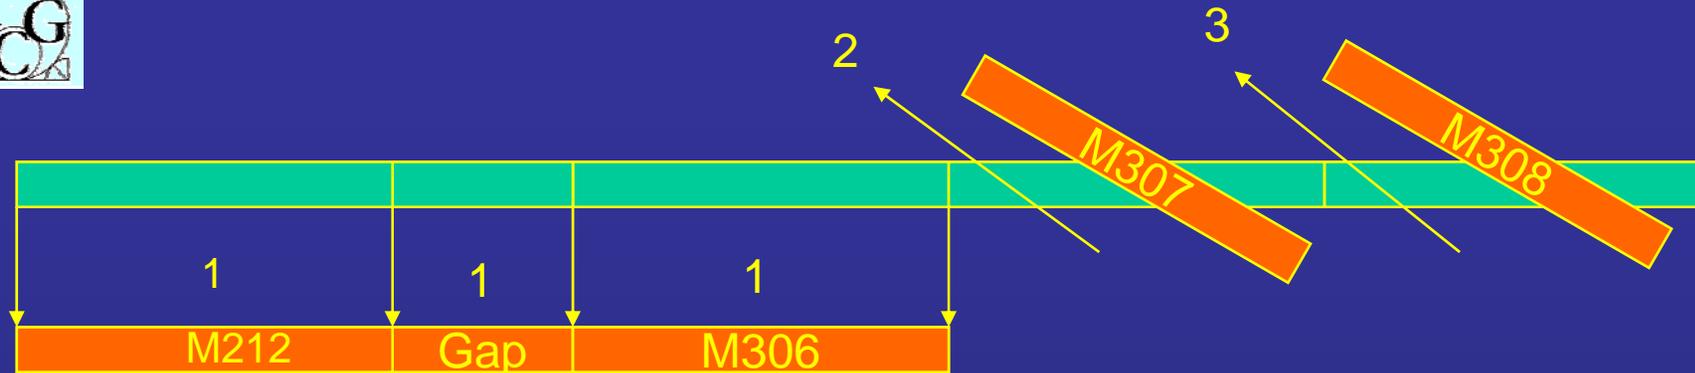
1. Panels M306 and M212, each side of the gap, and panel 213 fail by toe kick-in and rotate back.
2. Soil flows through resulting gap between M306 and M307, rotating panel 307.
3. Soil flows through resulting gap between M307 and M308, rotating panel 308, etc.

*Sequence of south wall panel movements*

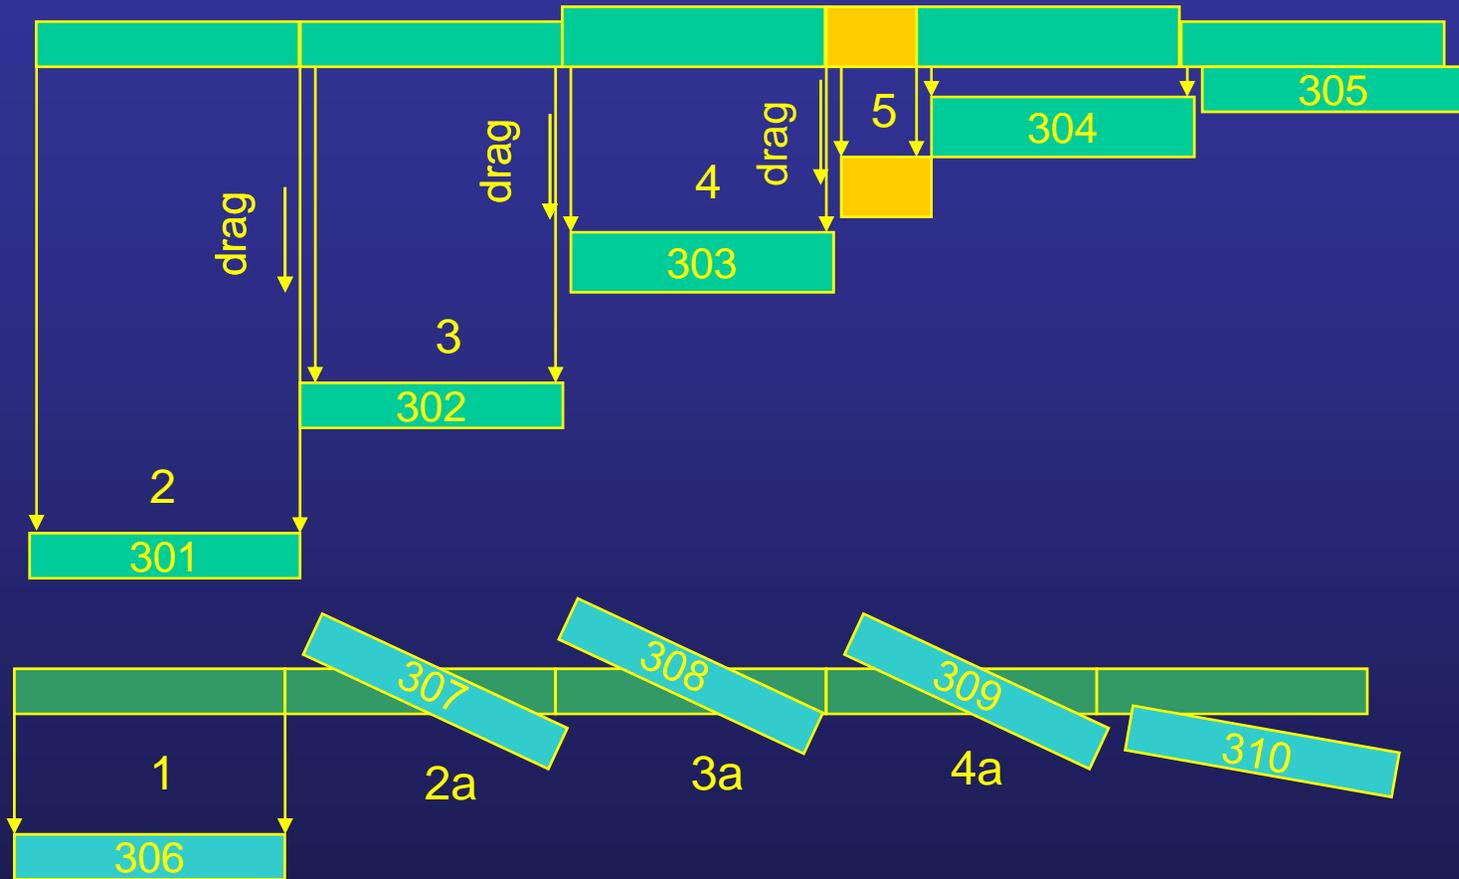
*Sequence of south and north wall panel movements*

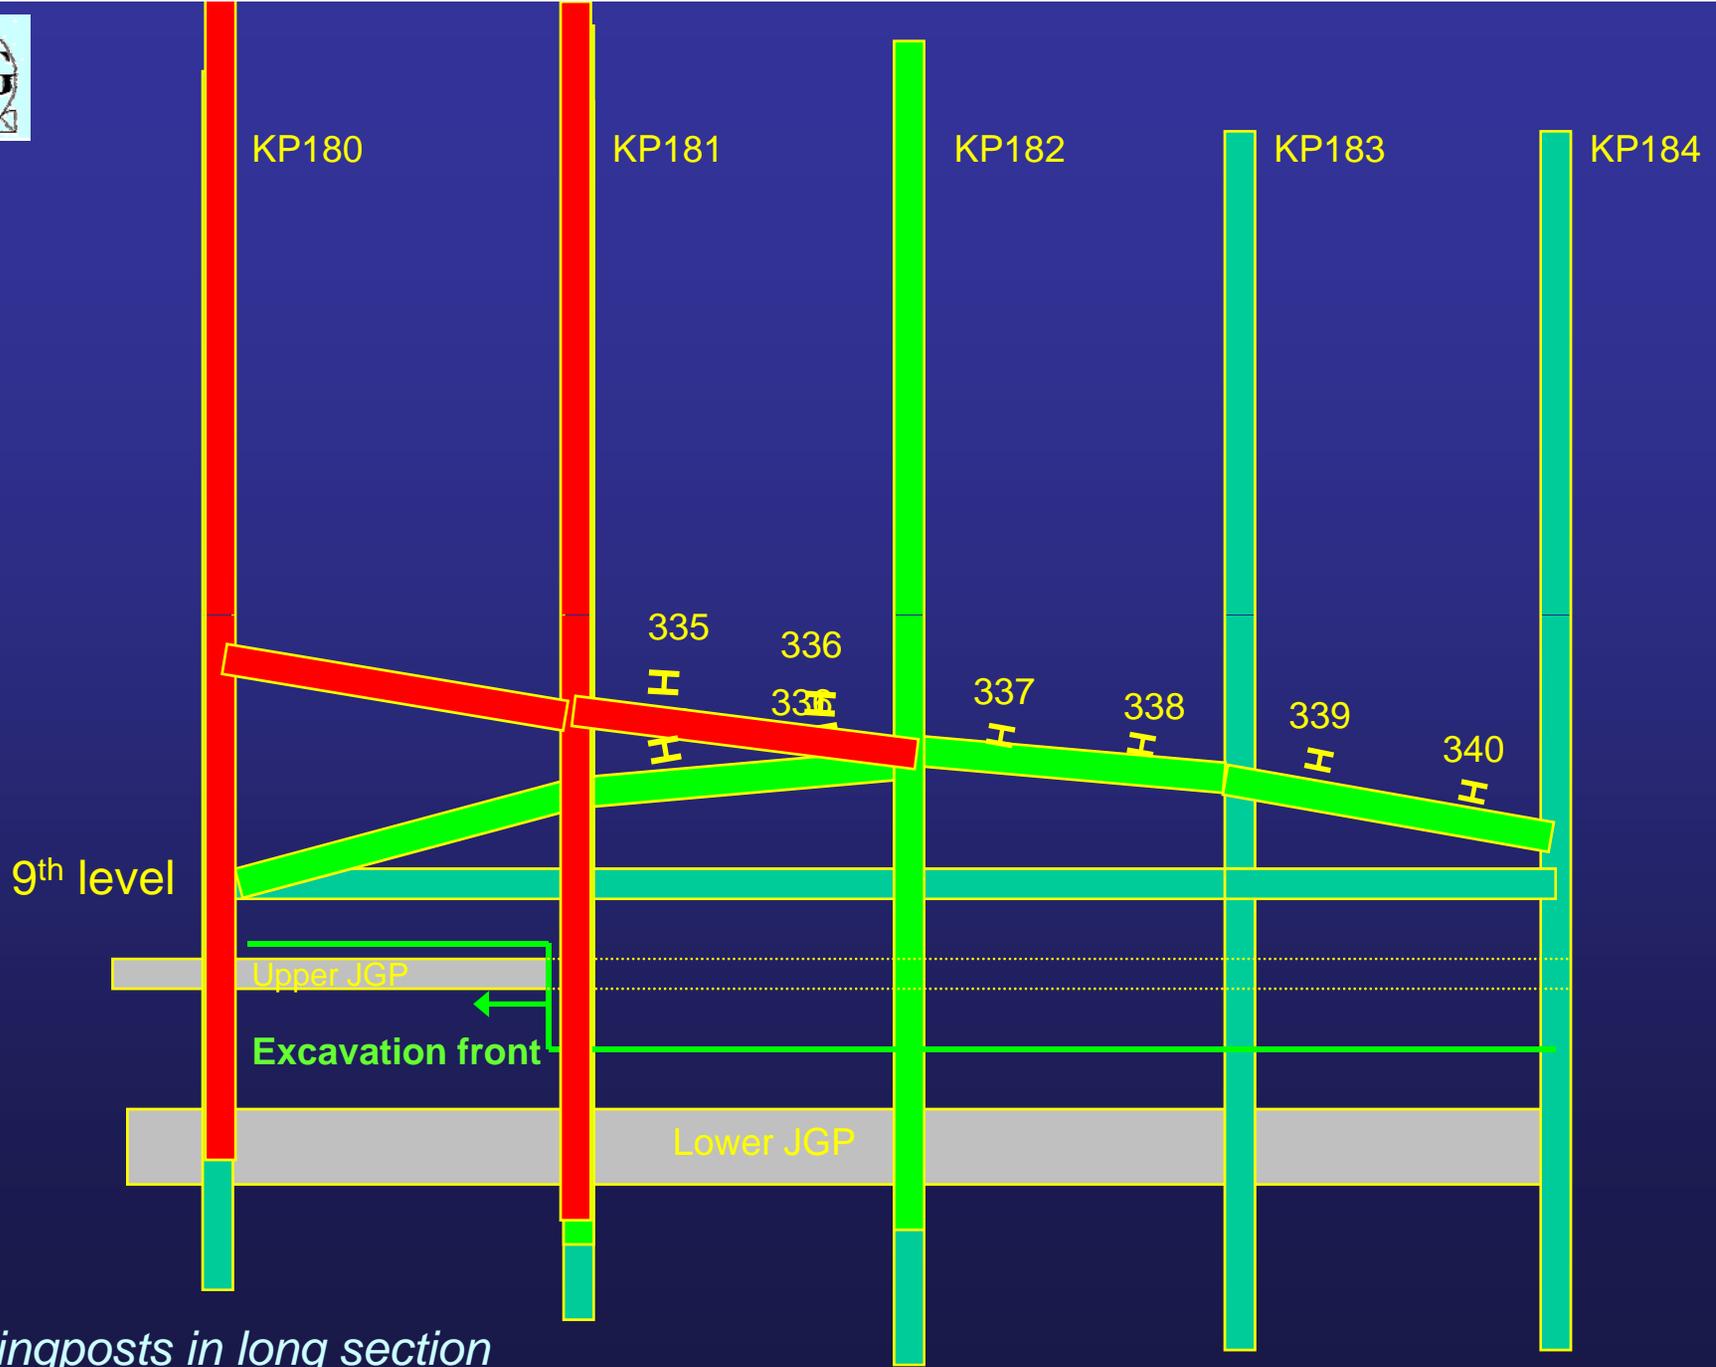
- Upward displacement of KP 180 and 181 accentuated by toe displacement of M306 and M212, where bored piles had been re-positioned and additional toe movement was possible
- Resulting RVD fed back into buried valley

*Kingposts in long section*
