# **Τα Νἑα** της Ε Ε Ε Γ Μ

# ΣΕΙΣΜΟΙ ΝΕΑΣ ΖΗΛΑΝΔΙΑΣ ΚΑΙ ΙΑΠΩΝΙΑΣ

Αρ. 37 – ΑΠΡΙΛΙΟΣ 2011 ΠΑΡΑΡΤΗΜΑ

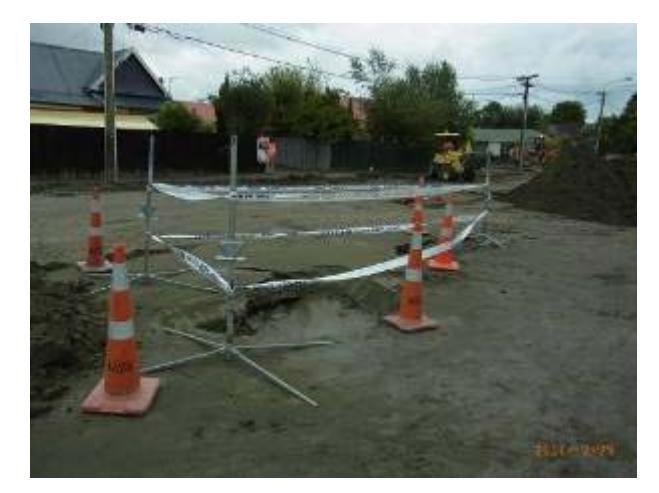
Photo 1 Big sand boil in Alard Street, Edgeware

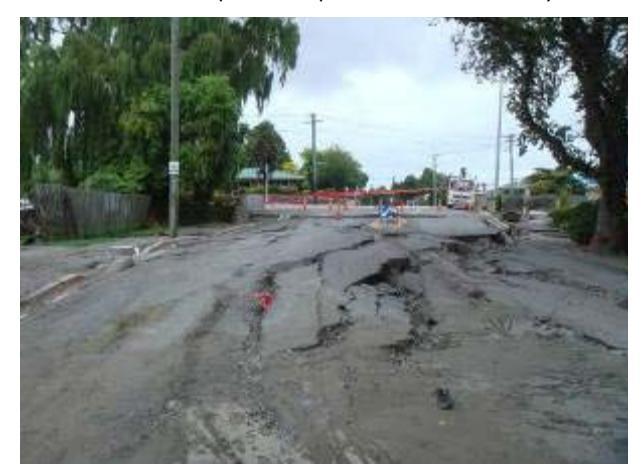
Photo 4 Damaged road embankment in Avonside Drive

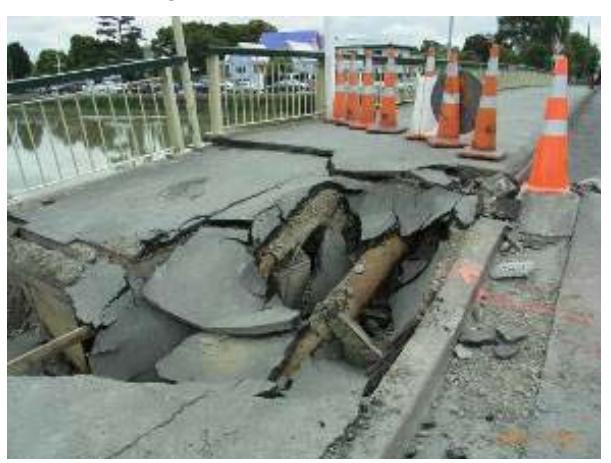
Photo 5 Pipeline damage at Avondale & Brighton on Avon River

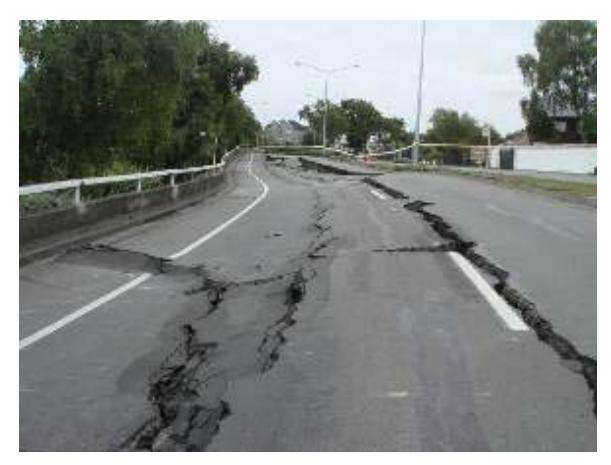
Photo 6 Collapsed portion of Fitzgerald Avenue

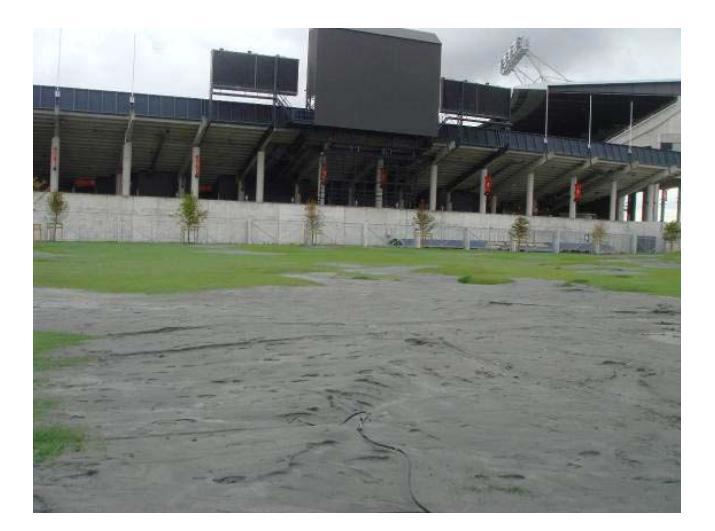
Photo 7 Liquefaction adjacent to AMI Stadium. The ground under the stadium was stabilized with stone columns. Around the stadium, liquefaction was observed everywhere, but the stadium did not suffer structural damage.

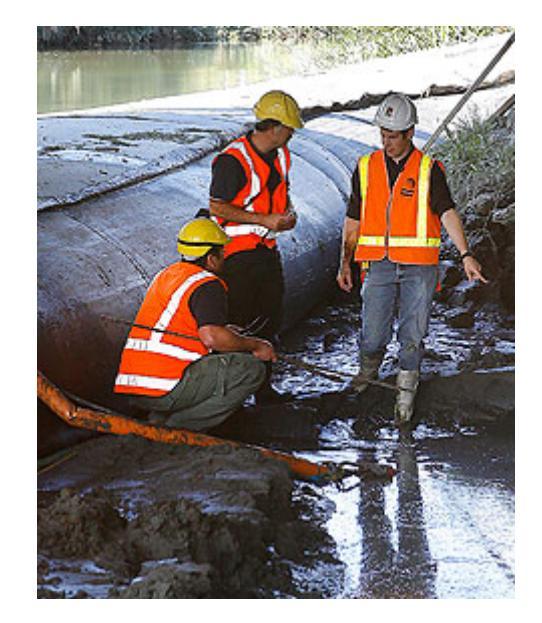
An inflatable dam has been set up to allow engineers to inspect the quake-damaged Avondale Rd bridge.

The 50-metre long "Aquadam" holds back water from the bridge foundations, allowing engineers to see the extent of quake damage.

Engineers inspect the Avondale Rd bridge with the help of an Aquadam.

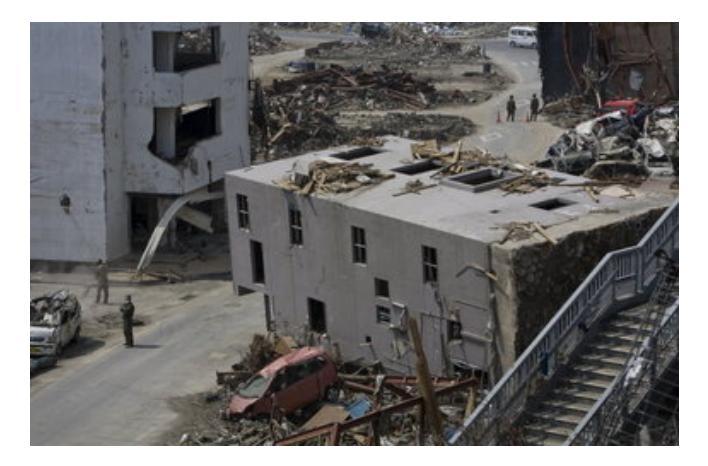
Japanese troops clean up and monitor traffic Friday around a four-story building knocked over by the March 11 tsunami in Onagawa, Japan. Oregon State University expert Harry Yeh says the building's unexpected failure upends standard and advice and precautions concerning tsunamis.

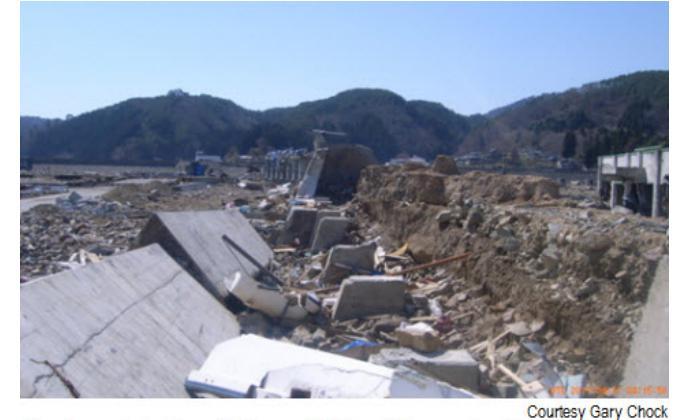
The outer protective tsunami defense wall at Tarou City was reduced to rubble.

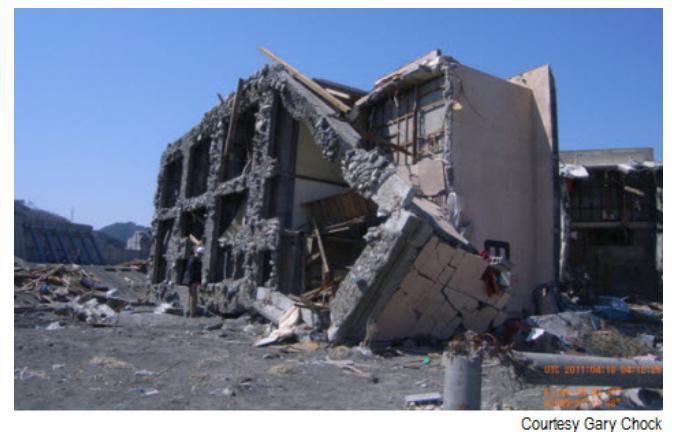
The tsunami's force flipped a masonry-walled dormitory in Otsuchi onto its side.

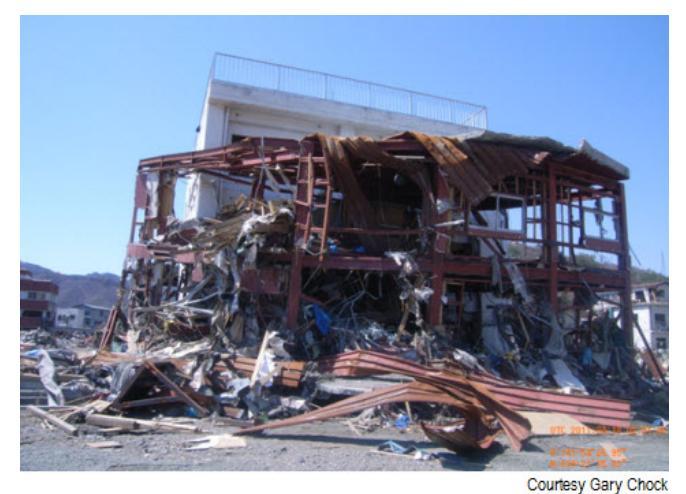
Steel-framed buildings like this three-story structure were still no match for the tsunami.

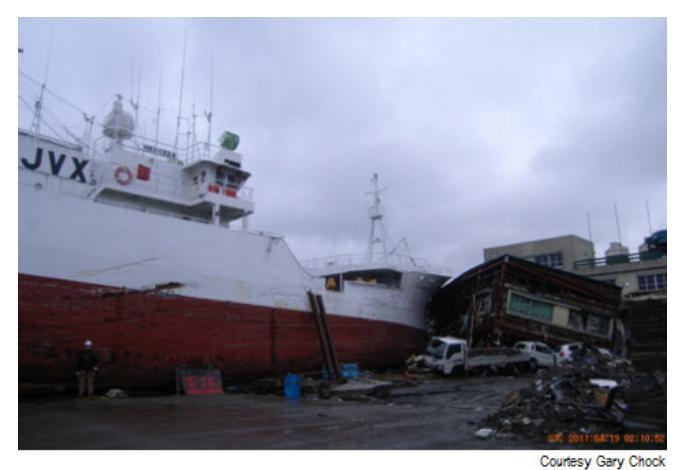
Lifted and carried by the tsunami, a large ship smashed into Kesennuma Port.

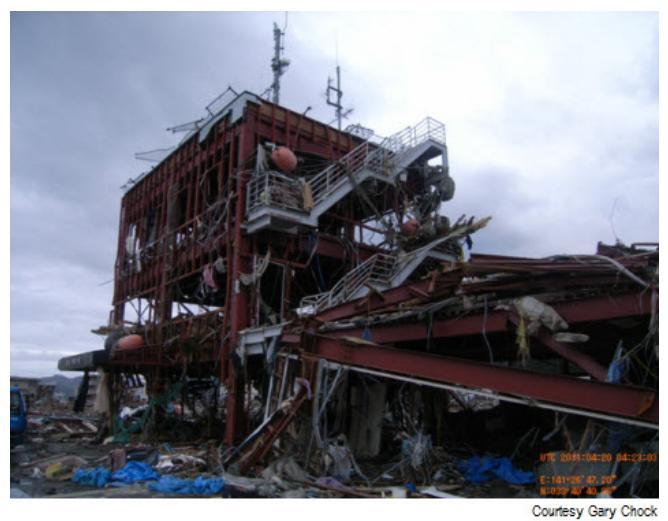
Minamisanriku's emergency operations center had been manned for the tsunami, but it was inundated.

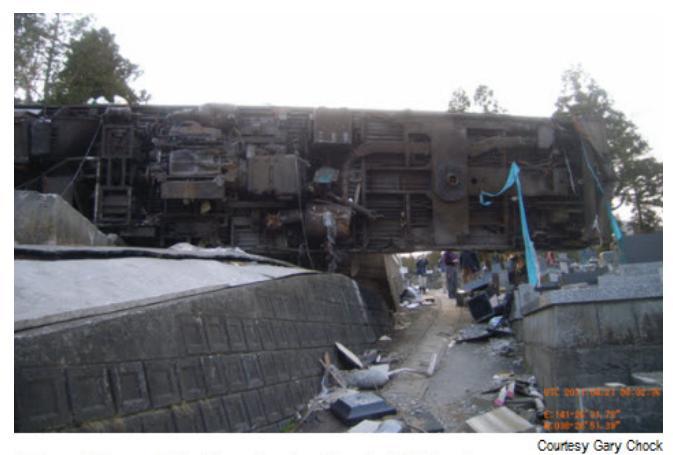
The tsunami's force carried a train car (seen from its underside) into an Onagawa cemetery on a hill.

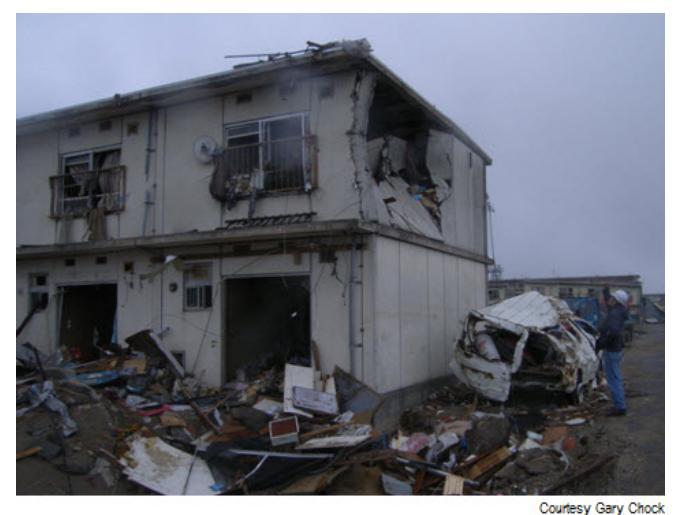
Team member lan Robertson studies damage to a precast concrete-bearing-wall building in Natori.

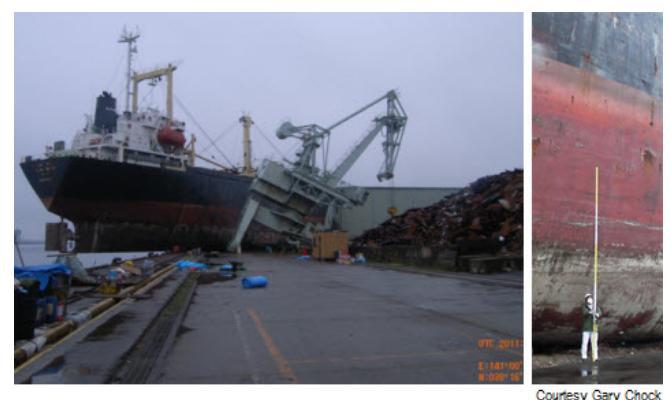
A major shipping vessel had been lifted onto the dock, wrecking a cargo-handling tower crane and adjacent building. For a sense of scale, Dr. Mogi of Saitama University held up a five-meter pole.

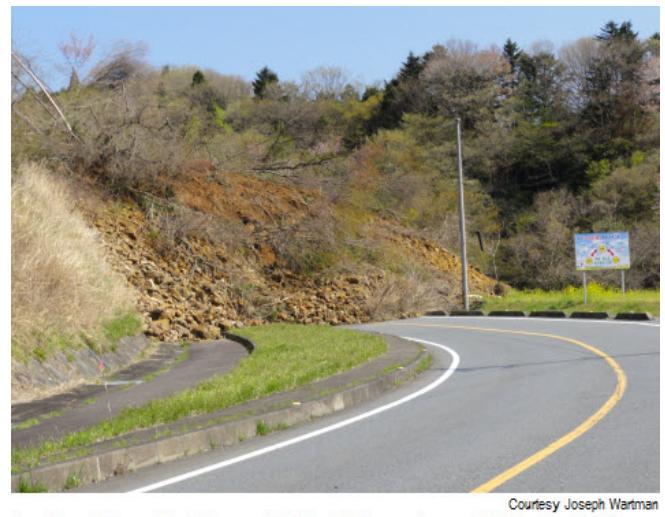
An earthquake-triggered landslide completely blocked this secondary road in Fukushima Prefecture.

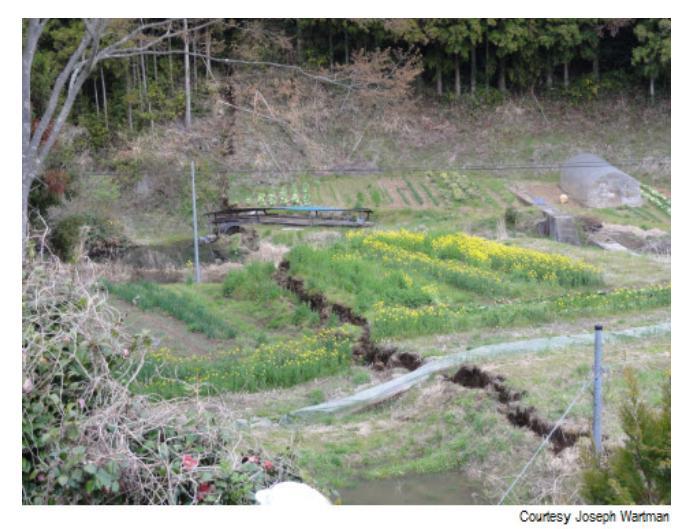
A 7.0 magnitude aftershock created a fault rupture several kilometers long.

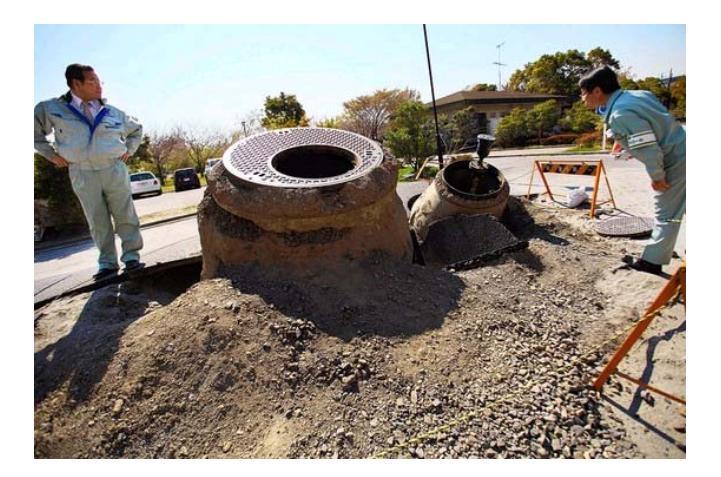
Soil liquefaction pushed manholes out of the ground in Urayasu.

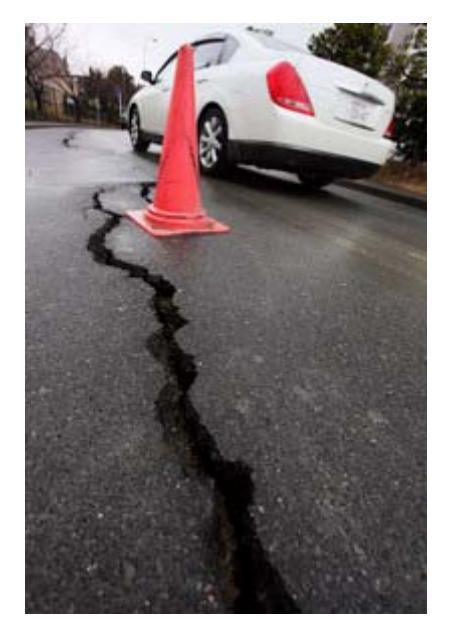
A car drives past a crack in the road from the recent earthquake in Urayasu.

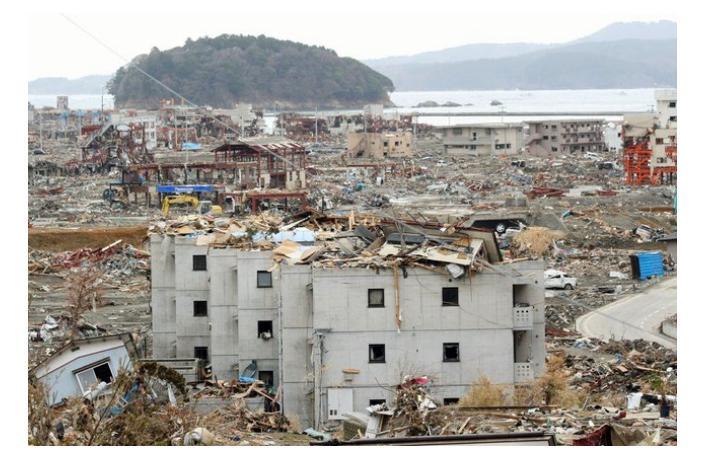
Debris sit atop what's left of a three-story building surrounded by rubble in the obliterated city of Minami-Sanriku, Japan. Reconstruction officials are calling for settlements to be built on high ground.

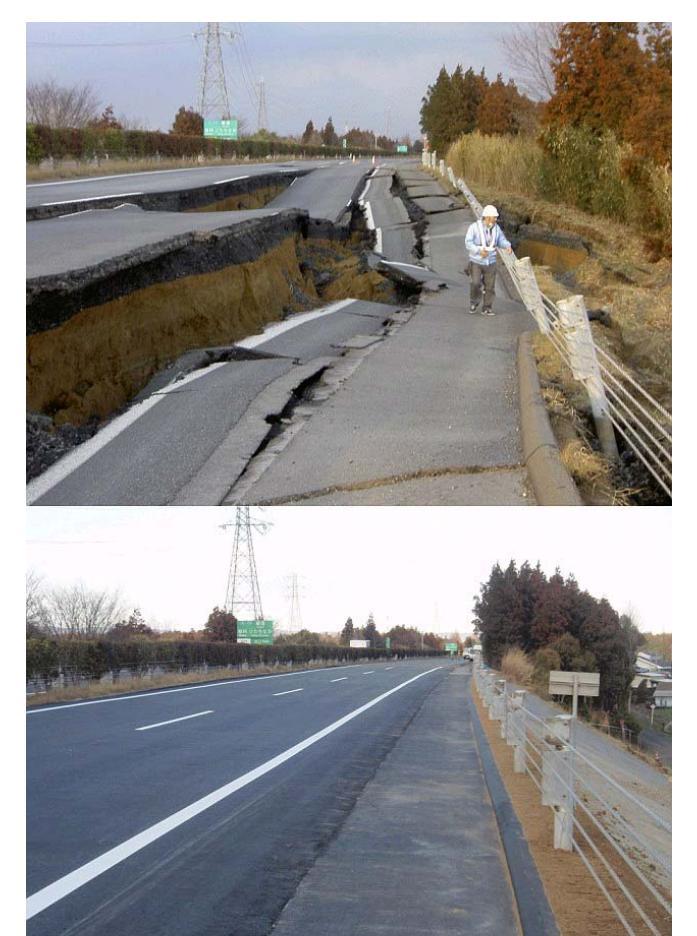
Η εικόνα των ρηγμάτων στον Ιαπωνικό αυτοκινητόδρομο δείχνει τη σφοδρότητα του σεισμού της 11ης Μαρτίου.
