# Τα Νέα της Ε Ε Ε Ε Γ Μ

Αρ. 139B – ΙΟΥΝΙΟΣ 2020

[Rehabilitation of Brougham Castle Bridge](#), David Wiggins, Kiera Mudd and Matthew Healey, *Engineering History and Heritage*

## Pore water pressure and total horizontal stress response to EPBM tunnelling in London Clay

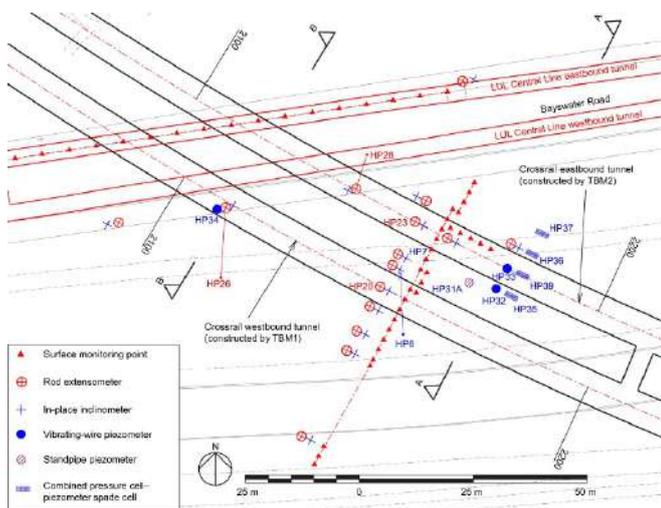
Fig. 1. Instrumentation layout plan

As can be seen from [Fig. 1](#), the spade cells are all very close to the eastbound tunnel alignment (therefore at some distance away from TBM1). Changes in pore water pressures,  $\Delta u$ , and total horizontal stresses,  $\Delta \sigma_h$ , measured by the spade cells in response to the westbound construction are shown in [Fig. 8](#). Spade cell HP39 was located at the same  $y$ - $z$  position as the deepest piezometer of HP33: its pore water pressure response, as shown in [Fig. 8\(a\)](#), has a similar pattern, with an increase in pressure (cf. [Fig. 6\(a\)](#)), but of slightly greater magnitude than the deepest piezometer in HP33 as TBM1 progressed. A potential reason for the differences in magnitude is that the piezometer within the spade cell responds more simultaneously with total stress changes as it is in direct contact with the ground (from pushing in the device) compared with the multi-level piezometer installed within a grout column. The other three spade cells HP35, HP36 and HP37, located at the elevation of the TBM axis, also exhibited similar pore water pressure responses but of smaller magnitude. Spade cell HP35, closest to TBM1 (11 m from its centre-line or about one diameter from the tunnel extrados), measured a slight drop of pore water pressure at  $x_f \approx 20\text{ m}$ , compared with the other three devices which showed a small increase.

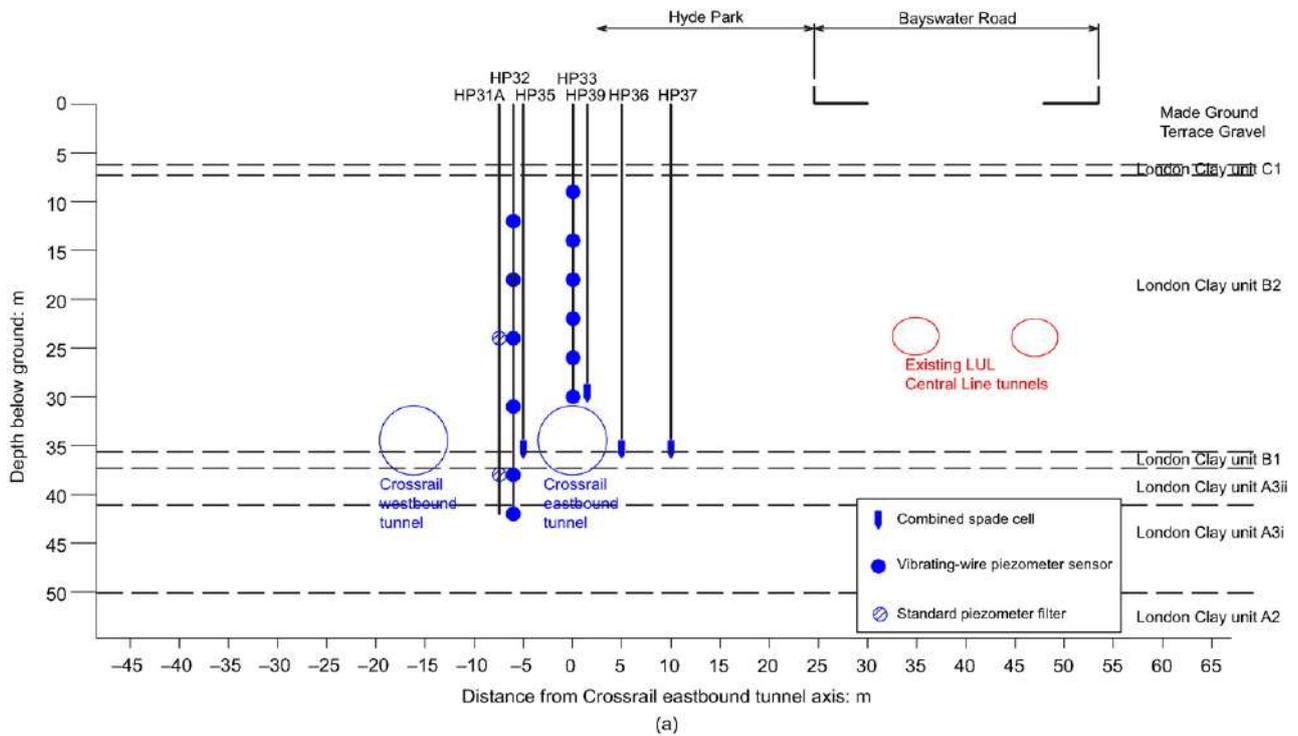
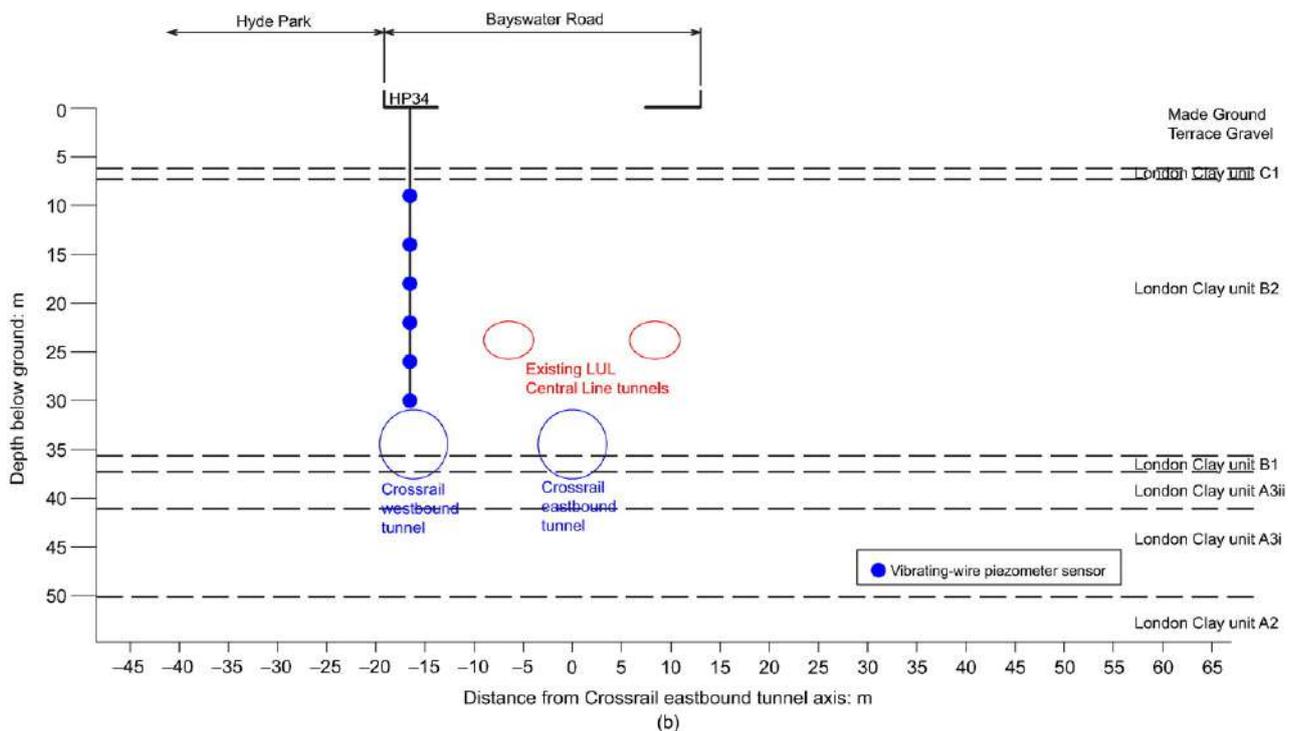
Fig. 2. (a) Cross-section of main array of piezometers and spade cells (section A-A). (b) Cross-section of piezometers in Bayswater Road (section B-B)

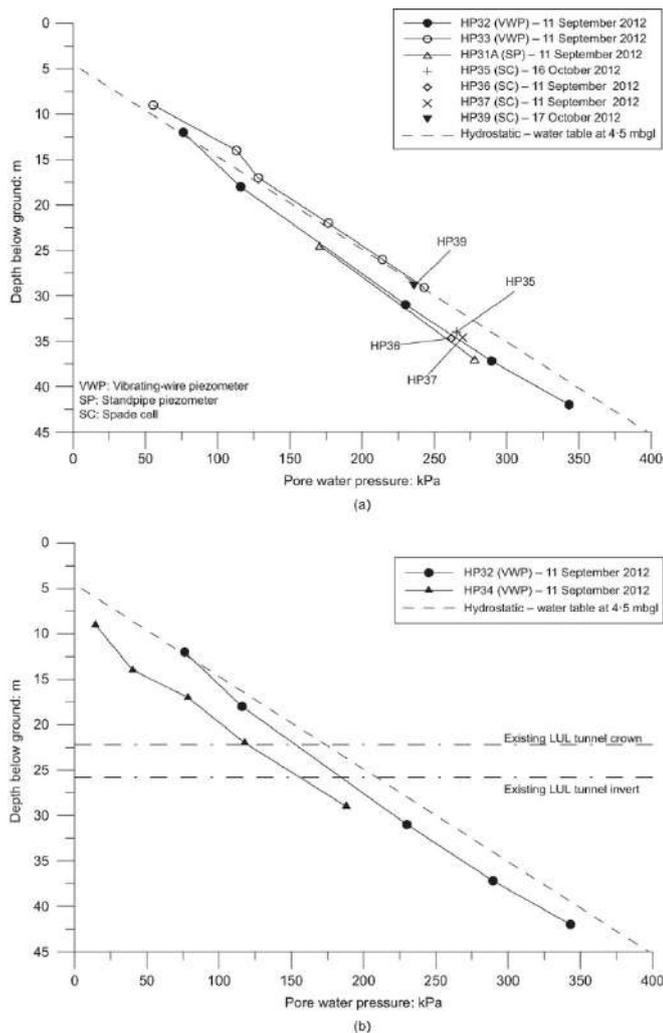
Fig. 3. Measured steady-state pore water pressures (after-Wan & Standing, 2014b): (a) in 'greenfield' ground by standpipe piezometer (HP31A), VW piezometers (HP32 and HP33) and spade cells (HP35, HP36, HP37 and HP39); (b) in the vicinity of the existing LUL running tunnels by VW piezometers (HP34) (HP32 also shown for reference)

The deep water table was historically artesian but is now much lower owing to excessive abstraction activities in the early 1900s. Following the 'Gardit' (general aquifer research development and investigation team) strategy the water table is maintained below its natural level by controlled abstraction ([Jones, 2007](#)). As a result, the LCF is under-drained. An example of such a profile at Waterloo is given by [Wright \(2013\)](#) and was also observed at this site in the steady-state pore-water pressure profile measured by one of the 'greenfield' multi-level VW piezometers and the standpipe piezometers (see [Fig. 3\(a\)](#)).

(Fig. 3(b)) that the steady-state pore water pressure near the existing Central Line tunnels is reduced, indicating that these tunnels, with cast-iron segmental linings, drain the surrounding ground. It should be noted that the profile for HP33

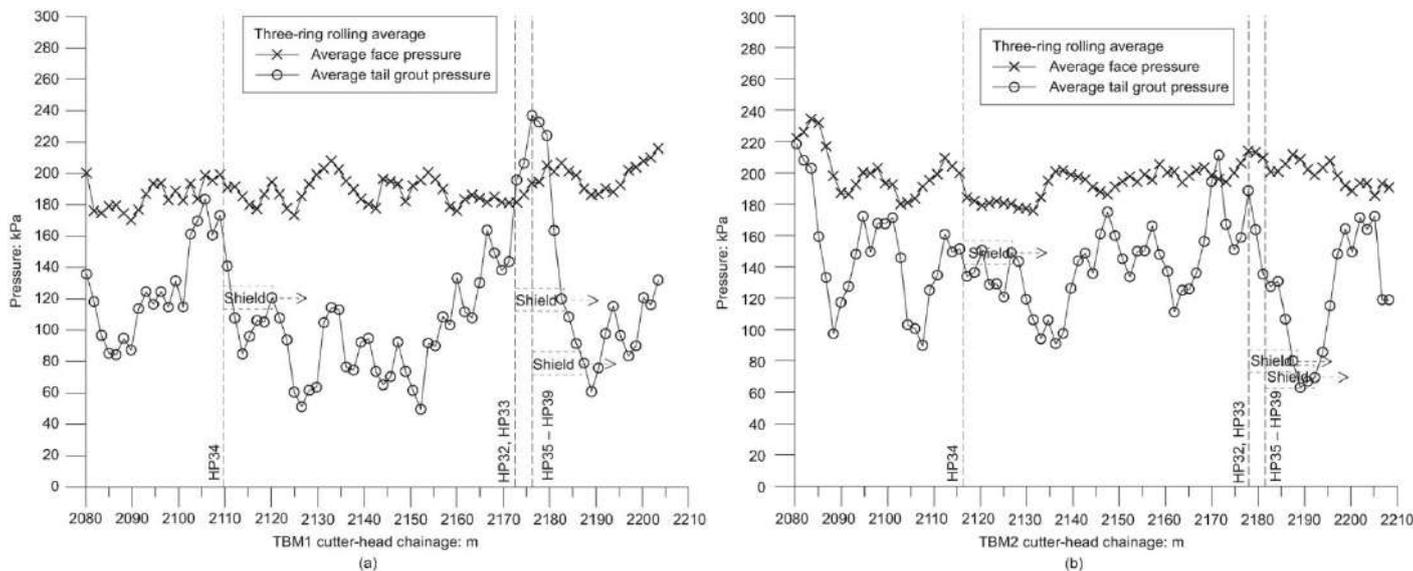
Fig. 4. Measured average face pressure and tail grout pressure of: (a) TBM1; (b) TBM2

representations of the TBMs in relation to the monitoring point are provided in Fig. 4. When comparing EPBM pressures with measured pore water pressure and total stress changes, the EPBM values shown in Table 1 are adopted for each instrument.

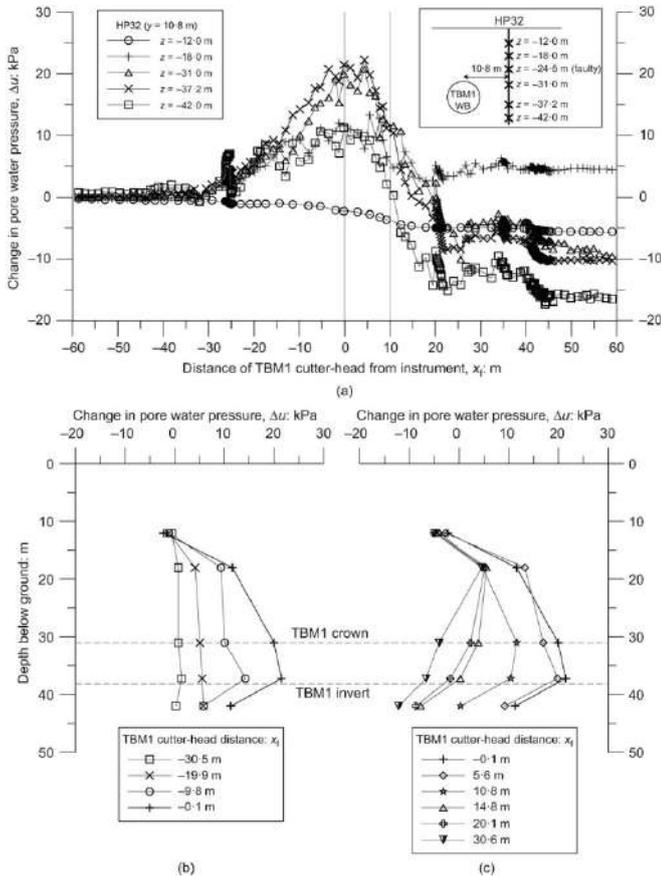
Fig. 5. Change in pore water pressure measured in piezometer HP32 in response to westbound construction (period 2): (a) variation with TBM1 cutter-head distance; (b) depth profiles when the TBM1 cutter-head was approaching the instrument; (c) depth profile when TBM1 cutter-head was leaving the instrument

As the TBM advanced and passed beyond the instruments, the pore water pressures at all elevations decreased as a result of the predominantly undrained unloading caused by the excavation until the TBM1 cutter-head was at a distance of about  $x_r = 25$  m. The magnitude of the final change of the pore water pressure depends on the balance between the loading and unloading effects, the distance from the TBM, and also the permeability of the London Clay at the point of measurement. The undrained shearing of the overconsolidated clay would also generate additional negative excess pore water

pressure. It appears that the shallowest sensor at  $z = -12$  m was too far from TBM1 to be affected by the effect of the approaching cutter-head, but measured a slight decrease in pore water pressure due to the effect of ground unloading. The TBM1 tail leaving the instruments does not seem to have any significant effect on the pore water pressure (near  $x_f = 10$  m) in HP32, although a very minor effect is noticed for the two sensors near the TBM crown and invert levels. By the time TBM1 is 60 m from HP32, all sensors have essentially stabilised, with the two shallowest ones being within  $\pm 5$  kPa of their original values and the others with net negative changes (the largest being  $\Delta u = -16$  kPa at  $z = -42.0$  m).

Before stabilising, there are two points in time (at  $x_f$  distances of about +20 m and +40 m) when the sensors closer to the TBM appear to indicate marked, but small ( $< 5$  kPa), reductions in pore water pressure, the magnitudes of which decrease with increasing distance of the TBM from the sensors. The data points, which represent hourly readings, are closely clustered at these  $x_f$  distances and so coincide with times at which the TBM slowed down or was not advancing. The reason for the reductions is not known. Similar responses are also observed when the TBM slows down in some of the later plots.

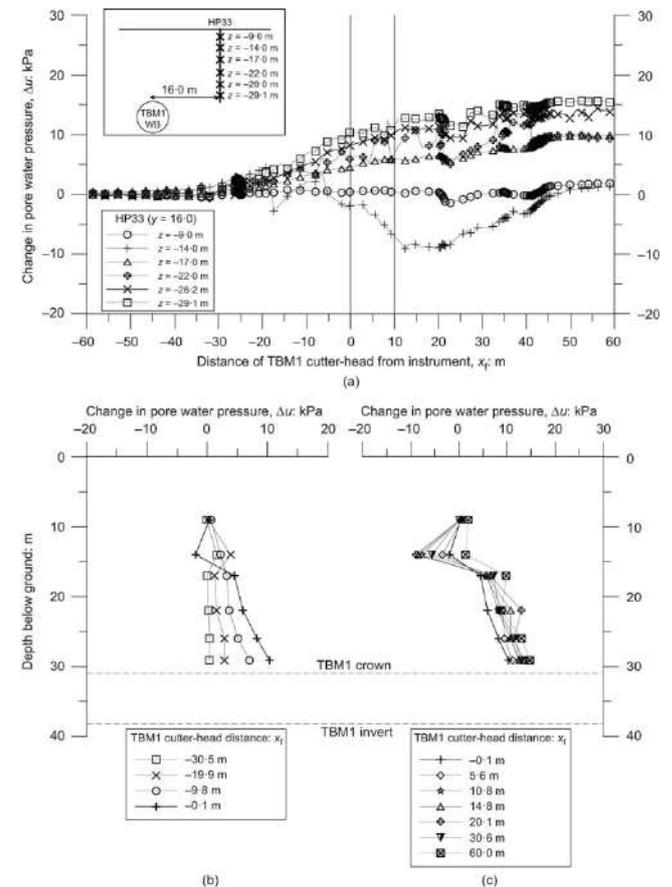
Fig. 6. Change in pore water pressure measured in piezometer HP33 in response to westbound construction (period 2): (a) variation with TBM1 cutter-head distance; (b) depth profiles when the TBM1 cutter-head was approaching the instrument; (c) depth profile when TBM1 cutter-head was leaving the instrument

Changes in pore water pressure measured by the VW piezometers in HP33 during period 2 are presented in terms of cutter-head distance in Fig. 6(a). HP33 is at a greater distance away from TBM1 than HP32 (about 16.0 m in plan from its centre-line) and therefore the overall response was of smaller magnitude. As with HP32, pore water pressures also started to change when  $x_f = -30$  m. The effect of the TBM1 stopping at  $x_f = -25$  m was not as obvious as measured in HP32 as HP33 was further from the tunnel. As the TBM1 cutter-head approached and passed beyond HP33, pore water pressure at the deeper four elevations gradually increased with a maximum  $\Delta u$  of about +15 kPa measured at  $z = -29.0$  m near the TBM1 crown level. Only small changes ( $\Delta u < 10$  kPa) were measured at the two shallowest sensor elevations ( $\Delta u \sim 0$ , at  $z = -9$  m). There was no discernible pore water pressure response above the TBM1 crown level to the ground unloading (i.e. pressure drop), as the shield tail passed HP33 (around  $x_f = 10$  m), except a small reduction at  $z = -14$  m. The response of the piezometer at this depth is slightly erratic at earlier TBM positions (e.g.  $x_f = -18$  m) and so the output from it could be erroneous, especially given the piezometer responses above and below it (at  $z = -9$  and  $-17$  m). Therefore, overall the effect of stress relief or shearing due to excavation was not registered by the piezometers within HP33.

Similar to the observation for HP32 (Fig. 5(a)), there were marked reductions in pore water pressure measured by the HP33 sensors at  $x_r = +20$  m, when the TBM advance slowed down, but their magnitudes are even smaller than those measured in HP32.

Profiles of  $\Delta u$  with depth when TBM1 was approaching and passing beyond HP33 are shown in Figs 6(b) and 6(c), respectively, and reflect many of the observations made above (especially regarding the piezometer at  $z = -14$  m: if the data from this device were omitted the profiles would be far more uniform). As discussed in Wan & Standing (2014b), the lowest three piezometers within HP33 were found during the pre-construction monitoring to be interconnected after installation. Despite this, independent immediate pore water pressure changes still seem to have been measured reliably by these three lowest sensors in response to the rapid loading and unloading during tunnel construction, with the pressure increase decreasing with distance from the tunnel crown.

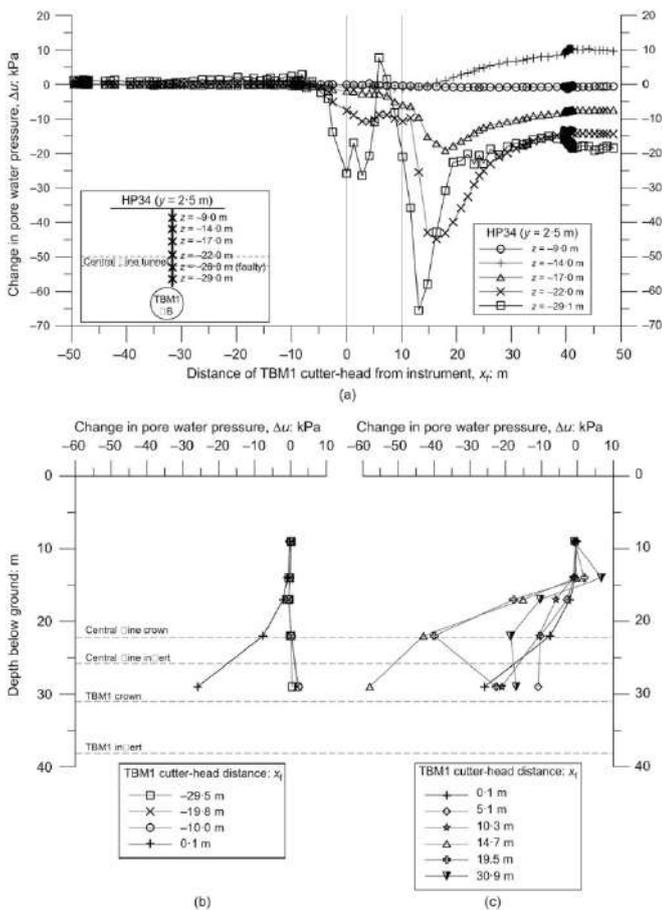
Fig. 7. Change in pore water pressure measured in piezometer HP34 in response to westbound construction (period 2): (a) variation with TBM1 cutter-head distance; (b) depth profiles when the TBM1 cutter-head was approaching the instrument; (c) depth profile when TBM1 cutter-head was leaving the instrument

Multilevel piezometer borehole HP34 is 5 m in plan from the extrados of the westbound Central Line tunnel and was located directly above TBM1 when it passed, with the deepest sensor at  $z = -29.0$  m, just 2 m above its crown. Consequently the measured pore water pressures might have been expected to be more pronounced as TBM1 approached and passed.

It can be seen from the measured values of  $\Delta u$  presented in Fig. 7(a) that this was not so (results from the piezometer at  $z = -26$  m are not shown as it was faulty). Increases in pore water pressure were less than 5 kPa as TBM1 approached HP34, compared with an increase of up to 22 kPa and 11 kPa measured at HP32 and HP33, respectively, which were more than 10 m horizontally from the TBM1 centre-line. The reduced increase in  $\Delta u$  probably occurs because of the close proximity of the adjacent existing Central Line tunnels, which would have affected the ground loading/unloading pattern and the development of any ground arching in front of the advancing TBM cutter-head.

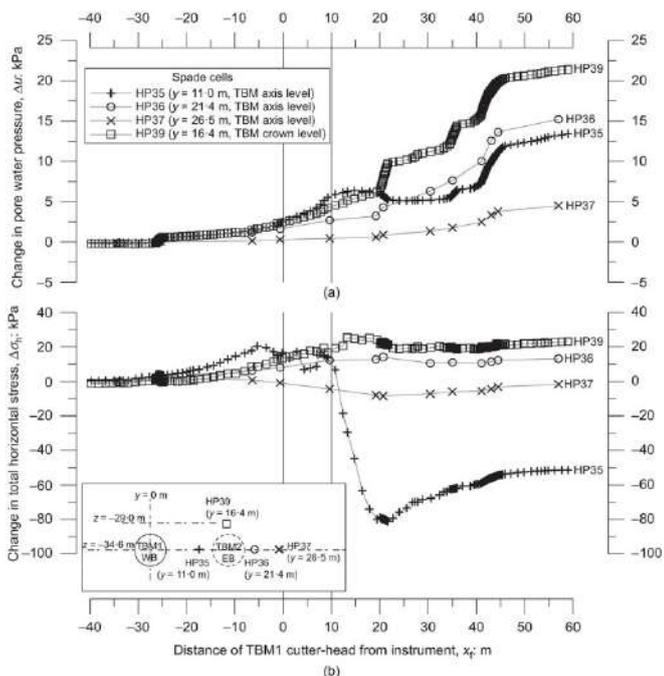
Fig. 8. Change in (a) pore water pressure and (b) total horizontal stress measured in spade cells HP35, HP36, HP37 and HP39 in response to westbound construction (period 2)

Total horizontal stress changes,  $\Delta \sigma_h$ , transverse to the axis of the tunnel are shown in [Fig. 8\(b\)](#). Those measured by HP35 were the largest in magnitude, it being the closest spade cell to TBM1 (although still 11 m from its axis). At this location, the total stress initially increased by 20 kPa in response to the approaching cutter-head (probably associated with ground arching in front of the cutter-head). The unloading

At the other spade cells (HP36, HP37 and HP39) further away from TBM1, initial increases in total stresses were smaller (up to  $+10\text{ kPa}$ ) as TBM1 advanced and passed, followed by negligible subsequent drops and rises after the initial increases (less than  $\pm 5\text{ kPa}$ ) compared with the response observed for HP35.

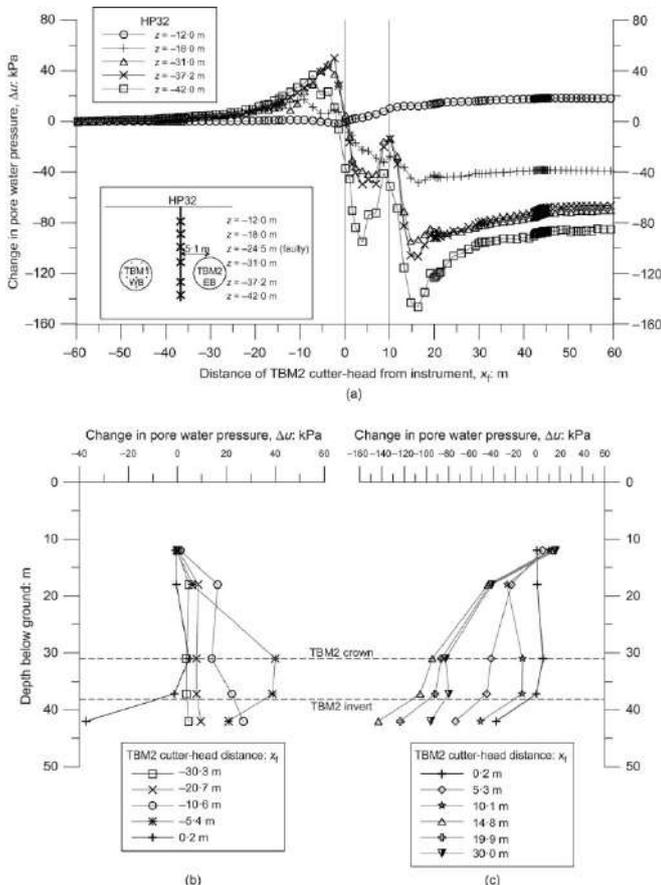
Fig. 9. Change in pore water pressure measured in piezometer HP32 in response to eastbound construction (period 4): (a) variation with TBM2 cutter-head distance; (b) depth profiles when the TBM2 cutter-head was approaching the instrument; (c) depth profile when TBM2 cutter-head was leaving the instrument

As the shield tail passed beyond HP32,  $x_f > 10$  m, there was a second rapid reduction as a result of further unloading (tail void closure). The maximum net reduction of pore water pressure was about  $-150$  kPa measured below the tunnel invert at  $z = -42$  m when  $x_f \approx 15$  m. Pore water pressures then started to recover by different degrees from the tail grout setting and becoming stiffer as TBM2 advanced further.

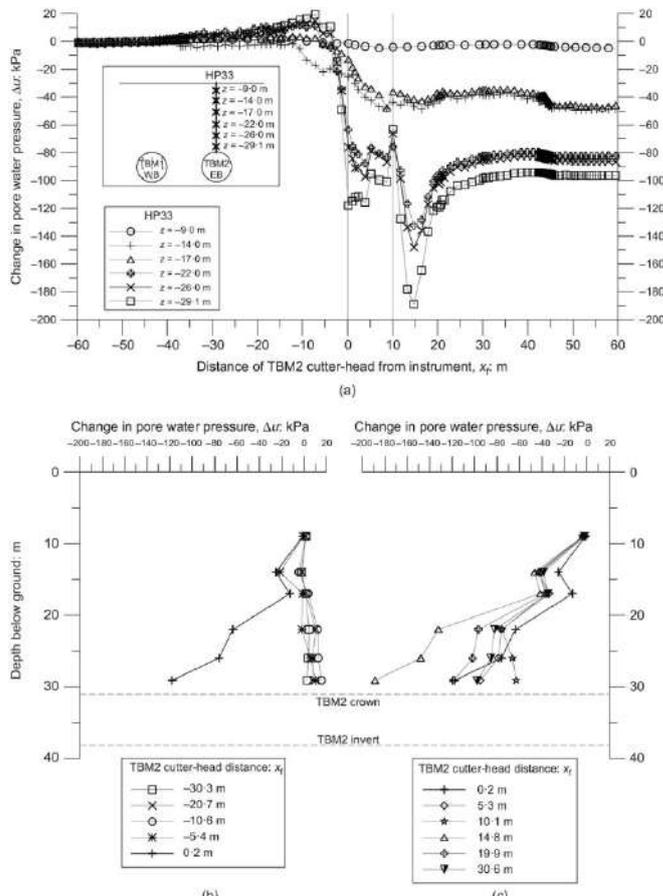
Fig. 10. Change in pore water pressure measured in piezometer HP33 in response to eastbound construction (period 4): (a) variation with TBM2 cutter-head distance; (b) depth profiles when the TBM2 cutter-head was approaching the instrument; (c) depth profile when TBM2 cutter-head was leaving the instrument

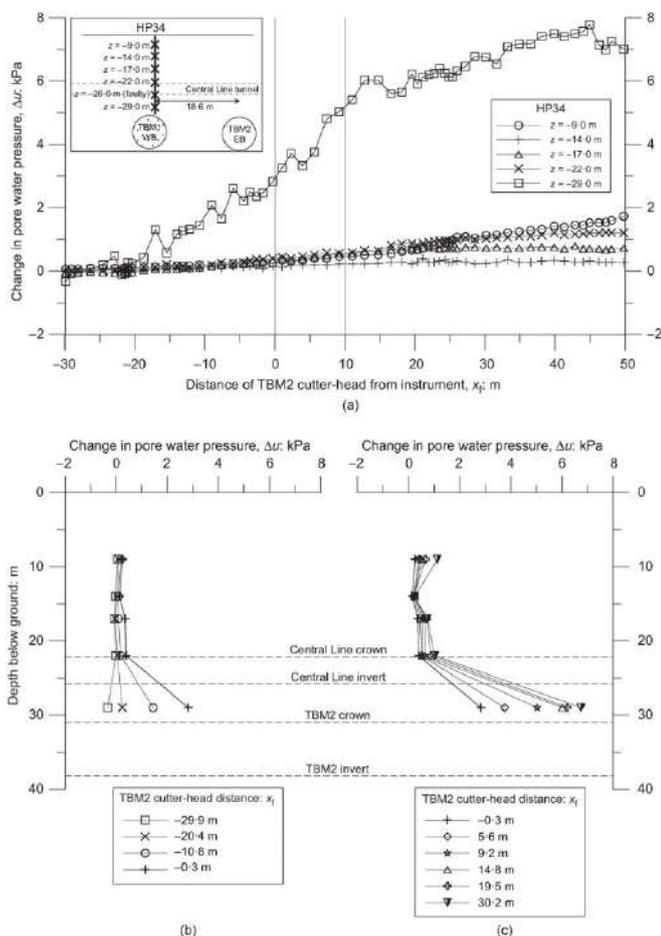
Fig. 11. Change in pore water pressure measured in piezometer HP34 in response to eastbound construction (period 4): (a) variation with TBM2 cutter-head distance; (b) depth profiles when the TBM2 cutter-head was approaching the instrument; (c) depth profile when TBM2 cutter-head was leaving the instrument

Pore water pressure changes measured within HP34 in response to eastbound tunnel construction, as shown in Figs 11(a)-11(c), were much smaller than those of HP32 and HP33, it being further away from TBM2 (18.6 m horizontally from its centre-line). Only the deepest sensor at  $z = -29$  m measured a gradual increase of pore water pressure up to +8 kPa during the passage of TBM2. Negligible changes were registered by the piezometers at other depths. The magnitude of the  $\Delta u$  response is even smaller than that measured within HP33 in response to the westbound tunnel construction (cf. Fig. 6). A likely reason for the smaller response at HP34 is the combined presence of the existing Central Line tunnel (see Fig. 1) and, perhaps more predominantly, the newly constructed Crossrail westbound tunnel. Both are stiffer than the ground and hence 'attract' more total stress changes induced by the eastbound tunnel construction. As a result the ground at HP34 would have experienced a smaller total stress change (and hence smaller excess pore water pressure) than the 'greenfield' ground at HP33 when the westbound tunnel was being constructed.

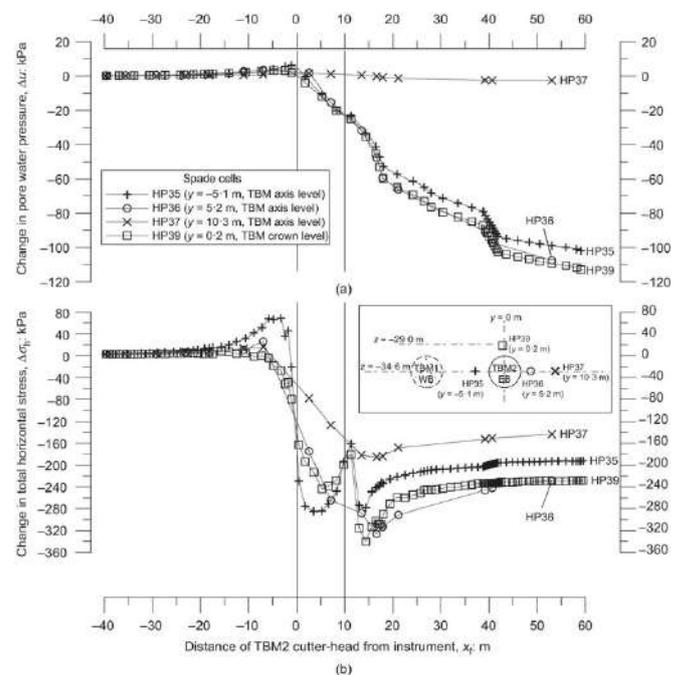
Fig. 12. Change in (a) pore water pressure and (b) total horizontal stress measured in spade cells HP35, HP36, HP37 and HP39 in response to eastbound construction (period 4)

An increase of total horizontal stress of up to +80 kPa was measured in HP35 prior to the cutter-head reaching the spade cells, probably as a result of the development of ground arching ahead of the approaching cutter-head (Fig. 12(b)). Very small total stress increases can be observed from the manual measurements at the other spade cell HP36, at the same offset but on the other (northern) side of the tunnel extrados, but no manual measurements were made at the time when the peak was observed in HP35. It therefore seems likely that greater  $\Delta\sigma_h$  values would have been observed at HP36, and perhaps HP37 (but judging from the trends, not to the same degree as HP35). However, no total horizontal stress increase was measured in the spade cell HP39 (hourly data-logged) directly above TBM2 crown, as might have been anticipated.

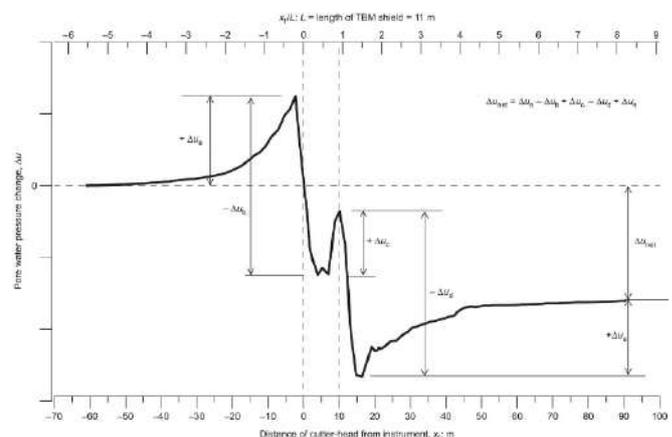
Fig. 13. Typical components of pore water pressure changes in relation to EPBM operations

The five components of pore water pressure changes, as shown in Fig. 13, the ranges over which they develop and their main causes, as postulated in Fig. 14, are described below.

- (a) The pore water pressure increases by an amount of  $+\Delta u_a$  when the cutter-head approaches, first due to the development of the 'domed' arching and then the 'longitudinal' arching around the cutter-head ( $x_f < -2$  m approximately).

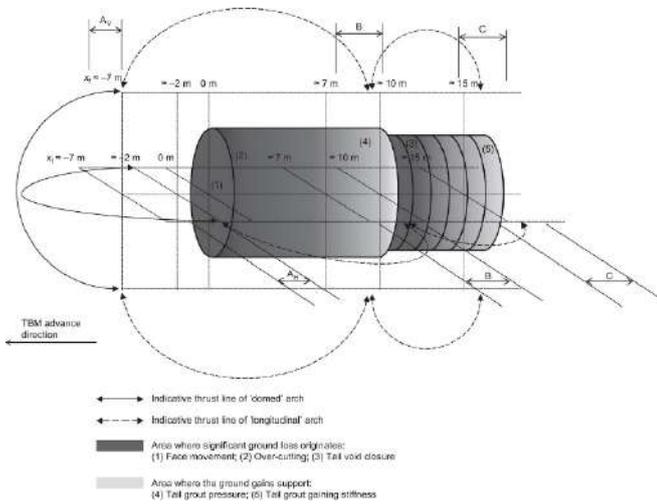
Fig. 14. Schematic representation of development of ground arching around TBM shield

By examining the immediate ground response in the close vicinity of the TBMs during their passage, a general pattern of pore water pressure changes can be formulated. The development of the pressure changes can be broadly divided into five stages/components in relation to the relative distance to the EPBM shield, as shown in Fig. 13 (typified by the response of the sensors at  $z=-31.0$  m and  $-37.2$  m in Fig. 9(a)). It is also instructive to relate these typical components to the effects of: (a) stress relief induced by ground losses at the cutter-head and tail void; (b) development of ground arching in front of the cutter-head (referred to as 'domed' arching) and along the shield body (referred to as 'longitudinal' arching) over softened ground that was subjected to greater ground losses; and (c) tail grout pressure compressing the ground around the tail skin. These effects and the postulated development of ground arching at different positions of an advancing EPBM are shown schematically in Fig. 14.

extent vertically than horizontally. It can therefore be inferred that the common arching spring-lines (the stiffer 'stationary' points in the ground) from which the 'domed' and 'longitudinal' arching mechanisms emanate in front of the cutter-head were further apart vertically than horizontally. This helps explain why, in front of the cutter-head, the measured pore water pressure above and below it started to drop earlier than at the side. Another potential explanation for this is that as the ground ahead of the cutter-head moved into the shield face, a proportion of the vertical stress above the projection of the tunnel crown was transferred to the sides, resulting in a reduction of the pore water pressure above the crown and an increase of the pore water pressure at the sides.

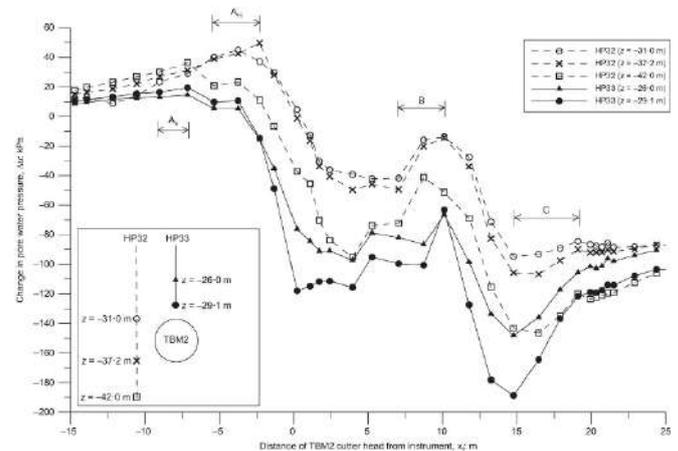
Fig. 15. Change in pore water pressure measured in piezometers HP32 and HP33 in the vicinity of the eastbound construction (period 4)

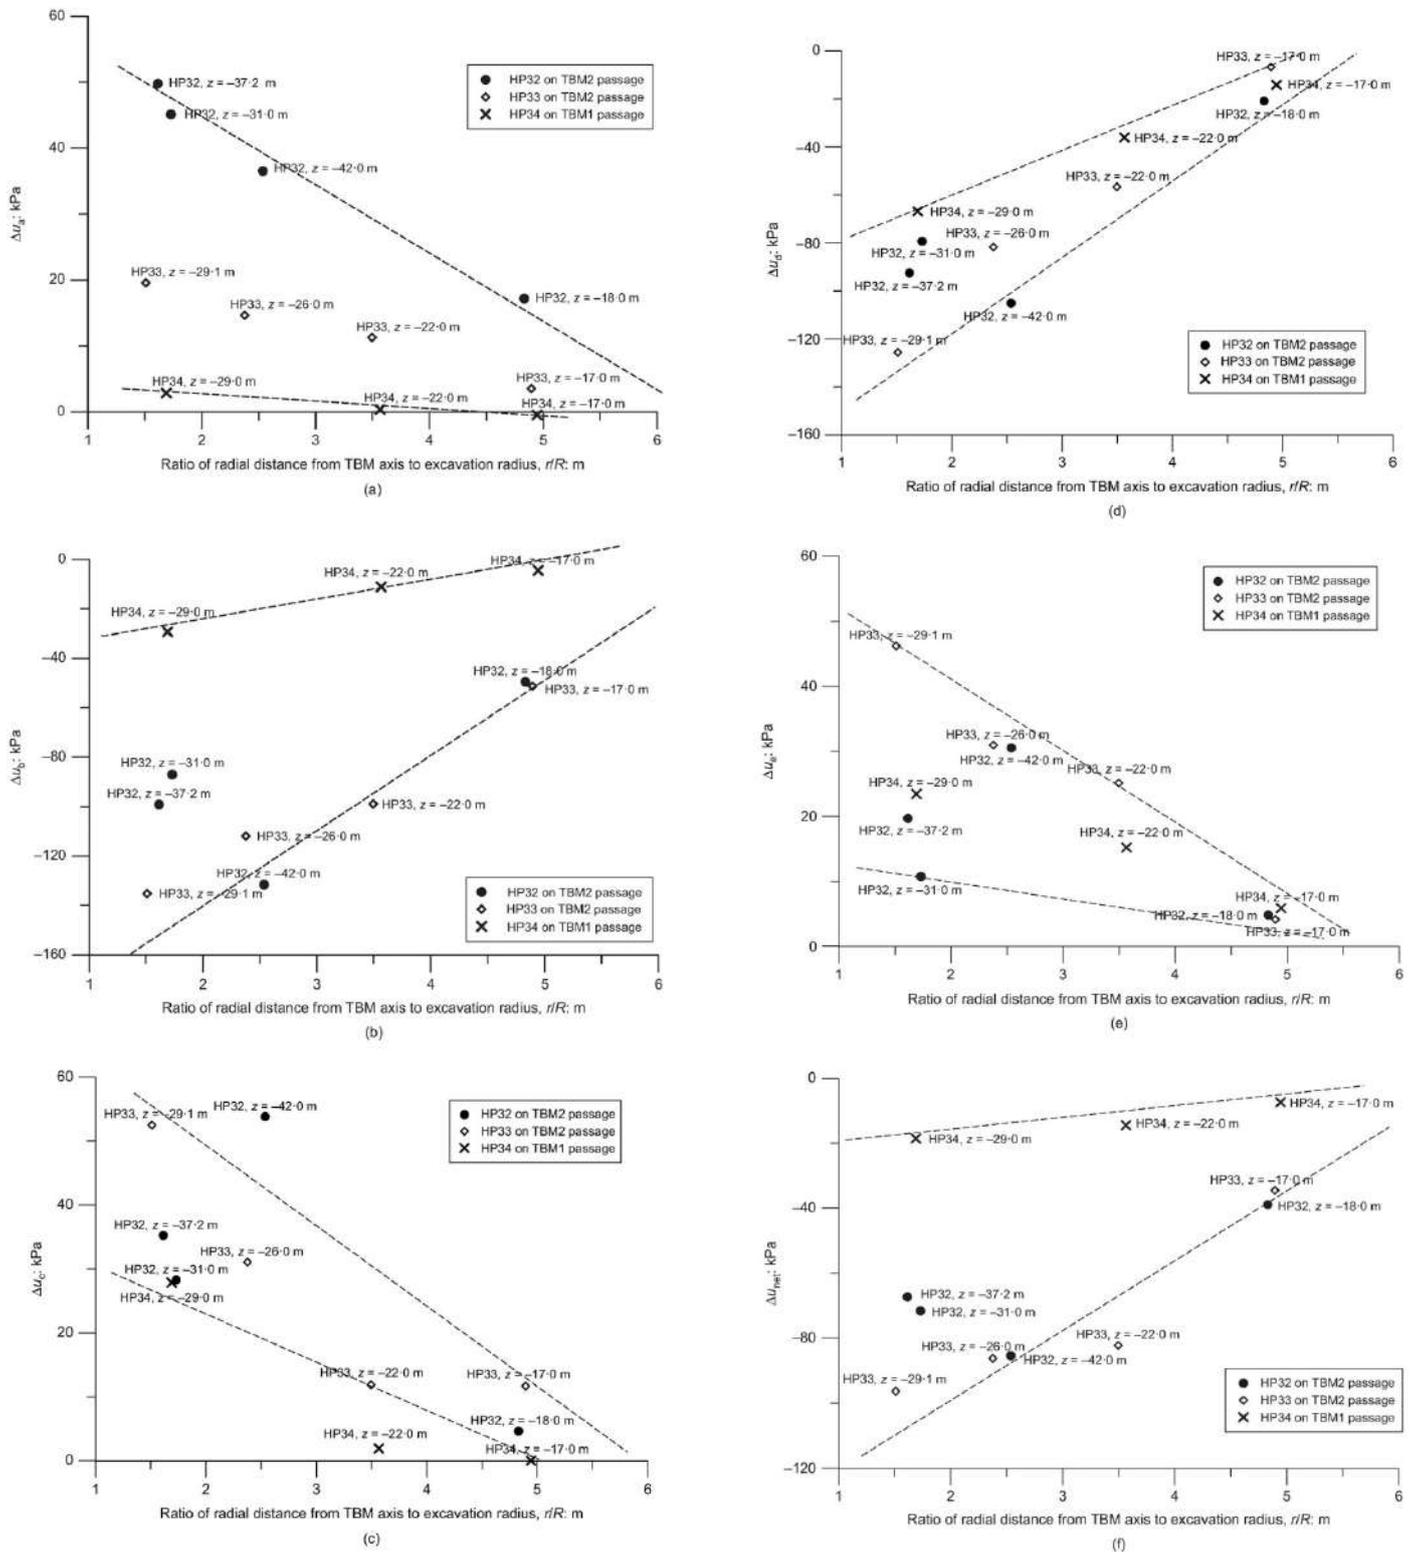
Fig. 16. Change of pore water pressure induced by: (a) TBM cutter-head approaching the instrument; (b) ground movement into TBM face and front of shield; (c) TBM tail approaching the instrument; (d) TBM tail void closure; (e) lining support. (f) Net change of pore water pressure induced by TBM passage

Variations in the five different components of pore water pressure change with the radial distance from the tunnel axis, as well as the net pore water pressure change, are depicted in Figs 16(a)–16(f). In general, the magnitude of the pressure change decreases with increasing distance from the tunnel. The immediate response induced by the different stages of EPBM operation became insignificant at a radial distance greater than about three excavation diameters from the tunnel axis (i.e.  $6R$ ).

The non-isotropic response in front of the cutter-head in terms of the magnitudes of the component of pore water pressure increase ( $+\Delta u_a$ ) is evident from Fig. 16(a), with the piezometers at the side (HP32) measuring a consistently greater pressure increase than those above the crown (HP33) at the same radial distance from the tunnel. However, the magnitudes of the other components of pressure increase measured behind the cutter-head, as shown in Figs 16(b)–16(e), indicate a more isotropic response. This corroborates the suggestion that the ground response to the tunnelling operations behind the cutter-head resembles that of a collapsing (or expanding) cylindrical cavity in an isotropic medium.

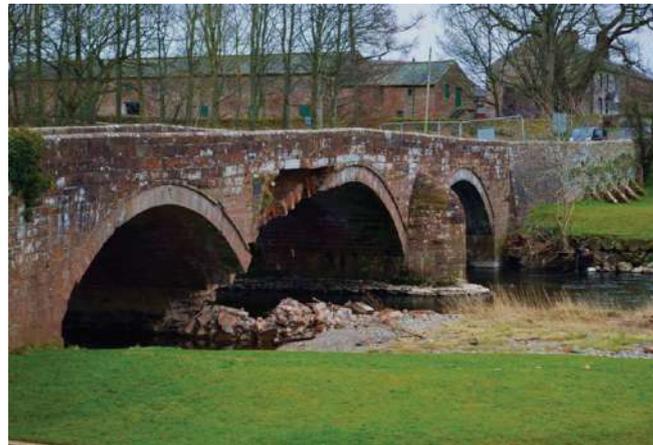
Figure 1. View of the damaged bridge from the northern bank looking south

Figure 1 presents a view of the damaged bridge.

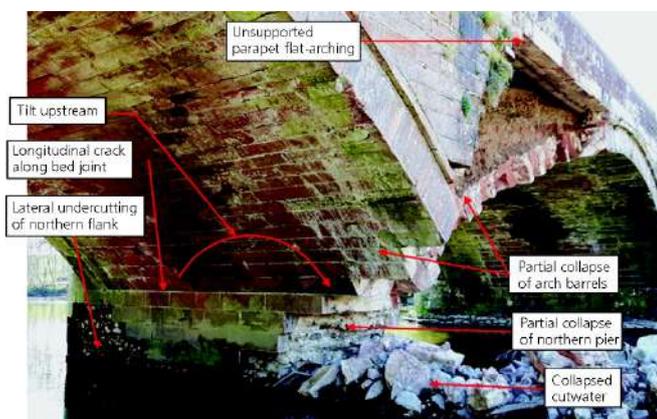
Figure 2. Brougham Bridge partial collapse of northern pier, viewed looking south

Figure 2 presents a striking visual record of the bridge in the damaged state.

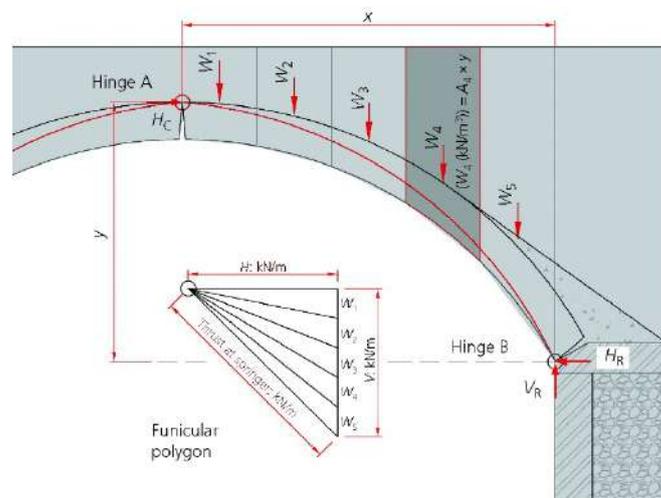
Figure 3. Thrust-line analysis of half-arch in minimum-thrust dead-load conditions

It is typical for masonry arches under dead loads to crack slightly at the crown (hinge opening towards the intrados) and at the springings (hinge opening towards the extrados), hence forming a three-pin statically determinate structure (Figure 3). The line of thrust passes through these hinges. The hinge locations can adjust to accommodate imposed load or to find support if damage is sustained. In order to calculate the line of thrust and its magnitude, funicular polygons can be drawn and the line of thrust plotted graphically. If the arch can be shown to have a valid load path which is contained entirely within the masonry, the structure is considered to be safe. The technique is described in detail by Heyman (1969, 1982, 1996).

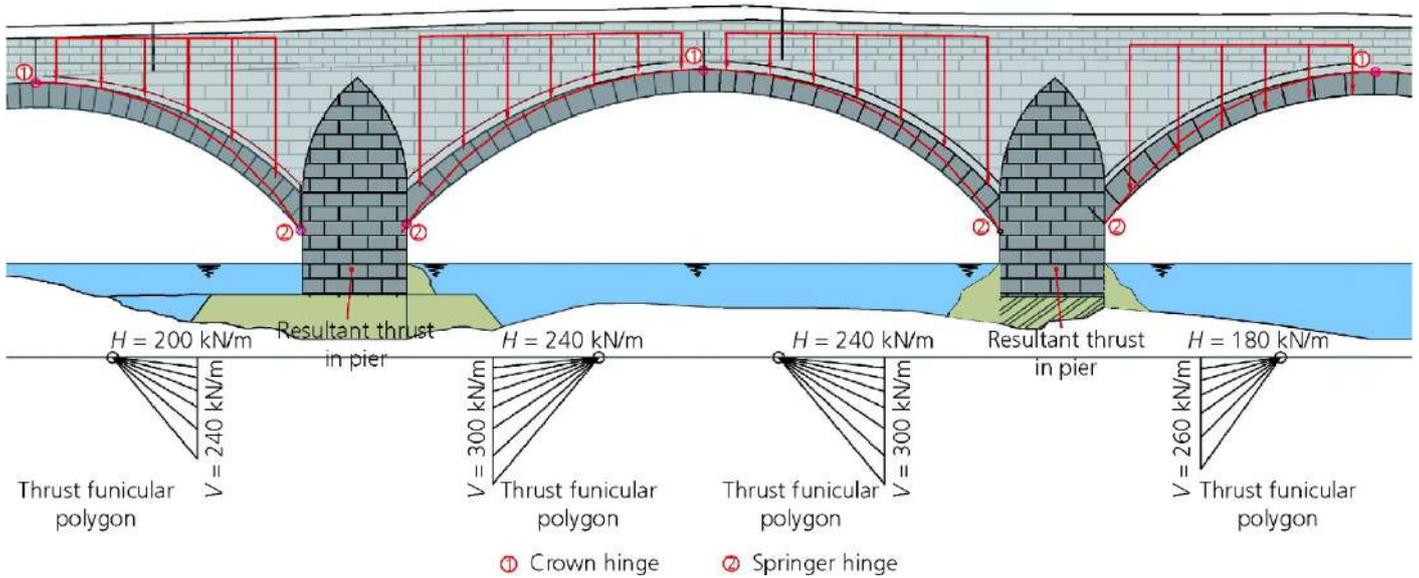
Figure 4. Longitudinal thrust-line analysis of thrust magnitudes in bridge

right-hand (central) arch:  $H = 240$  kN/m;  $V = 300$  kN/m

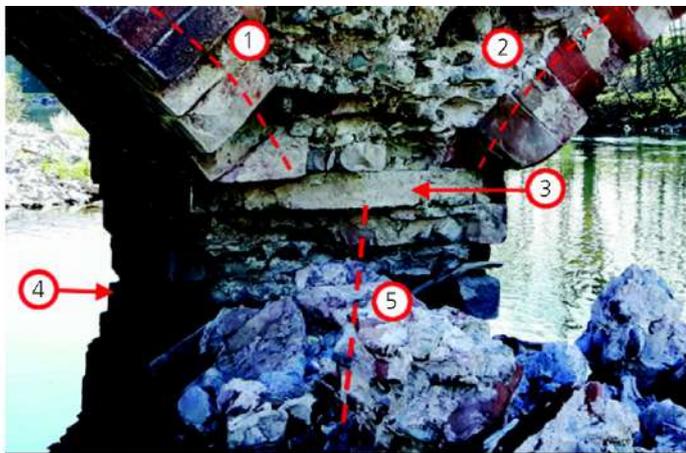
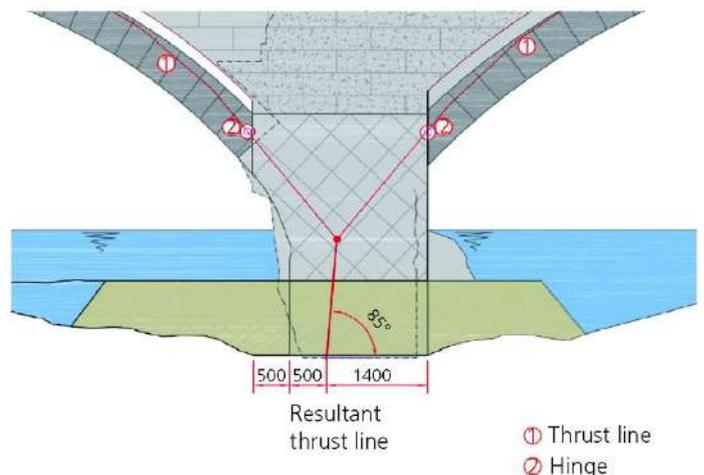
(a)

- ① LH arch thrust
- ② RH arch thrust
- ③ Pier capping slab
- ④ Lateral undercutting to LH flank
- ⑤ Resolved thrust in pier

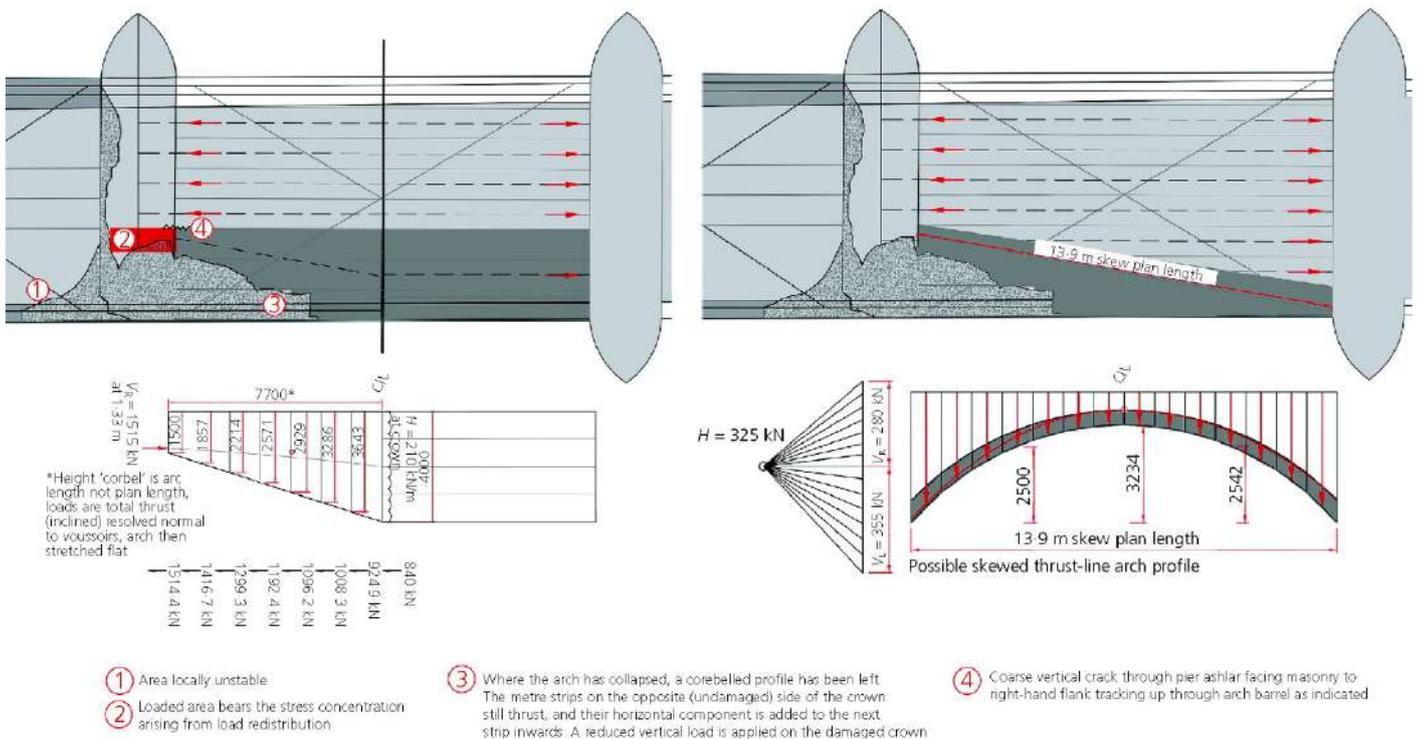
Figure 6. (a, b) Idealisations of the barrel partial collapse and the flow of force in the damaged state. Northern span considered to arch on plan in a similar manner to find support from the damaged pier

- The left-hand (northern) arch on the plan was considered to adopt a similar structural behaviour, and the damage on the plan was accounted for in the overall assessment.

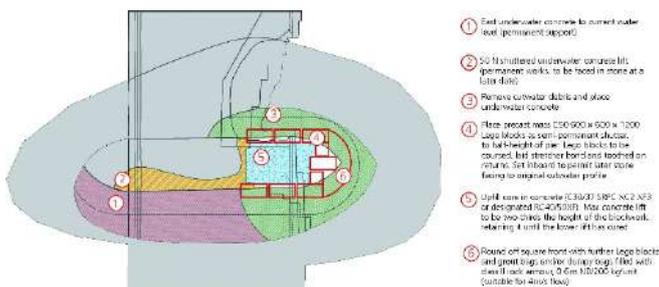
Figure 8 Plan survey on north pier temporary stabilisation works as completed prior to winter 2016. ND, nominal dimension; SRPC, sulfate-resisting Portland cement

Precast concrete 'Lego blocks' were lifted in from distance to form a shutter. Concrete was pumped in from safety, which then engaged the overhanging upstream face of the pier. Once early strength was reached, close-quarters access could be achieved to pack tightly the unsupported ashlar load-bearing facing masonry against the new concrete. Large-section granite rock armour was then used to form a 'falling protection' apron around the pier, and the bridge was left for the winter (Figure 8). Monitoring continued through the use of data loggers until the summer environment agency (EA) working window for the permanent reinstatement works, proving that the temporary stabilisation had arrested any further movement.

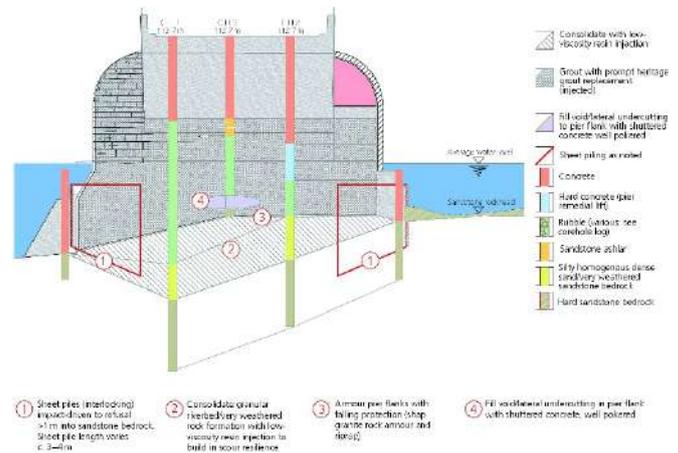
Figure 9 Transverse section through pier showing formation strata and foundation repair work requirements

bedrock (Figure 9). The root of the problem was hence demonstrated – a scour-susceptible formation.

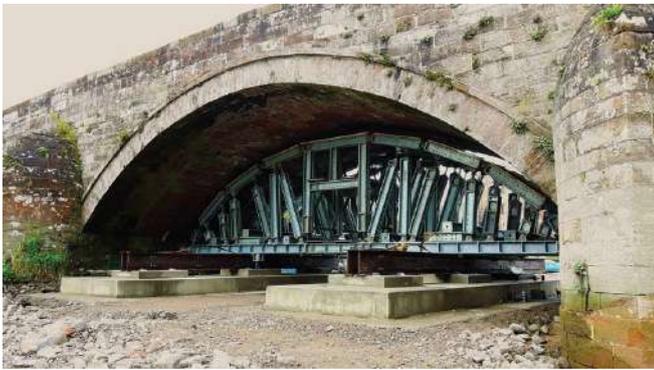
Figure 10 Centring system by temporary works specialist Mabey Contracting being rolled into position on girders on temporary spread foundations formed in the riverbed, viewed from downstream end. Note the hydraulic jacks between the tie-beam and concrete foundation bypassing the girders. The centring truss nodes each have a screw jack to fine-tune the shape up to engage the barrel intrados. Timber folding wedges are then driven into place to engage the masonry fully

Real-time movement monitoring was employed throughout the jacking activities. The piers were laterally braced by the centring system using waling beams off the bottom chord, to permit safe removal of the fill over the central span, keeping the thrusts safely resolved within the piers during the jacking activities.

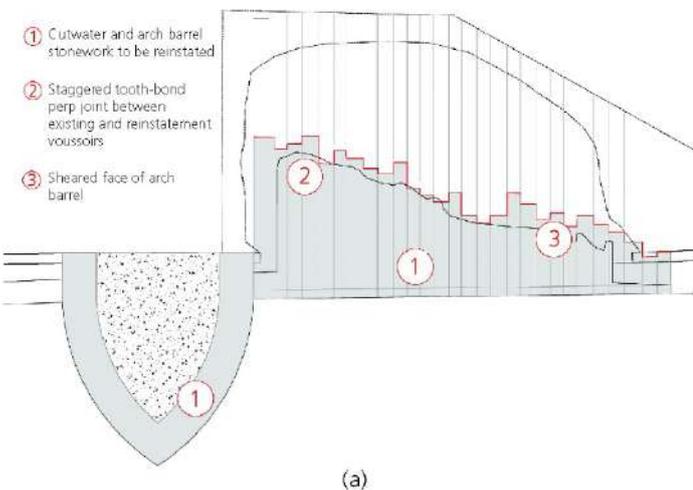
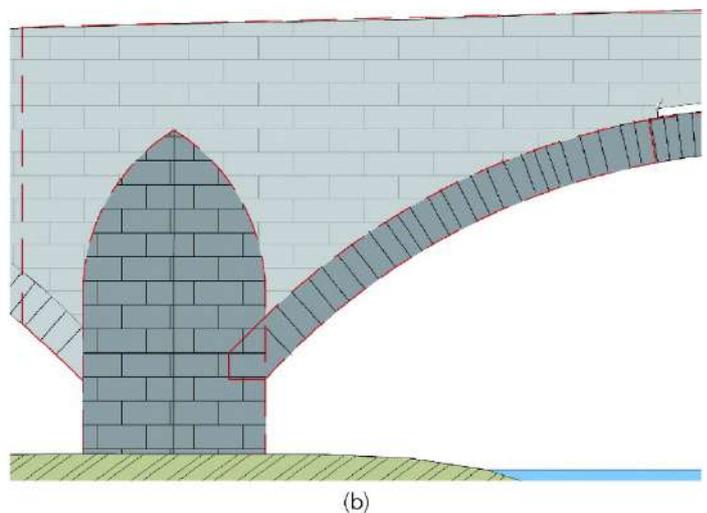
Figure 11 Arch barrel repair details: (a) plan and (b) sectional views

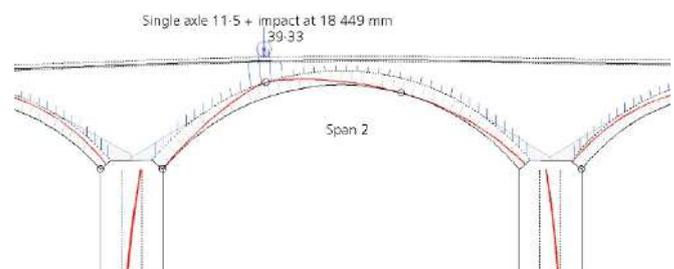
Figure 12 Central span under quarter-point loading with passive response from unloaded arches

17.5 t restricted access using the Archie-M thrust-line bridge assessment program. The program uses graphic statics to interpret masonry bridge behaviour under dead and live loads including rolling point loads (e.g. lorry axle in the Highways Agency (2001) standard). Figure 12 presents a graphic of the thrust-line feedback under a rolling point load at an onerous quarter-point position.
