# Τα Νέα της Ε Ε Ε Ε Γ Μ

Αρ. 139B – ΙΟΥΝΙΟΣ 2020

[Rehabilitation of Brougham Castle Bridge](#), David Wiggins, Kiera Mudd and Matthew Healey, *Engineering History and Heritage*

## Pore water pressure and total horizontal stress response to EPBM tunnelling in London Clay

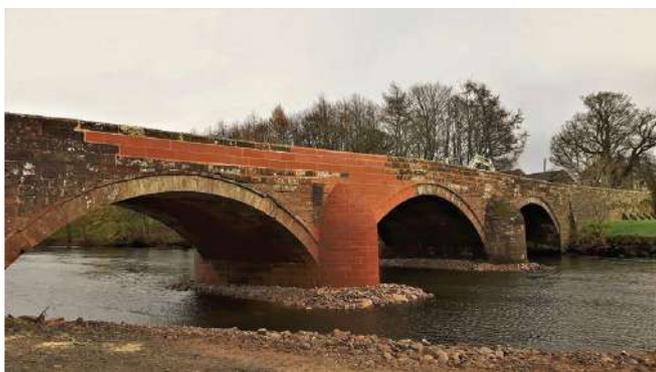
Figure 13 The rehabilitated bridge opened to traffic following a successful load test

The deformation stopped after the first 5 min loading period and remained constant under the load for the remaining 10 min at each location. A repeat of the load test was performed to investigate the initial response of the bridge to loading, and only nominal deformation was observed, importantly being elastic in nature (rebounding when the load was removed). The initial plastic settlement was hence determined to record the 'bedding-in' of the new work: by contrast, the pier itself exhibited zero deformation, which confirmed that the rebuilt skewback had bedded down into the pier. The repeat load test confirmed successful rehabilitation, and the bridge reopened to traffic (Figure 13).
