ΕΛΛΗΝΙΚΗ  
ΕΠΙΣΤΗΜΟΝΙΚΗ  
ΕΤΑΙΡΕΙΑ  
ΕΔΑΦΟΜΗΧΑΝΙΚΗΣ  
& ΓΕΩΤΕΧΝΙΚΗΣ  
ΜΗΧΑΝΙΚΗΣ

Αρ. 14 – ΜΑΙΟΣ 2008

Τακτική Γενική Συνέλευση της ΕΕΕΕΓΜ	1
Άρθρα	8
- C. Tsatsanifos "Contribution of geotechnical engineering in the rehabilitation of buildings and infrastructures"	8
- E. Hoek, C. Carranza-Torres, M. Diederichs and B. Corkum "Integration of geotechnical and structural design in tunnelling"	24

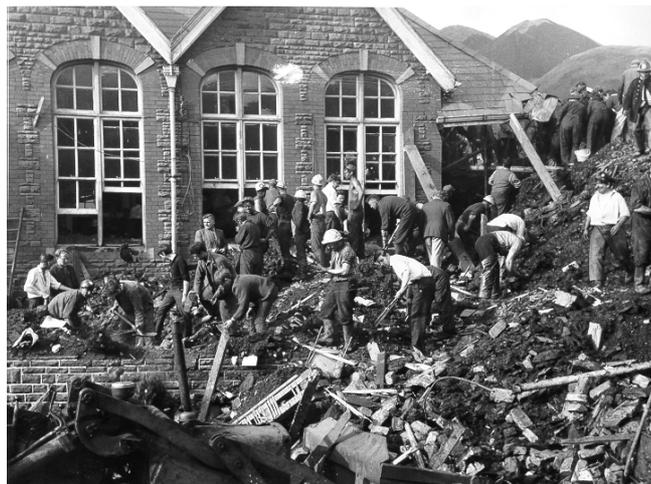
Figure 1. The Pantglas Junior School, Aberfan, South Wales engulfed by the debris of the flowslide.

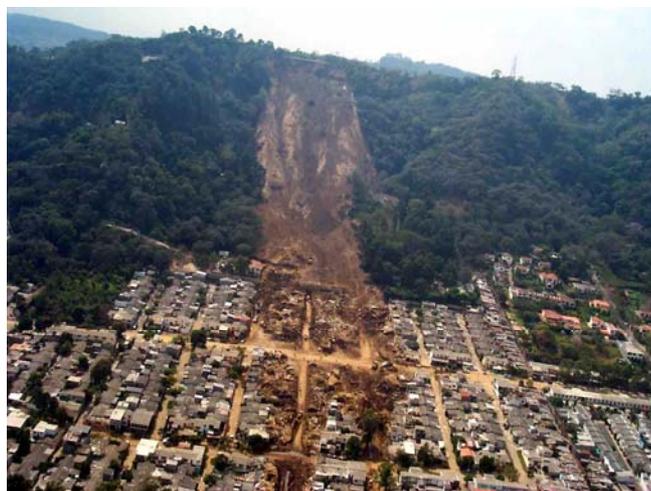
Figure 2. Oblique aerial view of landslide that buried Colonia Las Colinas, El Salvador.

A massive landslide occurred in the Las Colinas neighbourhood of Santa Tecla, El Salvador, Central America as a result of the  $M = 7.6$  earthquake of January 13, 2001. The landslide buried many houses in the neighbourhood under

tons of earth (Figure 2), leaving as many as 1,200 people dead.

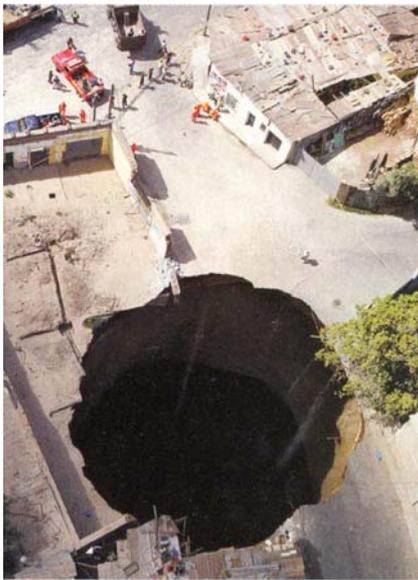
Figure 3. Leakage of a sewer pipe created a hole of 30.5 m diameter and 49 m depth in Guatemala City.

A clogged sewer line caused a sink hole in Portland, Oregon, USA on December 2006, which swallowed a truck – which had been sent to clean the sewer. Natural gas and water lines were also ruptured in the accident. A similar accident happened in Guatemala City, Guatemala on 22<sup>nd</sup> February 2007. A hole of 30.5 m diameter and 49 m depth opened (Figure 3) swallowing five houses and killing 3 persons. The accident was the result of the leakage of a deep buried sewer pipe in tuffs (pyroclastic deposits).

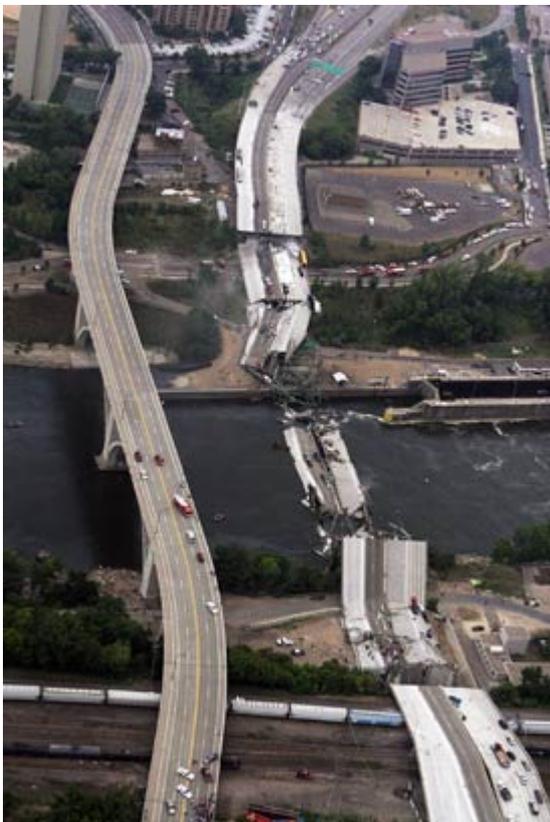
Figure 4. Aerial view of the collapsed bridge in Minneapolis (2<sup>nd</sup> August 2007).

A 120-ton concrete beam collapsed onto Interstate 70 in Washington County, Pennsylvania, USA, barely missing passing motorists on December 2005, while recently (2<sup>nd</sup> August 2007) the catastrophic collapse of the I-35W highway bridge over the Mississippi river in Minneapolis, Minnesota, USA, left 5 dead persons and 111 injured (Figure 4).

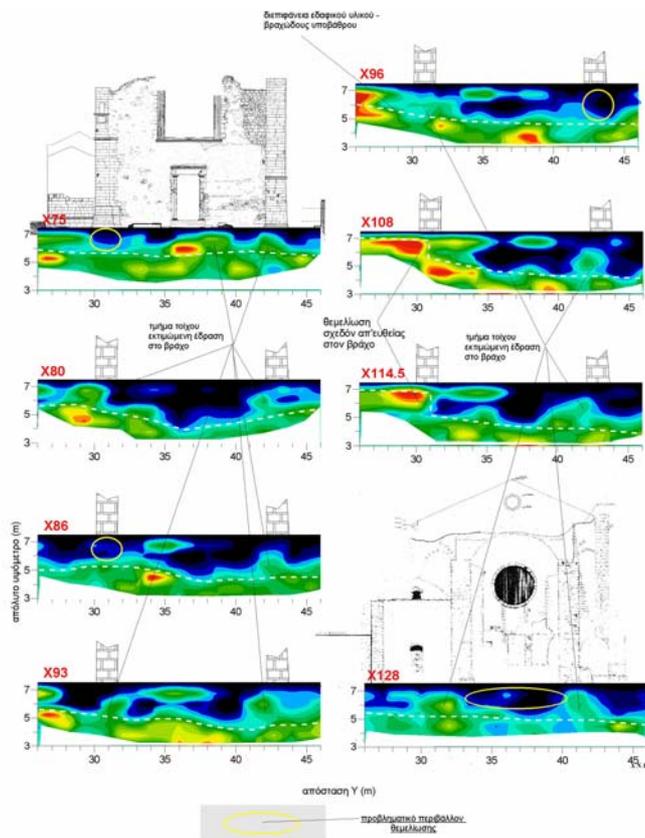
Figure 5. Vertical sections along the longitudinal axis of the Saint Peter of the Dominicans Church (Polymenakos & Tzatsanifos, 2003).

investigations consisted of three boreholes, with SPT tests on site and laboratory tests, later on, for the definition of the foundation conditions and a detailed geophysical investigation, involving seismic / acoustic tomography, for defining the details of the foundation bodies of the structure. The results of the geophysical investigation revealed that the foundation bodies of the church are resting on the bedrock, however there are some sections of the walls where either there is no foundation body, or the foundation body is resting on top of soft deposits (see Figure 5).

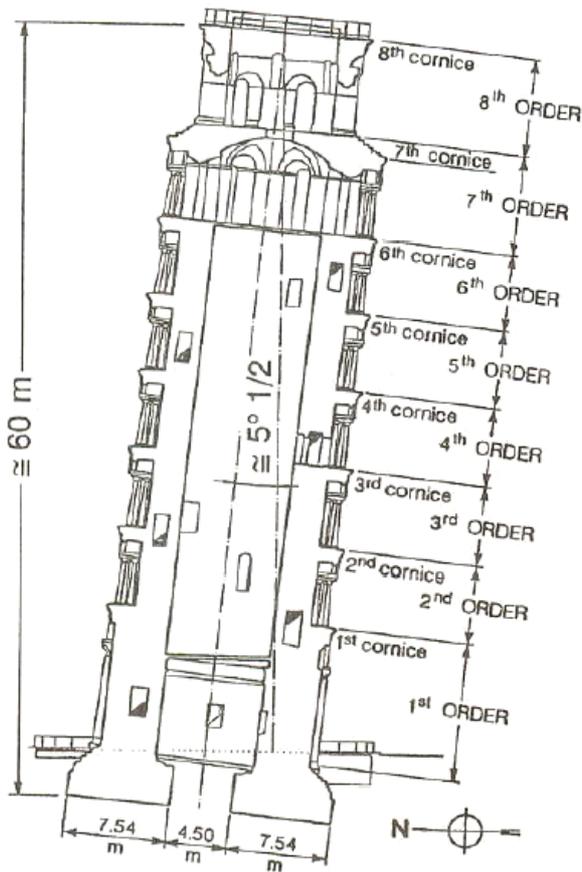
Figure 6. Cross section of the Leaning Tower of Pisa

The most famous example of the contribution of geotechnical engineering in the rehabilitation of a building is that of the Leaning Tower of Pisa, where the soil extraction method has been applied. The tower is founded on weak, highly compressible soils and its inclination has been increasing inexorably over the years to the point at which it was about to reach leaning instability (about 5.5 degrees to the vertical - see Fig. 6 from Burland et al., 2003).

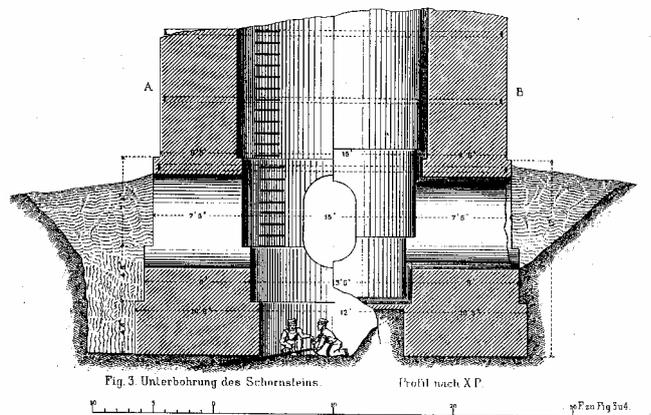
Figure 9. Vertical section at base of Bochum chimney showing the process of soil extraction (Johnston & Burland, 2004).

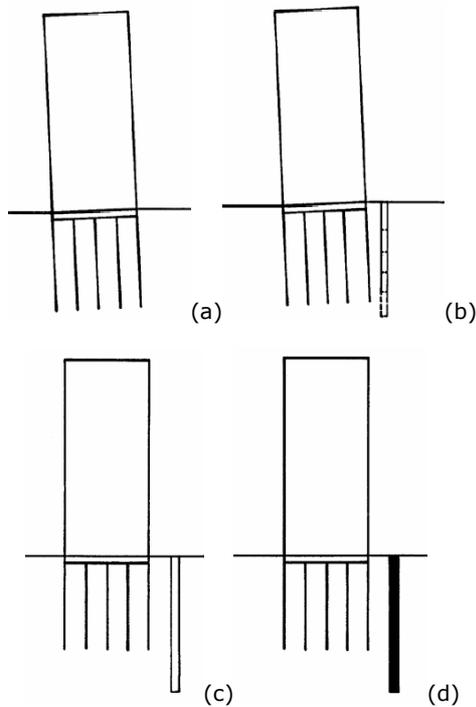
Figure 10. Principle of the RSS method: (a) Tilting of pile – supported structure (b) Progressive drilling of boreholes on the “high” side of the foundation (c) Restoration of structure tilt (d) Grouting of boreholes.

A similar to the soil extraction approach was proposed by Poulos et al. (2003) for the rehabilitation of buildings on piles which have undergone uneven settlements due to uneven ground conditions, or/and interaction among closely-spaced buildings, or/and faults in the foundation piling. The approach, which has been termed the "RSS" (Removal of Soil Support) method, involves the drilling of a number of boreholes on the "high side" of the building, so that restoring vertical movements will be developed within the area of the building foundation (see Fig. 10). A major advantage of the method is that it is not intrusive (i.e. it can be performed outside the building footprint) and can be controlled and adjusted via an observational approach.

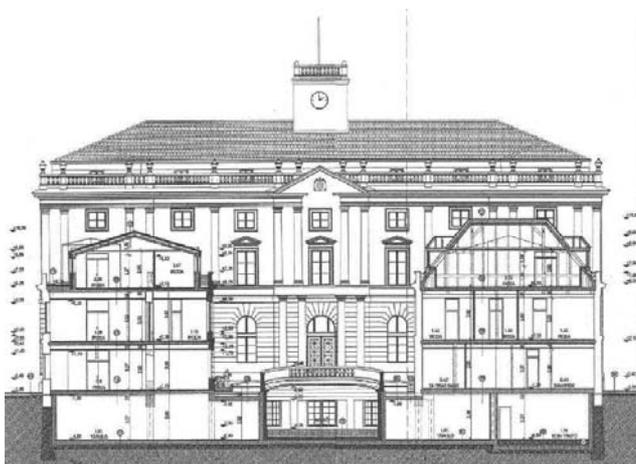
Figure 11. Architectural section of the renewed AEB Bank in Budapest.

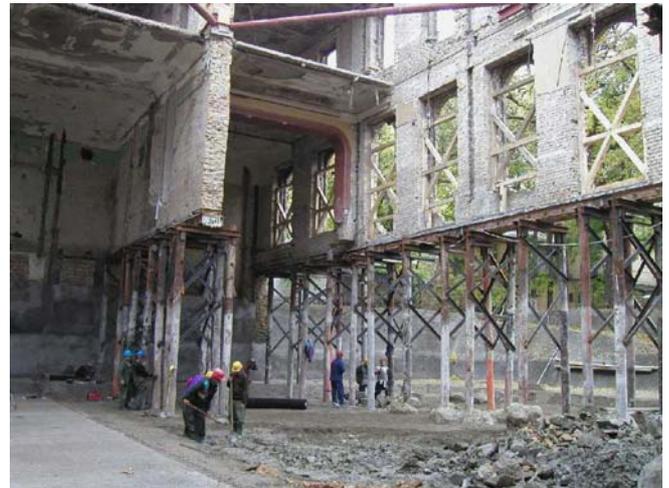
Figure 12. The AEB Bank building “in the air”

The loads of the internal walls were between 100 and 300 kN per meter and were transferred to the ground, temporarily, through micro piles (Figure 12).

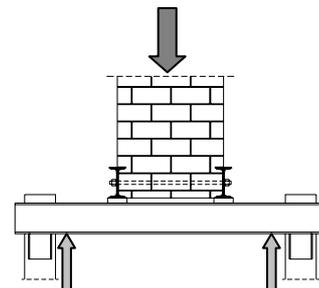
Figure 13. The connection between the micro-pile heads and the wall for the AEB Bank building.

In order to avoid any horizontal movements or / and vertical displacements of the very fragile brick-walls, jet piles were made on the two sides of the wall, and into them common steel tubes were placed. The connection between these so-called micro-pile heads and the wall is shown in Figure 13.

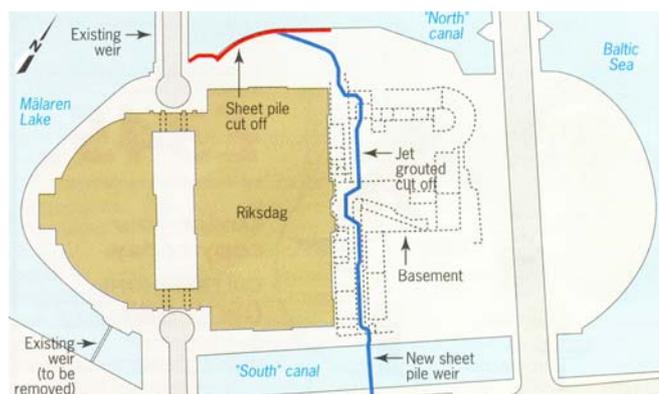
Figure 14. The cut-off dam to restore groundwater below Riksdag to the level of Lake Malaren

At the Riksdag the cut-off dam runs along the north side and then cuts across in front of its main façade, creating a curved L-shape (see Figure 14) that connects to the low weir, marking the transition between the lake and the tidal Baltic Sea.

The dam is made up of two rows of jet grouted columns, extending from 15 m to 30 m in a sandy moraine and penetrating 150 mm into rock (European Foundations, 2004).

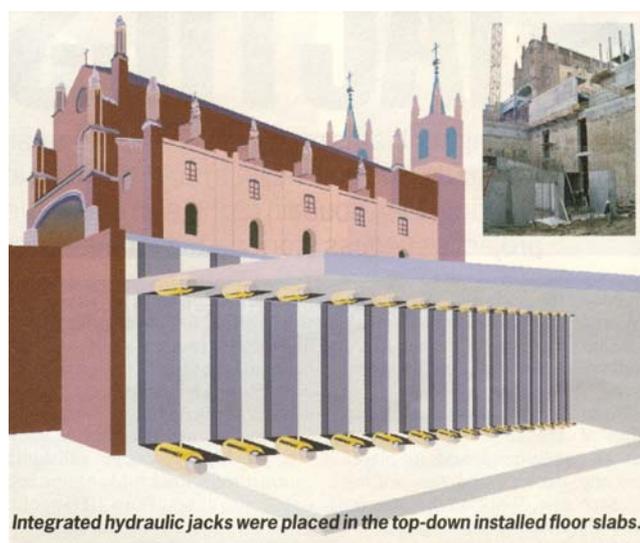
Figure 15. The retaining system for the construction of the Prado Museum's underground extension

The ground movements were controlled with the novel use of 34 integrated hydraulic jacks that in effect reacted and pushed back the retaining walls as they started to move. The excavation was built top-down and jacks were installed to connect the two new "floating floors" to the retaining walls, incorporating a system which measured movement in the wall caused by the load of the surrounding buildings and traffic (see Figure 15).

At each of the two floor levels, separated vertically by 8 m, 17 double-acting 500 t capacity jacks were installed, each with 100 mm stroke. Individual jacks were equipped with a positioning sensor to measure movement and a tilting swivel saddle to compensate for side load caused by non-centred loads (European Foundations, 2004).

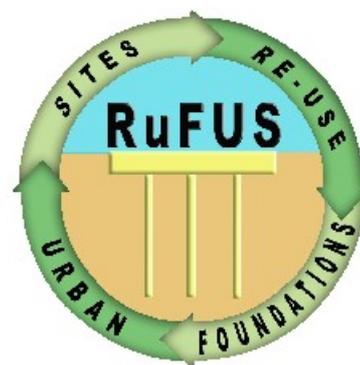
Figure 16. The RuFUS rosette.

As mentioned before, in rehabilitating old structures one should consider the existing foundations, and the impact of these old structures will have on modern geotechnical design. Existing foundations might perform satisfactorily under new loads, even though they are decades old. The research project "Re-use of Foundations on Urban Sites" (RuFUS), financed by the 5<sup>th</sup> European Commission Framework, has aimed at providing ways to overcome the barriers, both technical and non-technical, to the reuse of foundations for sustainable development. The outcome of the project was presented and discussed at the RuFUS Conference (19-20 October 2006) and published at the conference proceedings as well as in A Best Practice Handbook.

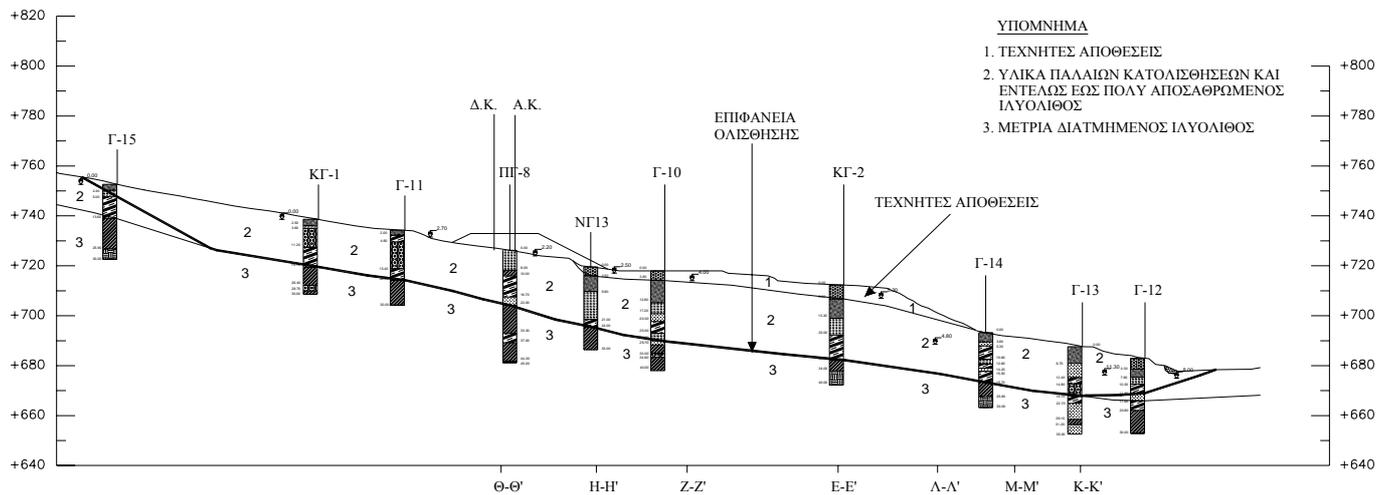
Figure 17. Slope section of the Anthochori Landslide with the assumed failure surface and the applied external loadings.

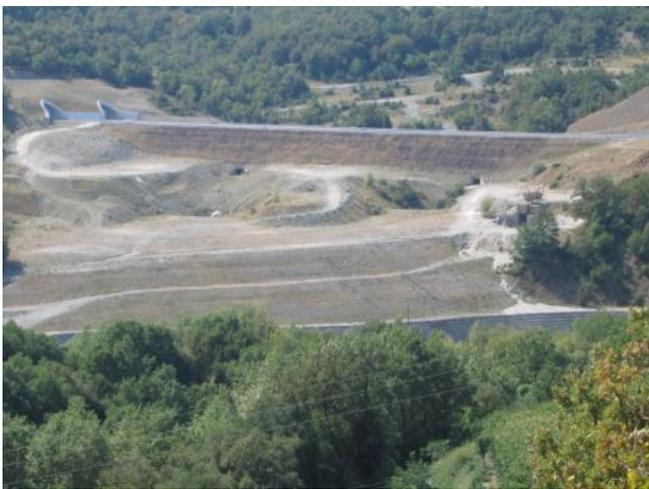
Figure 18. The Anthochori Embankment on the Landslide Area after the Construction of the Remedial Measures.

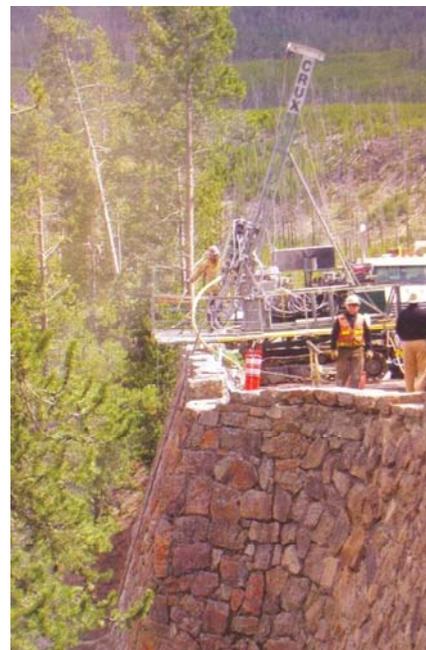
Figure 19. Micropile installation at Gibbon Falls Retaining Wall (Barrows et al., 2005).

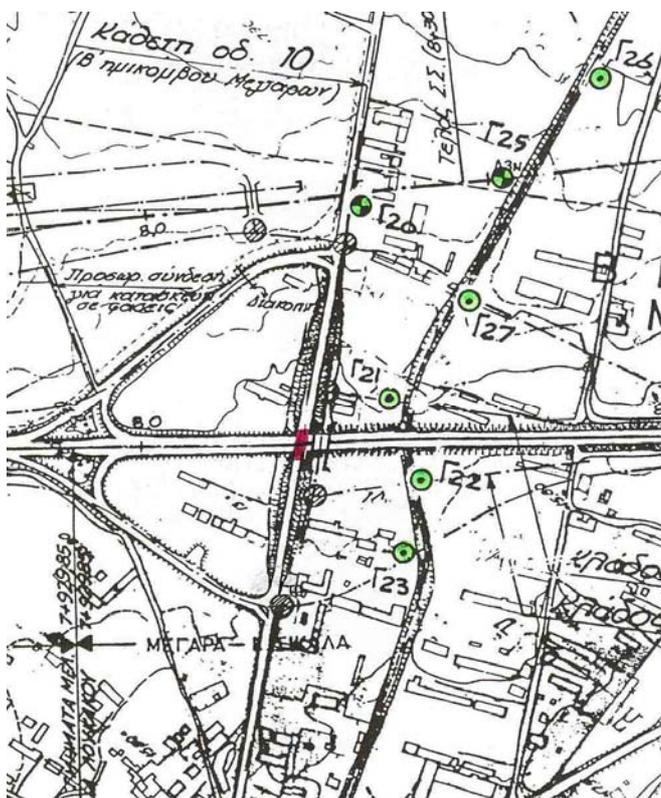
Figure 20. Location of bridge with differential pier settlements and of boreholes, on which the design was based.

The design of the pile foundations of the bridge was based on the results of boreholes performed for a series of neighbouring structures, however at a distance of about 100 m (see Figure 20).

The pile tips reached a depth of about 10.5 m below ground surface, according to the design, where a layer of dense gravels with sand has been foreseen. However, the design did not take into account that through that area a small stream was passing, having created, through its old meanders, different subsoil conditions within short distances. Thus, while the piles at the north pier reached the gravel layer, those of the south pier did not and after 15 months from the beginning of the measurements of the settlements

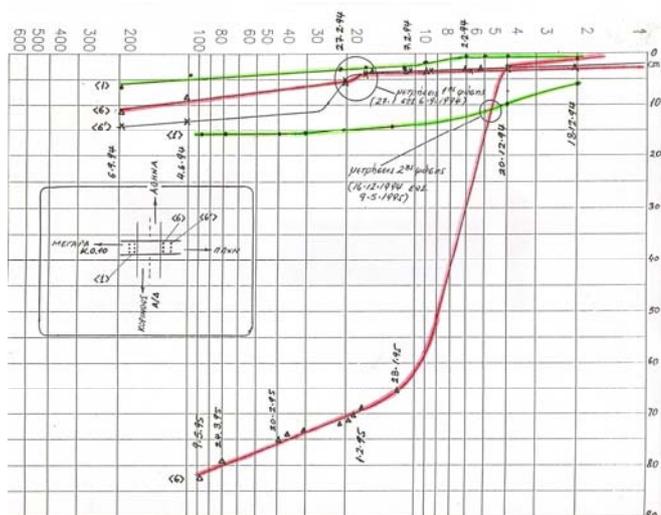
Figure 21. Settlements of the central piers of the bridge (red: south pier, green: north pier).

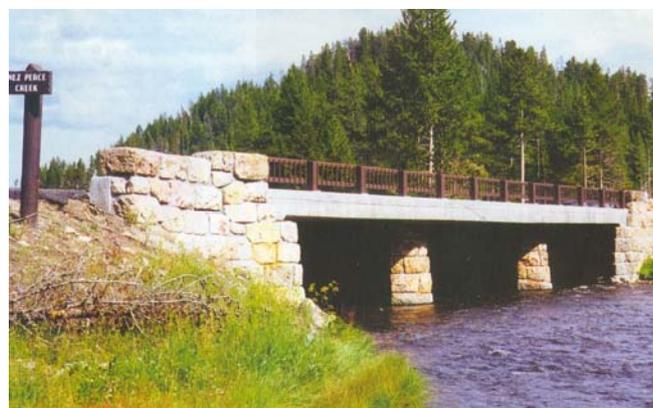
Figure 22. Nez Perce Creek Bridge at the Yellowstone National Park, USA (Barrows et al., 2005).

Nez Perce Creek Bridge in Yellowstone National Park USA (see Figure 22) was widened in 1996 to allow for increased traffic and larger vehicles, and to comply with current safety standards. It has been determined that the stone masonry piers would not sustain the design seismic loads but it was important to retain the look of the original work. One of the steps taken to accommodate these new design loads was to add steel reinforcement to the piers to make them more ductile and self-stable, and to isolate them from the bridge deck. This technique involved placing micropiles through each pier at 1.5 m spacing, and extending those 3 m into bedrock. The deck isolation was achieved by elastomeric/steel bearing pads which allowed the pier masonry to remain untouched. The bridge abutments were widened by deconstruction of the stone masonry and constructing new concrete core walls for the additional width. To retain the same masonry look, the walls were faced with original stones as well as stones conserved from roadway excavation (Barrows et al., 2005).

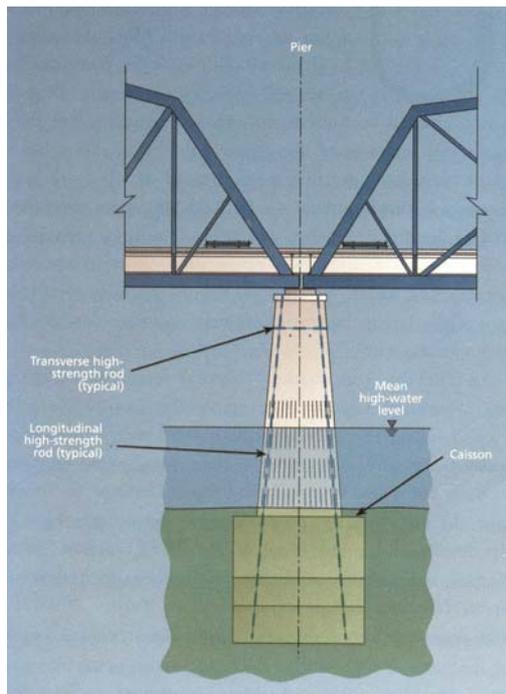
Figure 24. Pier 3 replacement at the Million Dollar Bridge, Alaska.

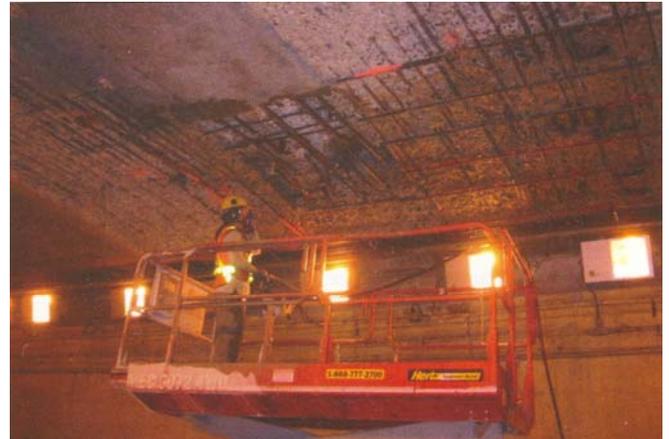
Figure 25. Crews prepare the main joint between tunnel sections for structural repair and strengthening of George Massey Tunnel.

Though the quality of the precast concrete was good, there was only about half the reinforcing that would be used today. This made the structure incapable of handling any relative movement produced by the new design earthquake.

Structural upgrade involved adding reinforcement to ensure that an earthquake would induce many well distributed cracks as opposed to a few large ones. The biggest challenge was finding space where to add steel. Trucks already "scrape" the ceiling so only the ceiling corners, the floors and the walls were reinforced, as well as the wind tubes and the air ducts (see Figure 25).

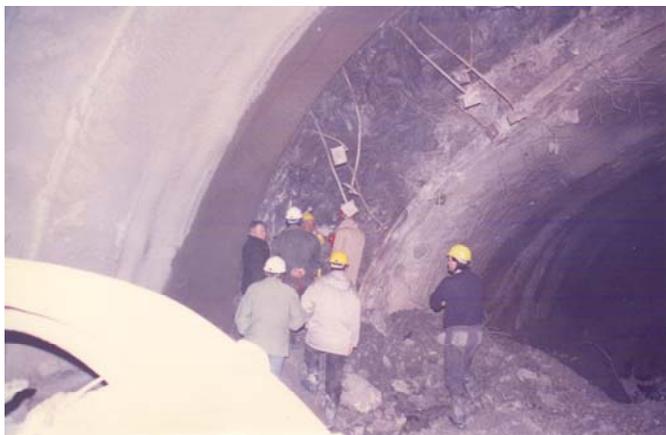
Figure 26. The maximum squeezing deformation of the Tymfristost Tunnel was as much as of 2 m.

Due to contractual problems and lack of funding the project has proceeded intermittently in three different contracts, with a halt of more than two years (from September 1995 to October 1997) between the second and third contract. During this period a 531 m long section of the top head, already excavated along the whole length of the tunnel, in an area with a rock mass of poor strength and deformation characteristics, suffered from excessive deformations, which destroyed the primary support and led to substantial closure of the opening (see Figure 26).

In the process of rehabilitating the tunnel, a series of forth and back analyses were performed taking into account the new ground conditions. The analyses revealed that the deformation of the tunnel was due to the squeezing behaviour of the rock mass (Tsatsanifos et al., 2000) which could be tackled effectively through the "immediate" closure of the primary lining ring (Tsatsanifos, 1995). The excavation of the tunnel cross section along this part (130 m<sup>2</sup>) was subdivided into top heading, bench and invert drifts, while three support classes were specified. Shotcrete (0.30 ÷ 0.40 m thick), with two layers of T131 wire mesh, lattice girders Pantex 70/30/D30 and systematic rockbolting (13/ 14 6 ÷ 9 m fully grouted bolts at each excavation step) were used for the primary lining. The excavation step of the top heading was 1 m and the complete closure of the primary lining ring was done every 2 m.

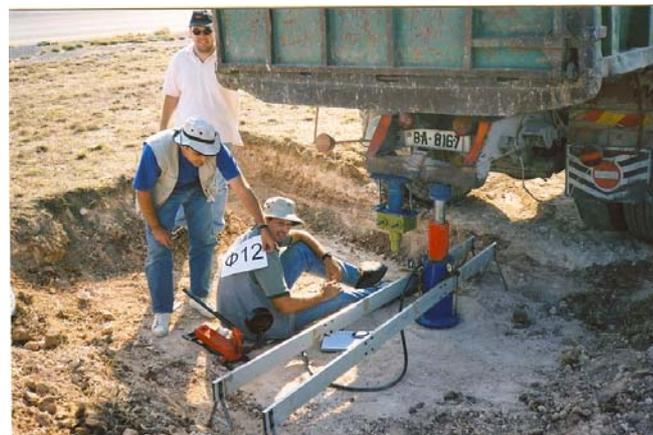
Figure 27. Geotechnical investigations for the rehabilitation of Tanagra airport runway pavement.

Figure 27 shows a location of the geotechnical investigations performed for the design of the rehabilitation of the Tanagra Airport Runway Pavement. The results of the investigations and the subsequent preliminary design revealed that it was more economic to reconstruct the whole pavement instead of rehabilitating it (Magrioti et al., 2003). The tricky think in this case was that, since Tanagra airport is a military airport in a 24 hours operation, the time allocated for the investigations was only one day, hence all the boreholes and trial pits had to be drilled / excavated and

the pavement reinstated within this one day. To tackle this problem, special materials for the local rehabilitation of the pavement were used.

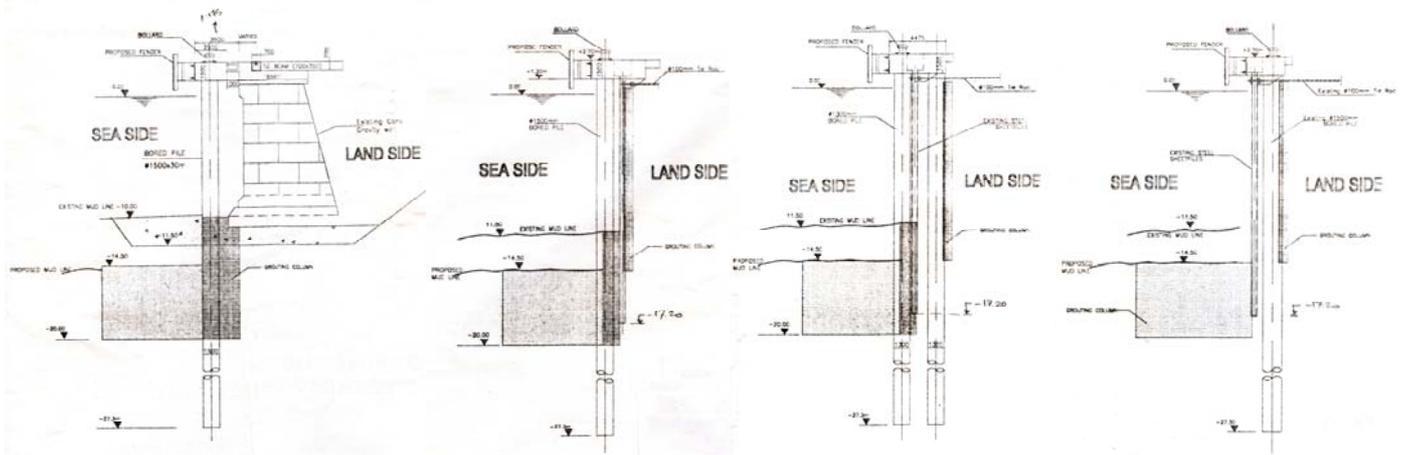
Figure 28. Different sections along the Apapa Bay, Lagos, Nigeria quay wall: (a) Gravity wall area, (b) Steel sheet-pile A area, (c) Steel sheet-pile B area, (d) Steel sheet-pile C area

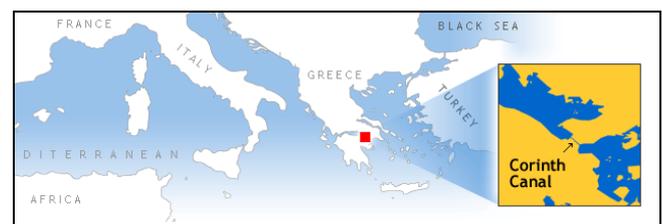
Figure 28. The Corinth Canal and its location.

The rock formations in the flanks of the Corinth Canal consist of Neocene deposits of marls and sandstones. There are several faults running in east-west direction at a perpendicular angle to the canal axis, some of them seismically active. These geologic features were responsible for a number of major landslides into the Canal at several instances. On account of these landfalls, the Canal often had to be closed for repairs. The most serious such incident happened in 1923, when the Canal remained closed to traffic for 2 years on account of 41,000 m<sup>3</sup> of earth which had fallen in. Another major interruption of operation occurred in 1944, when the retreating German Army set explosives to the flanks of the Canal and caused 60,000 m<sup>3</sup> of earth to cave in. To make repairs even more difficult, the Germans also sunk railroad cars into the canal. It took 5 years to clear the Canal for traffic then.

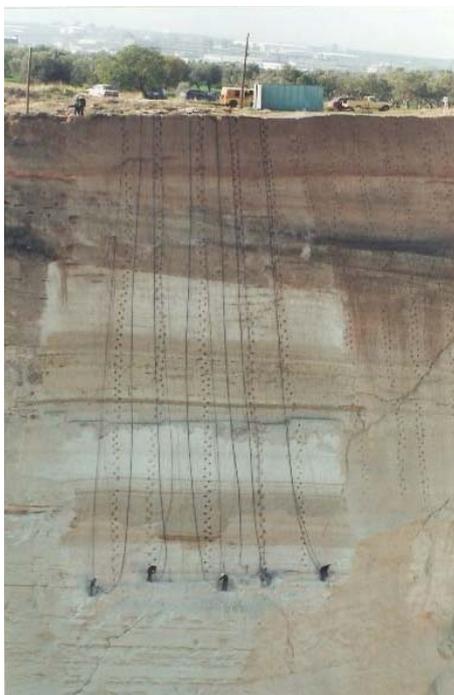
Figure 29. Rehabilitation works on the slopes of the Corinth Canal

In all these cases major rehabilitation works had been required for the re-opening of the Canal. Currently, in order to safeguard the passage of the ships through the Canal, continuous rehabilitation of the slopes is required, as shown in Figure 29.

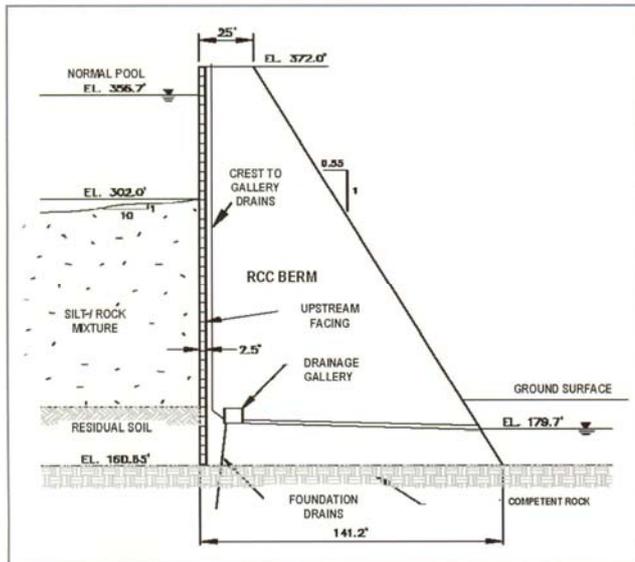
Figure 30. Saluda Dam's typical RCC berm section (Bair and Koleber, 2006).

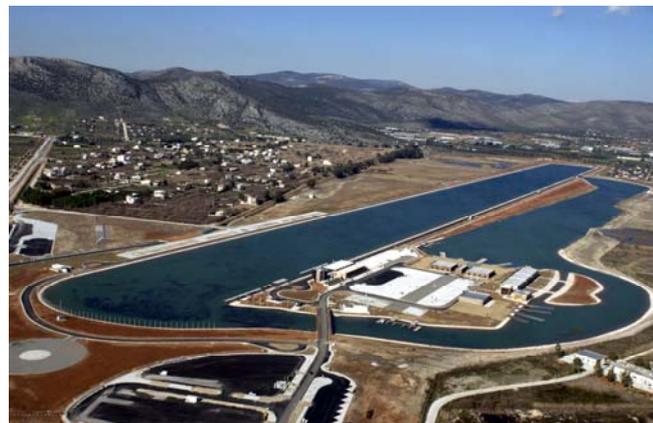
Figure 33. The Athens 2004 Olympic Games Rowing and Canoe Centre at Shiniias, Marathon.

The design of the Olympic Centre (see Figure 33) presented some very interesting geotechnical problems to deal with and provided all the necessary works in order to reinstate the old marshland through the water overflow from the rowing ponds to the marshland (Tsatsanifos, 2004).

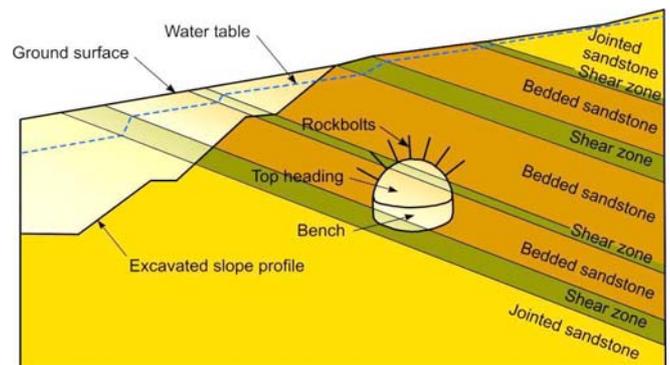
Figure 1. Geometry of the original slope showing the rock layers, the location and geometry of the tunnel and slope excavations and the original water table.

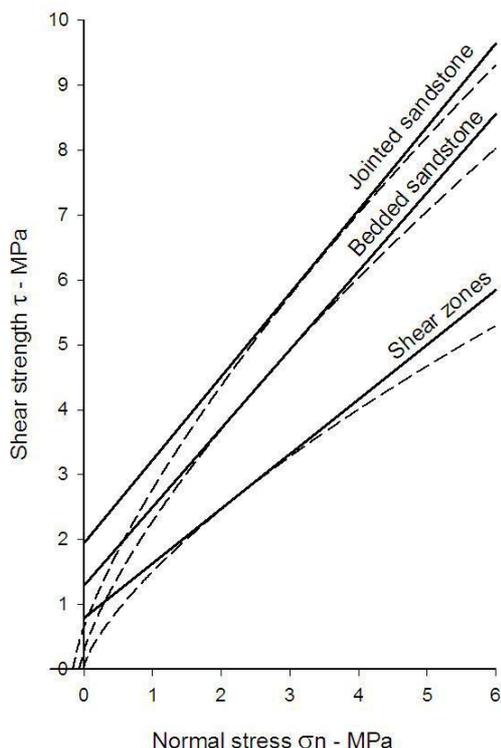
Figure 2. Mohr failure envelopes for individual rock units.

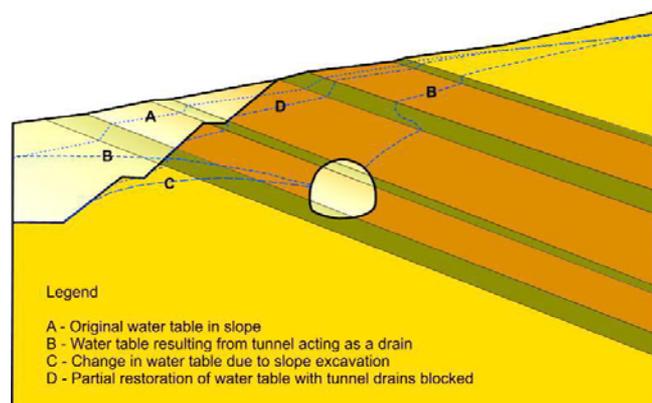
Figure 3. Water tables at different stages of tunnel and slope excavation and assuming long term blockage of the tunnel drains.

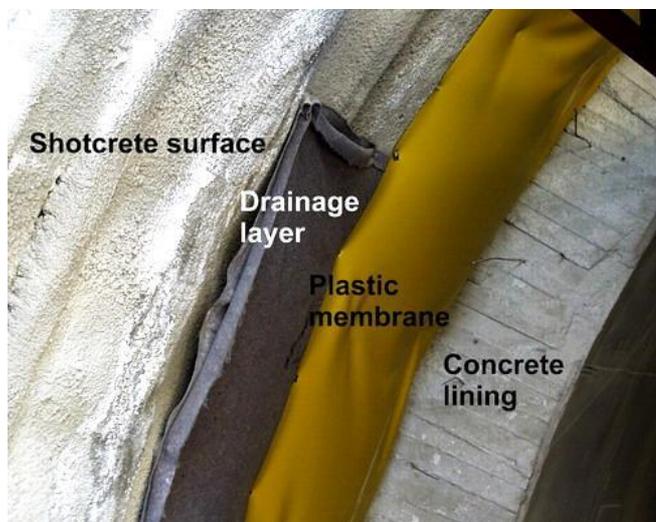
Figure 4. Construction of a complete tunnel lining consisting of an initial lining of lattice girders embedded in shotcrete, a geotextile drainage layer, a waterproof plastic membrane and a cast-in-place concrete final lining.

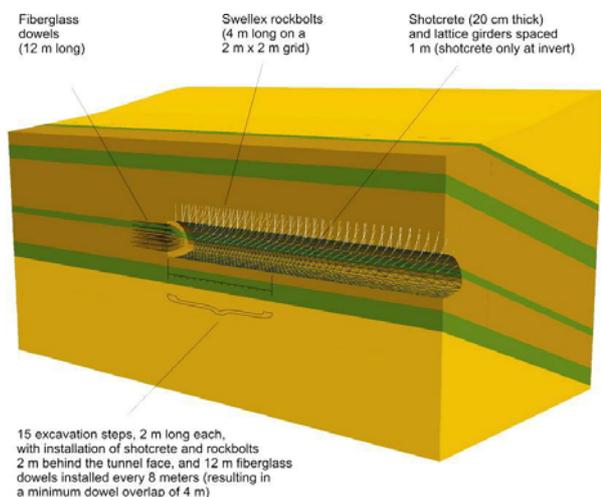
Figure 5. View of the three-dimensional numerical model used to analyze stability of the tunnel face.

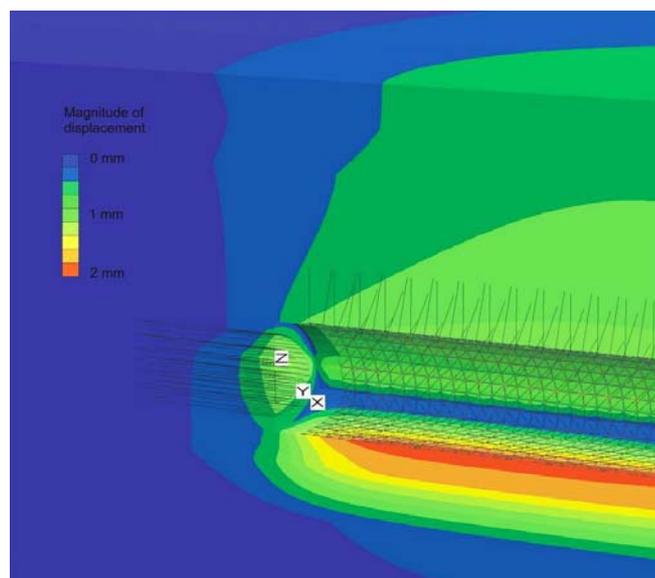
Figure 6. Representation of contours of magnitude of displacements for the last stage of excavation in the three-dimensional model of Figure 5.

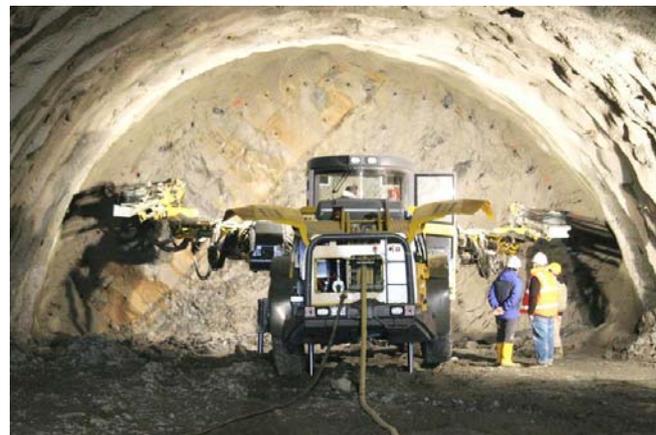
Figure 9. A simple top heading shape in good quality interbedded sandstones and siltstones. The tunnel arch is supported by means of rockbolts and a layer of shotcrete and no face support is required. The flat floor requires no special treatment other than good drainage of surface water accumulations.

For large span tunnels the top heading shape preferred by contractors is illustrated in Figure 9. This consists of an arched roof and a flat floor. The flat floor is simple to excavate and it provides an excellent road base for construction traffic. In good rock at low to moderate stress levels, this top heading shape is acceptable. The suitability of this top heading profile for this example is investigated below.

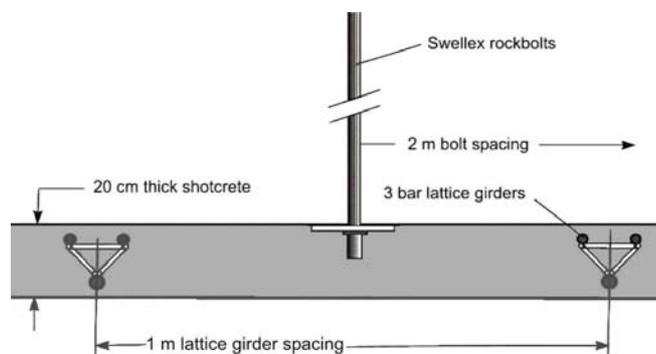
Figure 10. Reinforcement and support for the top heading arch consisting of standard Swellex rockbolts on a 2 m x 2 m grid and 3 bar lattice girders spaced at 1 m centers and embedded in a 20 cm thick shotcrete lining (Not to scale).

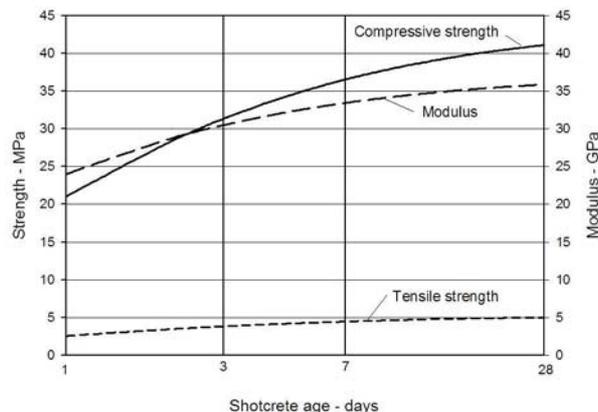
Figure 12. Assumed time dependent properties for shotcrete.

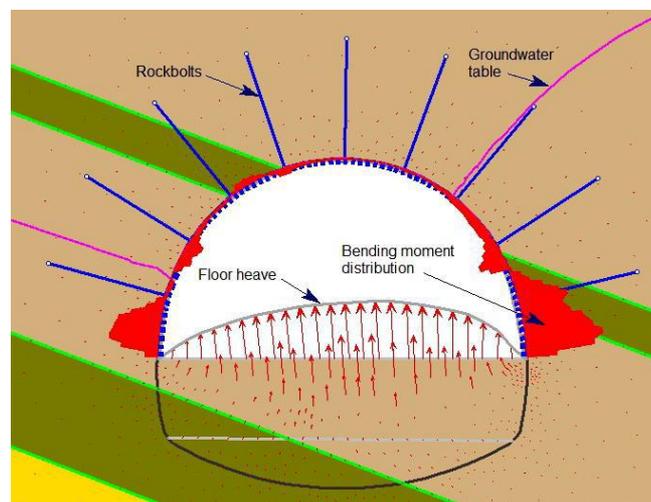
Figure 13. Bending moment distribution in the lining of the top heading with a flat unsupported floor on day 3 after installation of the support.

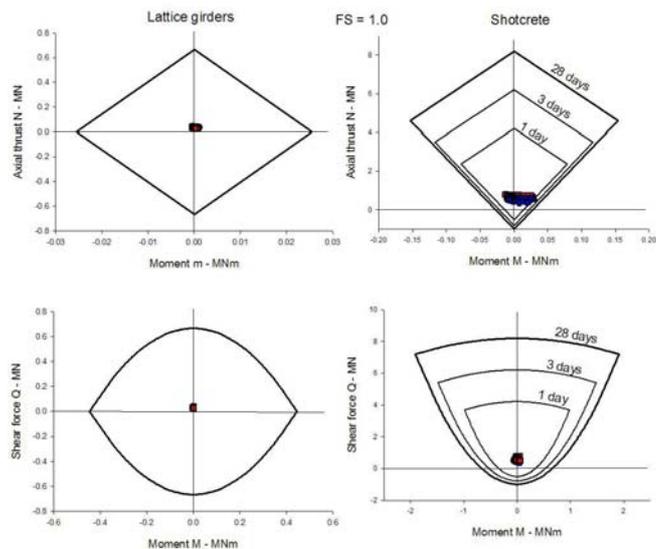
Figure 14. Support capacity diagrams for a 20 cm shotcrete lining, reinforced with 3 bar lattice girders, placed in a top heading excavation with a flat floor (see Figure 9).

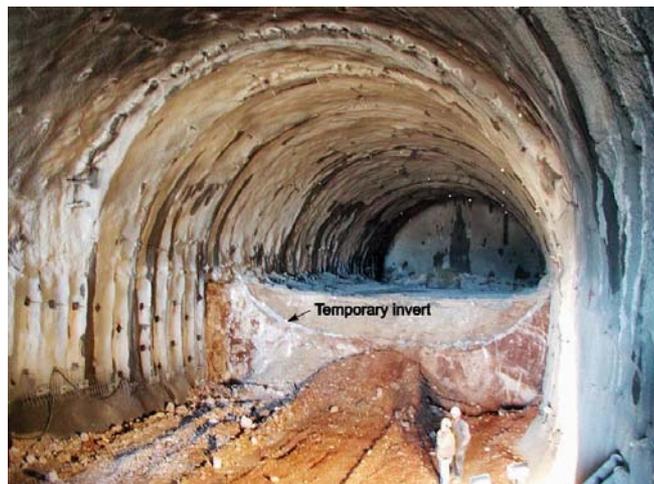
Figure 15. Top heading and bench excavation in a weak rock tunnel where a temporary shotcrete invert was used to control floor heave.

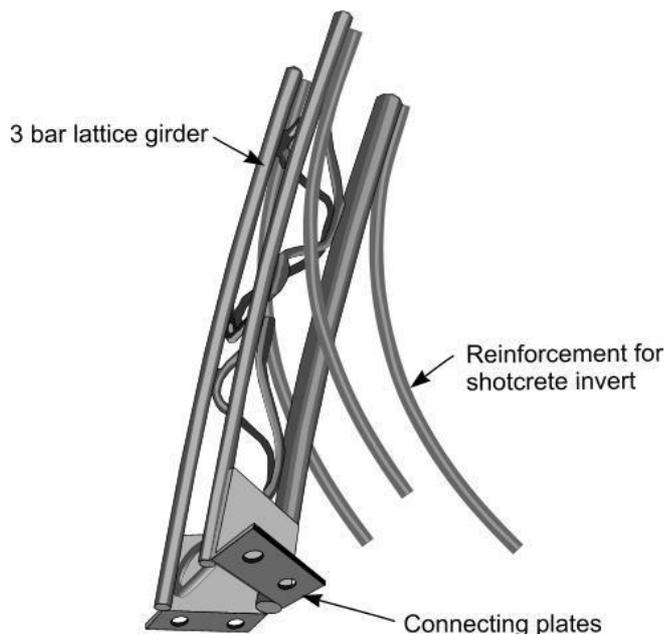
Figure 16. Additional reinforcement at the junction between the top heading arch legs and the temporary shotcrete invert.

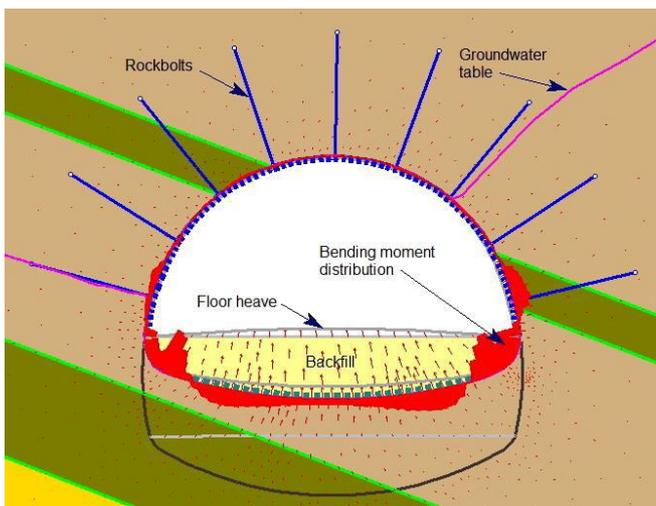
Figure 17. Bending moment distribution in a top heading lining with a curved shotcrete invert covered by backfill (see Figure 15).

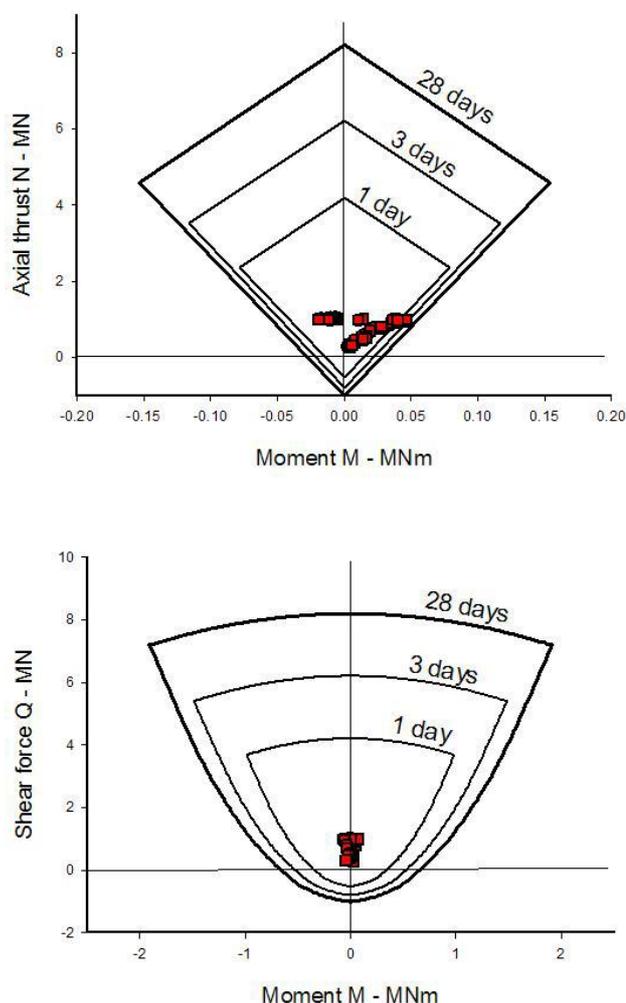
Figure 18. Support capacity plots for the 20 cm thick unreinforced shotcrete invert in Figure 17.

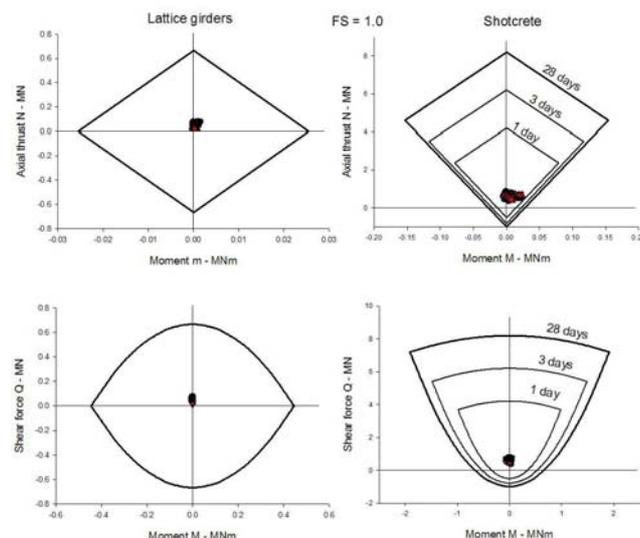
Figure 19. Support capacity diagrams for a 20 cm shotcrete lining, reinforced with 3 bar lattice girders, placed in a top heading excavation with a curved shotcrete invert (see Figure 15).

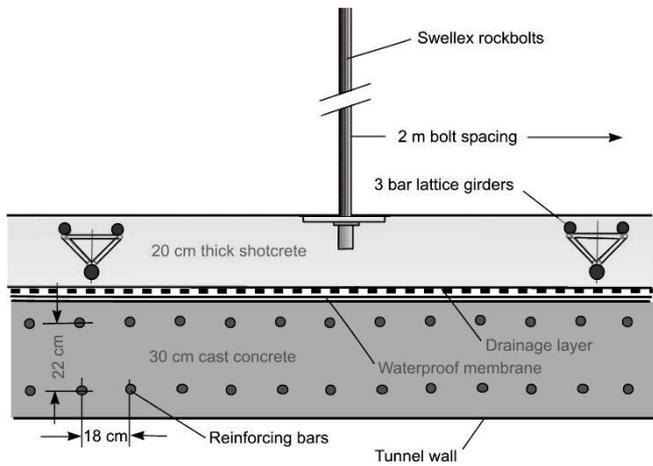
Figure 20. Geometry of composite final lining consisting of a 20 cm thick initial shotcrete lining, a drainage layer, a waterproof membrane and a 30 cm thick cast concrete lining (Not to scale).

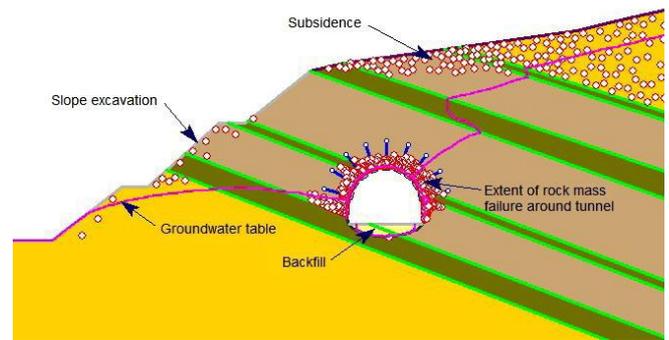
Figure 21. Changes in stress and groundwater conditions as a result of excavation of the open cut for an adjacent carriageway can result in propagation of failure zones in the rock mass.

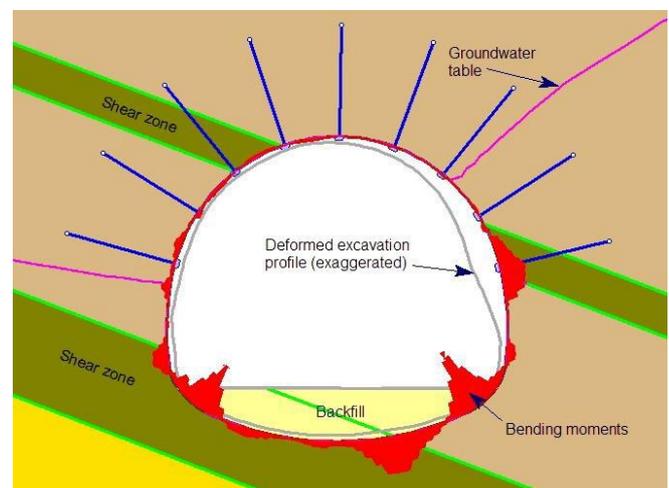
Figure 22. Distribution of bending moments and deformations of the final tunnel profile after installation of the final lining and excavation of the adjacent cut.

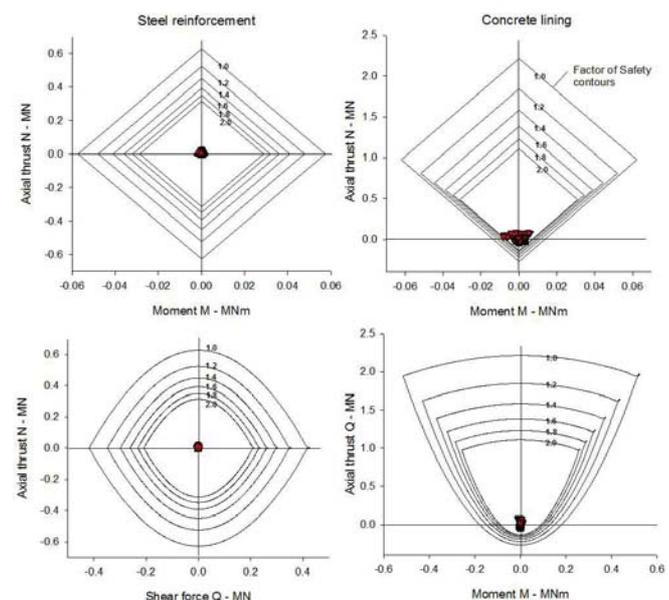
Figure 23. Support capacity plots for the final concrete lining.

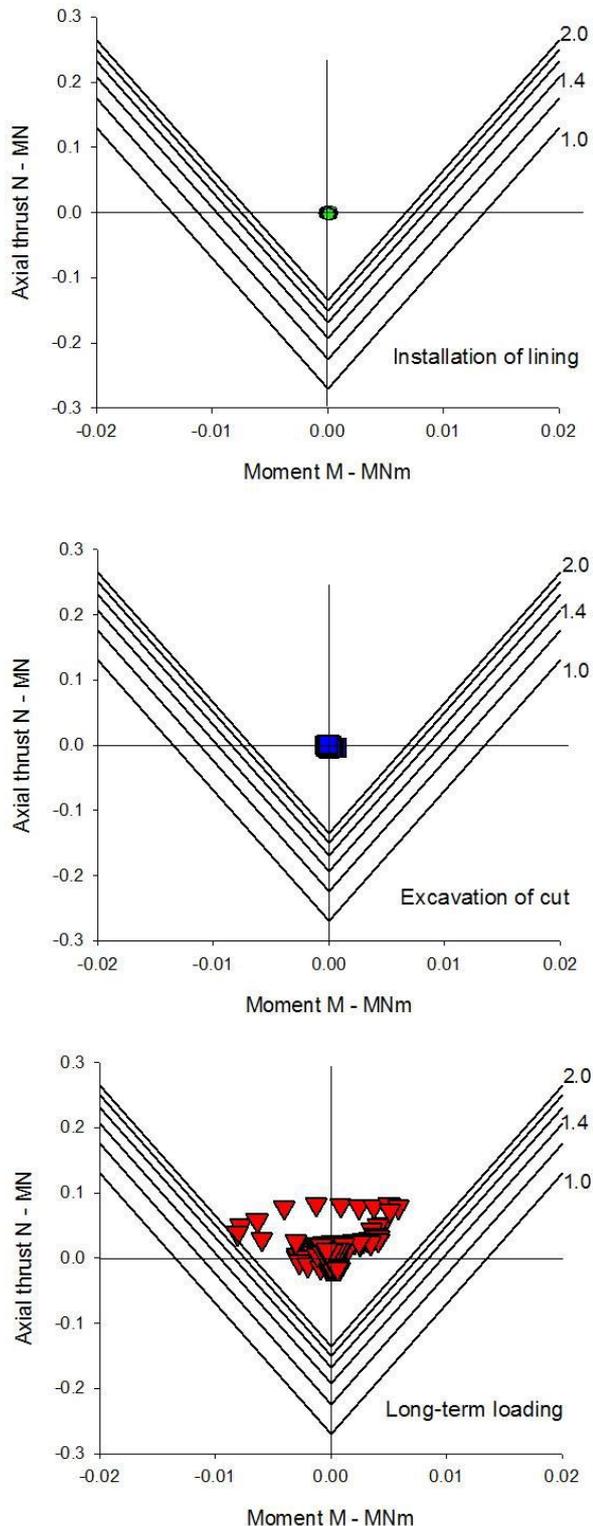
Figure 24. Detail of moment versus axial thrust development in the final concrete lining from the installation of the lining, the excavation of the open cut and long-term loading conditions.
