ΕΛΛΗΝΙΚΗ  
ΕΠΙΣΤΗΜΟΝΙΚΗ  
ΕΤΑΙΡΕΙΑ  
ΕΔΑΦΟΜΗΧΑΝΙΚΗΣ  
& ΓΕΩΤΕΧΝΙΚΗΣ  
ΜΗΧΑΝΙΚΗΣ

Αρ. 14 – ΜΑΙΟΣ 2008

Τακτική Γενική Συνέλευση της ΕΕΕΕΓΜ	1
Άρθρα	8
- C. Tsatsanifos "Contribution of geotechnical engineering in the rehabilitation of buildings and infrastructures"	8
- E. Hoek, C. Carranza-Torres, M. Diederichs and B. Corkum "Integration of geotechnical and structural design in tunnelling"	24

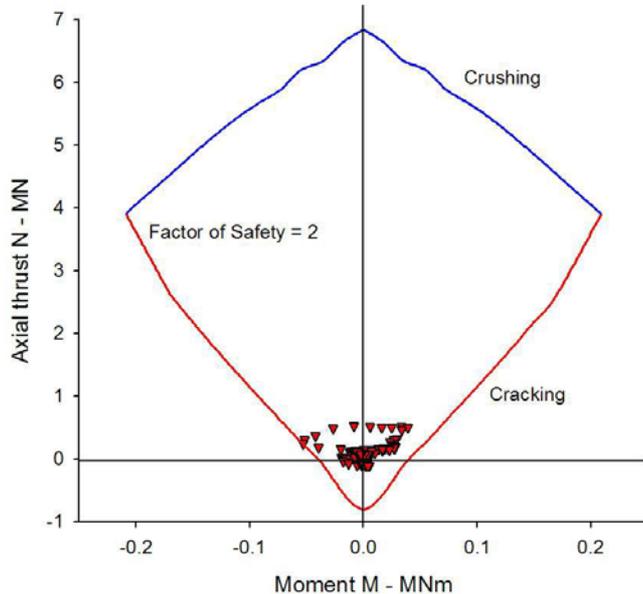
Figure 25. Minimum Moment-Thrust capacity for the reinforced concrete final lining calculated by the structural program Response 2000 (Bentz, 2000) for a factor of safety of 2.0.

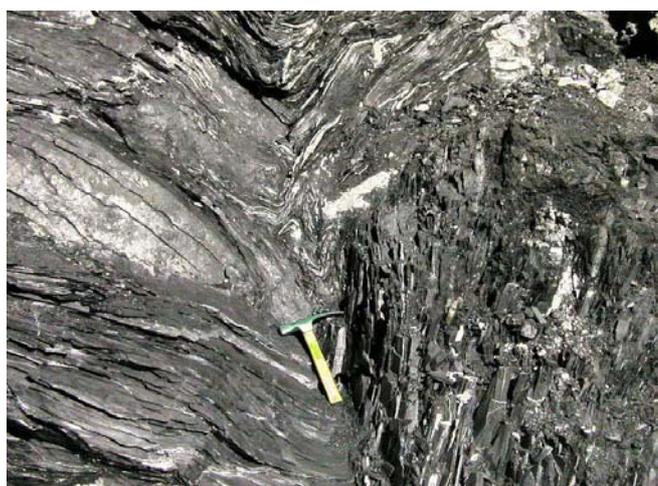
Figure 27. Graphitic phyllite in the tunnel face. Note the tight secondary folding and high variability of fabric orientation – rock hammer in center is 45cm long.

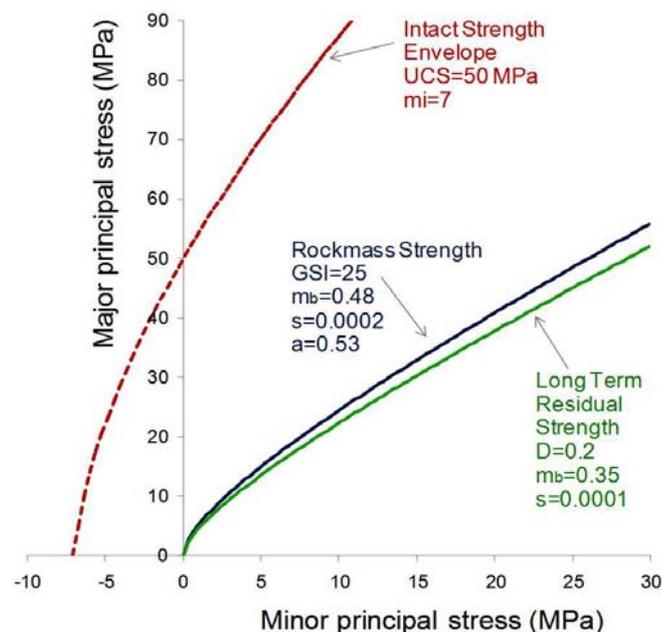
Figure 28: Rock mass strength parameters for Case 2 analysis. In situ stress = 28MPa.

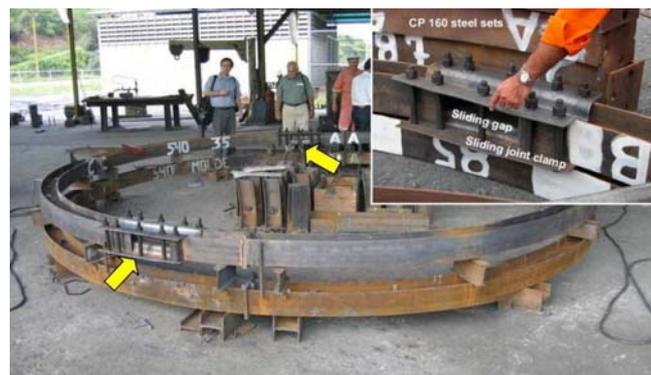
Figure 30. Circular steel arches (W6 X 20) with two sliding joints (detail in inset).

The original design called for the complete steel set to be erected near the face and a 20 cm layer of shotcrete sprayed over the sets with 1 m gaps left over the sliding joints as shown in Figure 31. The two sliding joints are installed just below the spring line for a total circumferential closure of 60 cm (2 x 30 cm). Once the gap is closed by tunnel deformation, the gap is filled with shotcrete and an additional 40 cm of shotcrete, reinforced by means of circumferential rebar, is applied to the inside of the liner. The effect of the sliding gap is illustrated by the dashed support response line in Figure 29. This simple convergence-confinement analysis does not consider moments and neglects the interaction between support layers. In

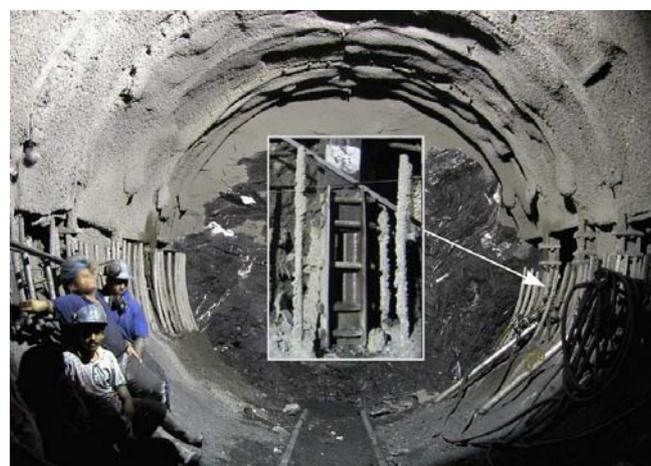
Figure 31. Initial Liner composed of circular steel arch and 20 cm of shotcrete. Inset shows detail of sliding joint with shotcrete gap. Note rebar in place to reinforce final shotcrete layer.

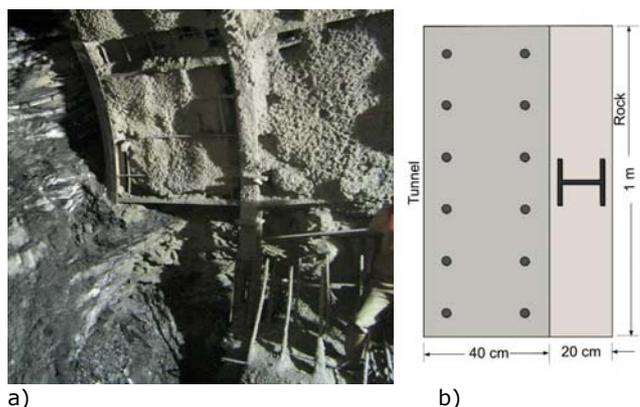
Figure 32. a) Configuration of mid-height bench (partially disintegrated in this photograph) and upper steel arch installed ahead of lower section and sliding joint. b) Final 60 cm section with outer shotcrete and steel set composite section and inner reinforced shotcrete section. The tunnel is to the left and rock mass is to the right of the section.

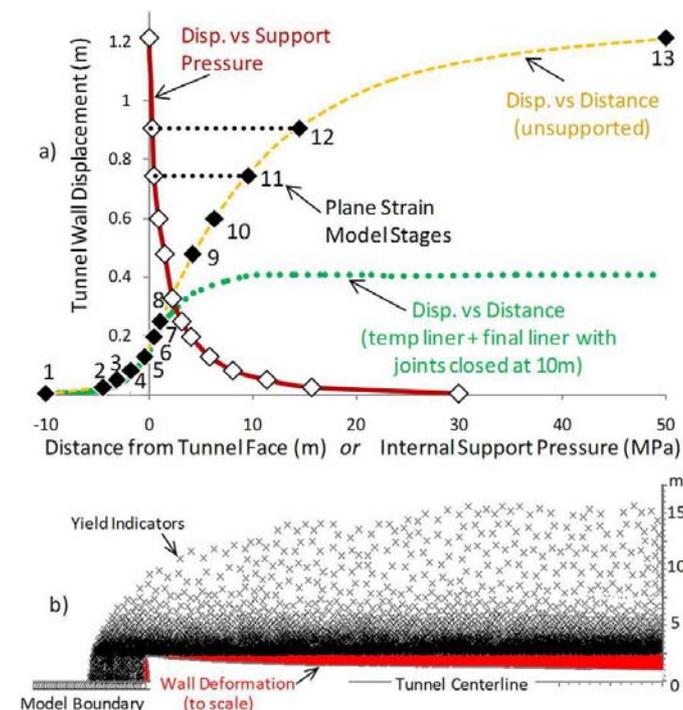
Figure 33 a) Ground reaction curve "Disp. vs Support Pressure" and corresponding longitudinal displacement profile "Disp vs Distance (unsupported)" for a axisymmetric model. Normalized plastic radius = 6.5. Longitudinal displacement profile function fitted based on Appendix 1. Point symbols and number ID's represent corresponding stages in plane strain model (related symbols are linked between two curves as shown for stage 11 and 12 by dotted lines). Sup-

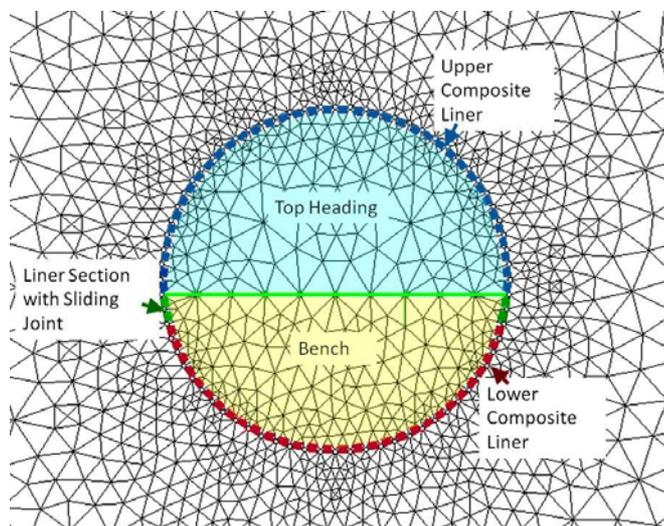
Figure 34. Finite element mesh, geometry of excavation stages and liner segments for 2D plane strain analysis of sequenced excavation and support.

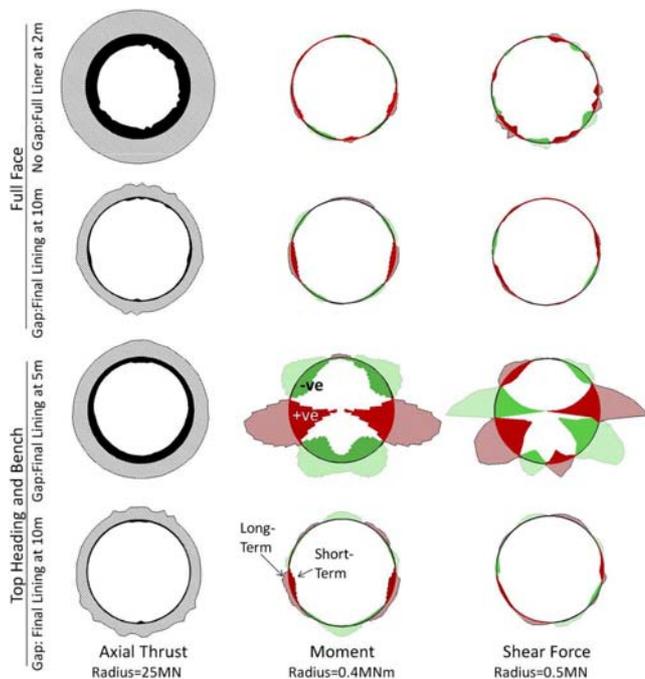
Figure 35. Relative magnitudes and distribution of total axial load, moment and shear load in the final 40 cm thick reinforced layer. Values plotted inside tunnel as solid represent short term loading conditions. Hatched values outside of tunnel represent long term conditions. Red shading indicates positive values for moment and shear, Green shading indicates negative values. This inner final liner layer is modeled elastically. This plot does not include residual loadings in the plastic outer lining layer (steel sets embedded in 20 cm shotcrete).

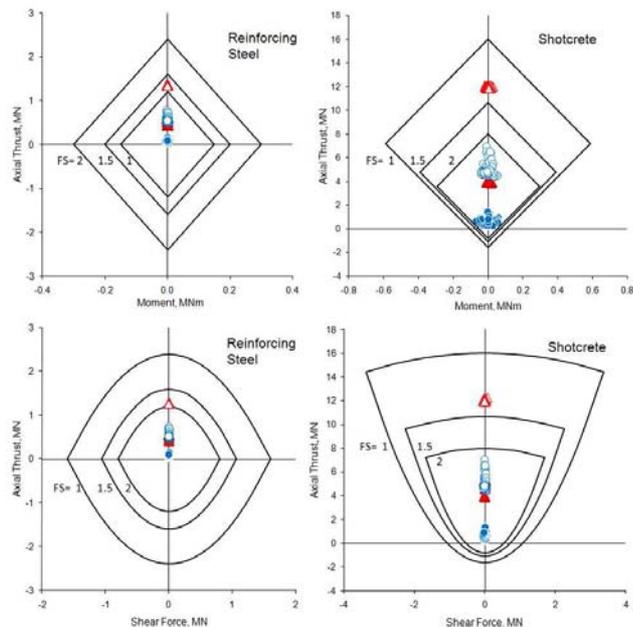
Figure 36. Partitioned liner loads compared to component capacity envelopes for full face tunnel option. Circles represent a full 60 cm lining, as per Figure 32b, installed in one step 2 m from the face. Triangles represent the option involving W 6x 20 sets installed at the face with a sliding gap in combination with 20 cm of shotcrete, followed at 10 m distance by a filled gap and 40 cm of reinforce shotcrete. These plots are for the inner 40 cm of reinforced shotcrete only. Filled symbols represent short term loading while open symbols are for long term loading.

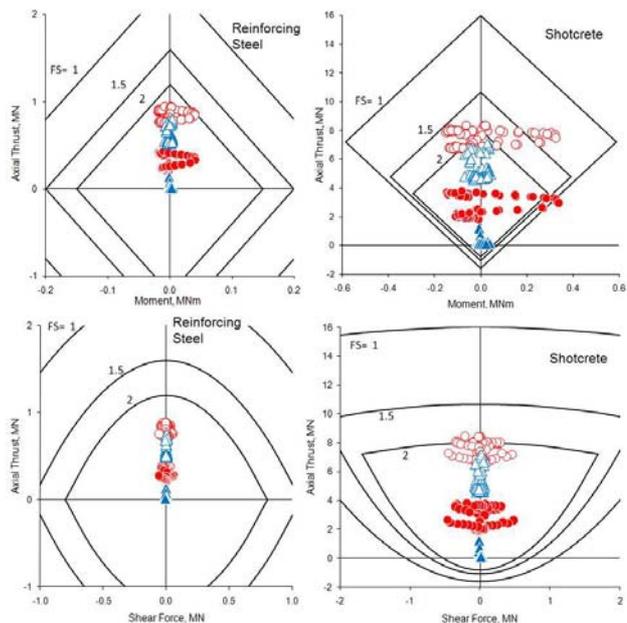
Figure 37. Partitioned liner loads compared to component capacity envelopes for top heading and bench options. In these analyses, the sliding joint (gap) closes automatically under load between 5 and 10 m. Circles represent completion of the final lining at 5 m from the face (before gap closure). Triangles represent the completion of the final lining at 10 m from the face (after gap closure). These plots are for the inner 40 cm of reinforced shotcrete only. Filled symbols represent short term loading while open symbols represent long term loading.

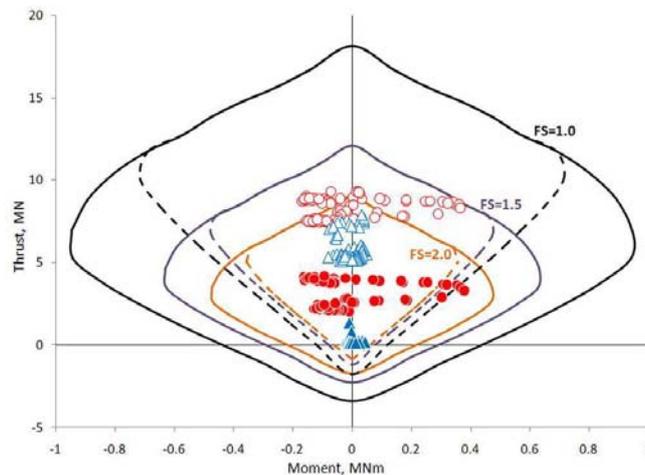
Figure 38. Total (non-partitioned) thrusts and moments from modeled inner liner of 40 cm reinforced shotcrete. Dashed envelopes represent limits for initial cracking of shotcrete. Solid envelopes represent capacity limits accounting for the development of additional moment capacity in the cracked liner as well as accounting for the tensile strength of the reinforcement (Vecchio and Collins, 1986). Triangles represent installation of the final lining at 10 m; circles represent completion at 5 m. Filled symbols indicate short term loading; open symbols indicate long term loading. Sliding joint closes automatically between 5 and 10 m from the face.

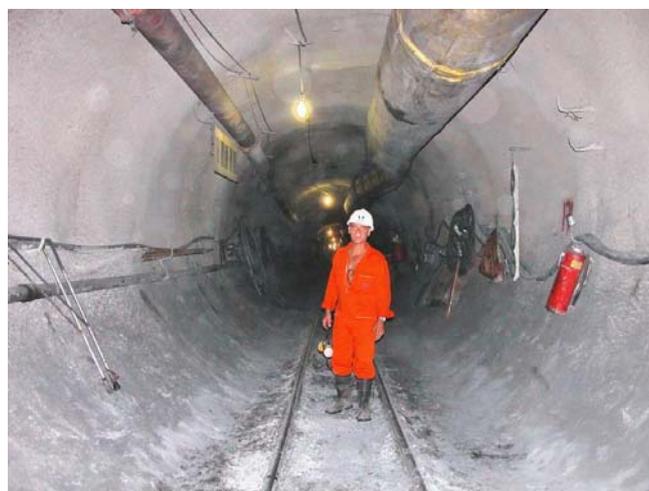
Figure 39. Completed section of tunnel with a 60 cm thick reinforced shotcrete lining, placed in two layers as described above.

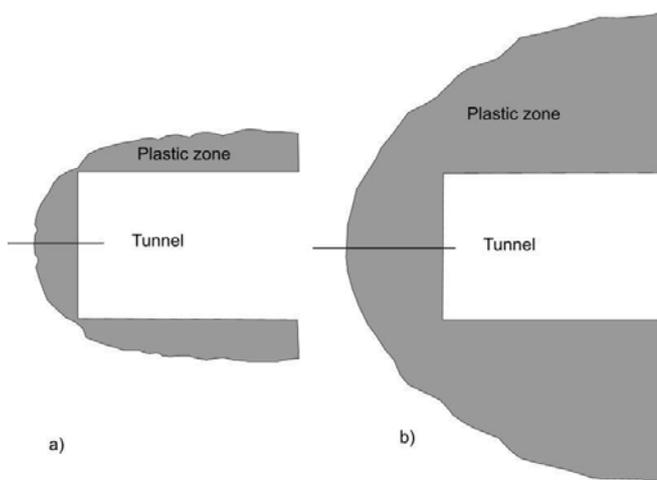
Figure A1.2: a) Plastic yield zone developing as tunnel advances to the left. Maximum plastic zone radius is less than twice the tunnel radius and the wall yield zone does not interact with the face yield zone (Panet's 1995 longitudinal displacement profile is valid); b) wall yield zone more than double the tunnel radius and interacts with face yield zone (Panet's longitudinal displacement profile is not valid).

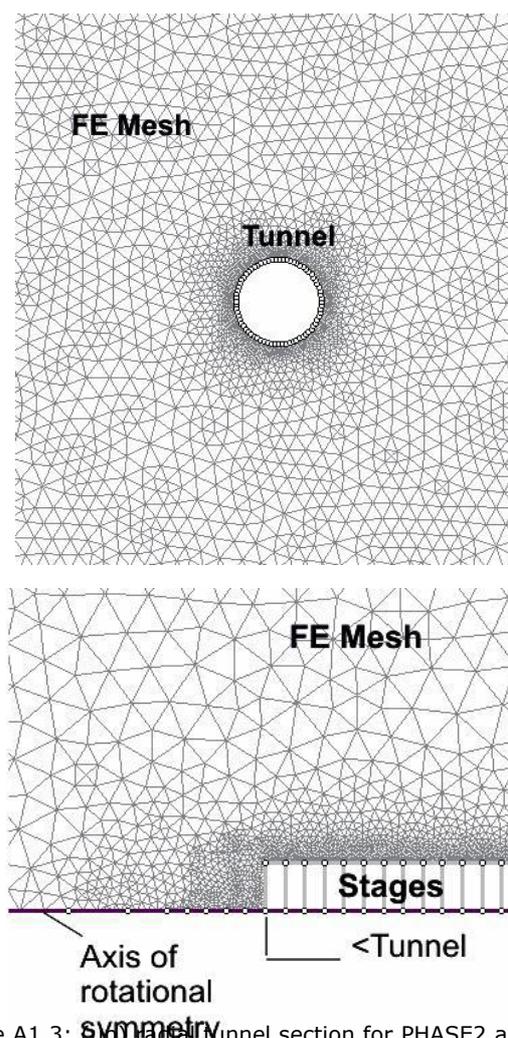
Figure A1.3: (top) radial tunnel section for PHASE2 analysis; (down) axisymmetric model with 1 m excavation stages (tunnel advances to the left).

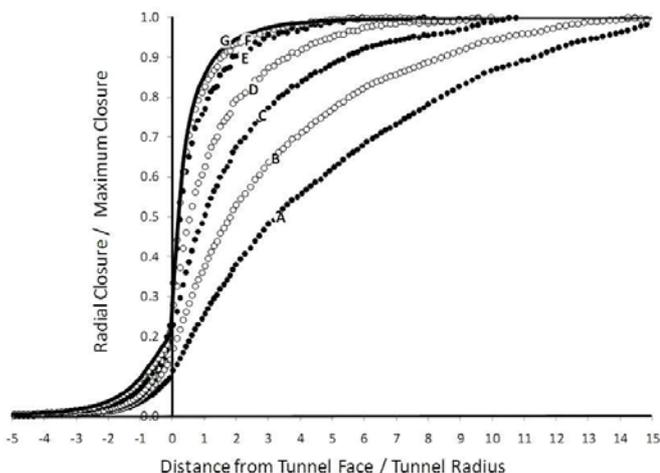
Figure A1.4: Modeled longitudinal displacement profile results for axisymmetric models: (top) constant  $P_0$  model results; (bottom) constant  $V_{crm}$  model. Labeled results (A-G) correspond to models in Table A1.3.

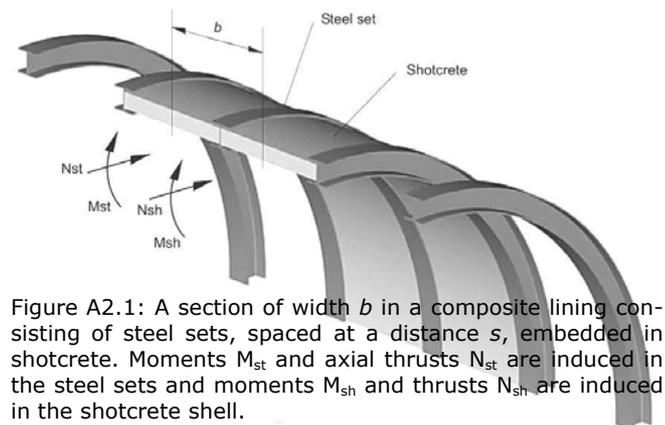
Figure A2.1: A section of width  $b$  in a composite lining consisting of steel sets, spaced at a distance  $s$ , embedded in shotcrete. Moments  $M_{st}$  and axial thrusts  $N_{st}$  are induced in the steel sets and moments  $M_{sh}$  and thrusts  $N_{sh}$  are induced in the shotcrete shell.

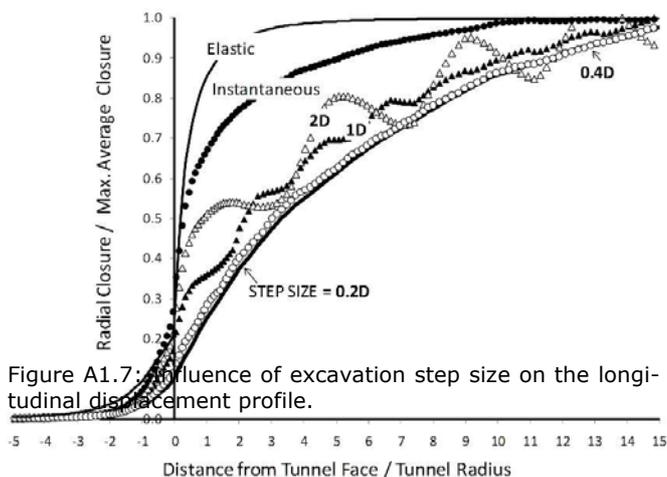
Figure A1.7: Influence of excavation step size on the longitudinal displacement profile.

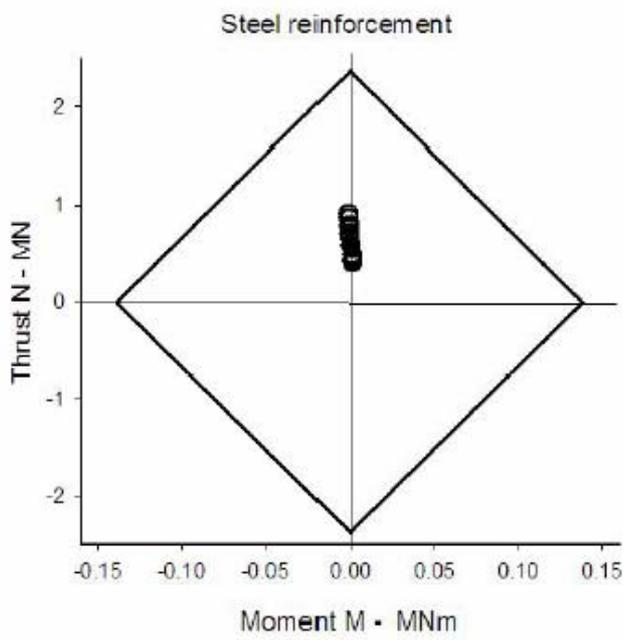
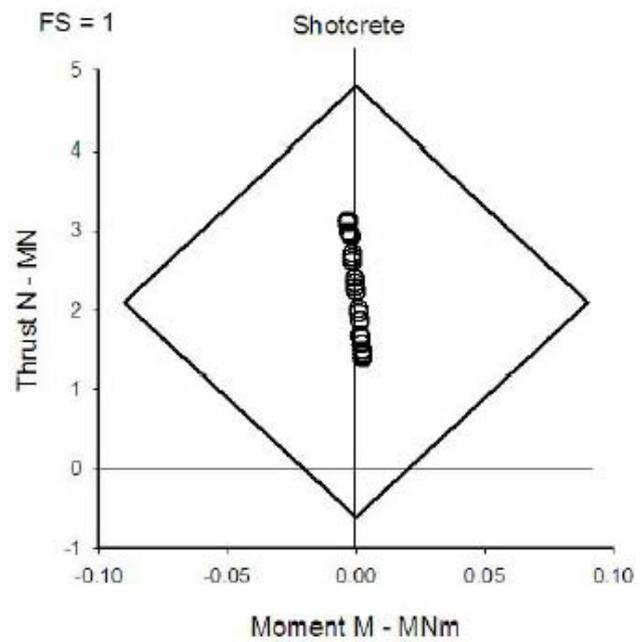
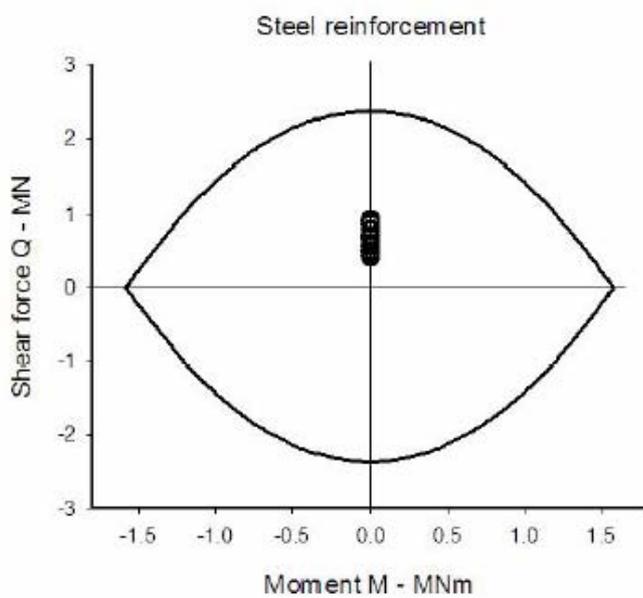
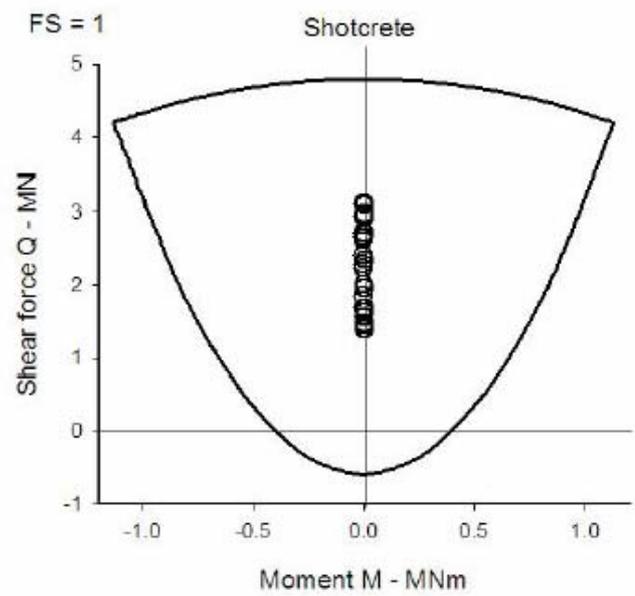
Figure A2.2. Support capacity diagrams and induced lining forces for the example described above.
