Canterbury earthquake  
(magnitude 7.1),  
Darfield-Christchurch  
Sept 4, 2010

A photographic account from a visit on  
Sept 8, 2010

By: P. Marinos, R. Rodogianni, G. Tsiambaos, N.  
Sabatakakis & B. Christaras

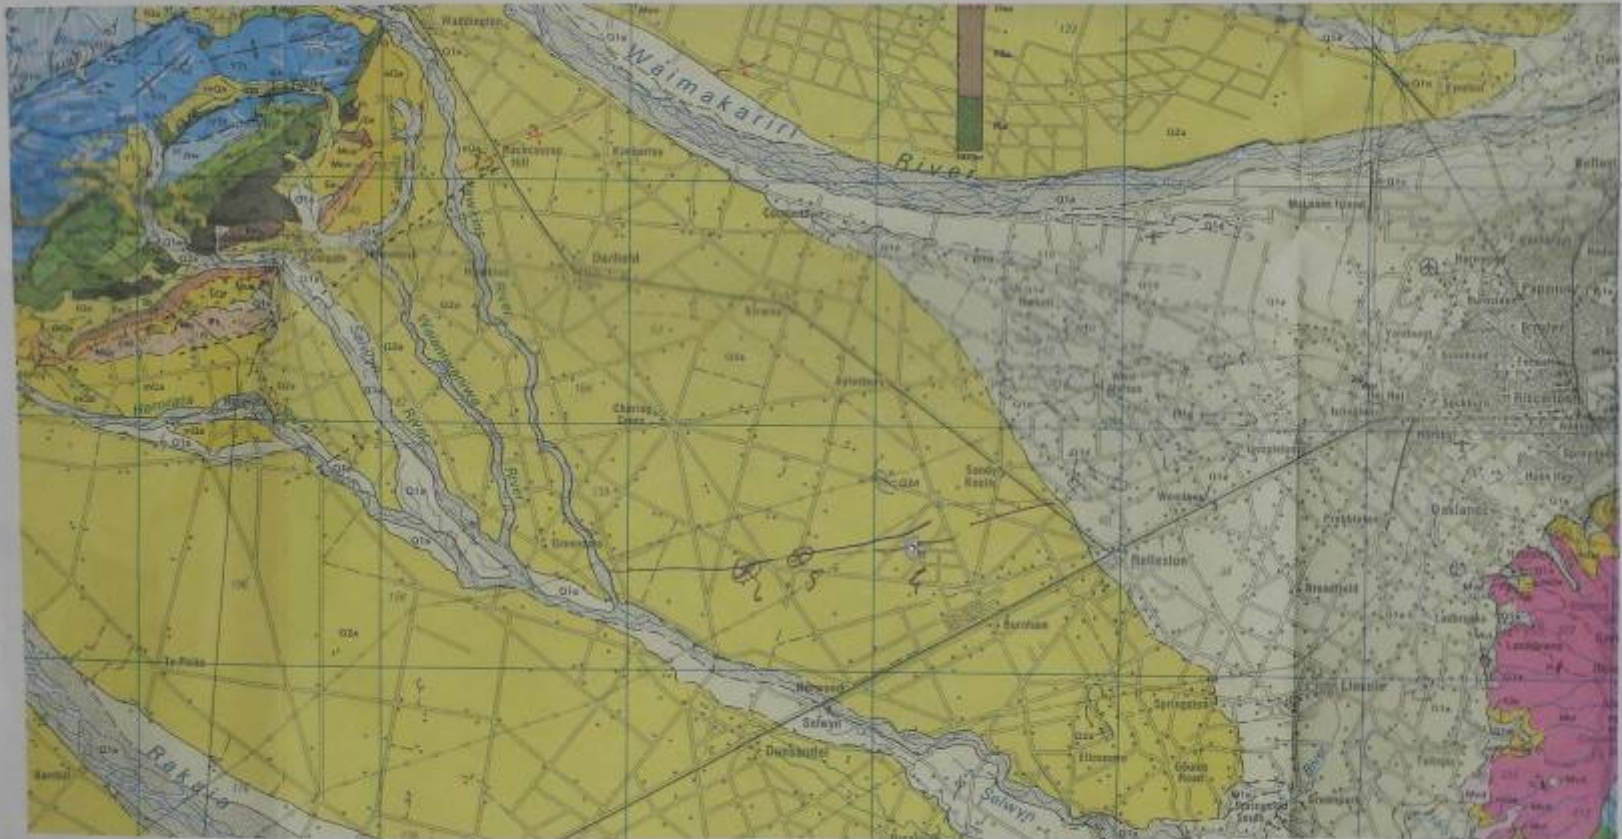
# The fault

Strike slip right lateral about 3 m horizontal offset. En  
echelon. Observed length 13km

Vertical displacement of about few 10s of cm,

Small inverse component.

Width of zone of deformations 10-30m

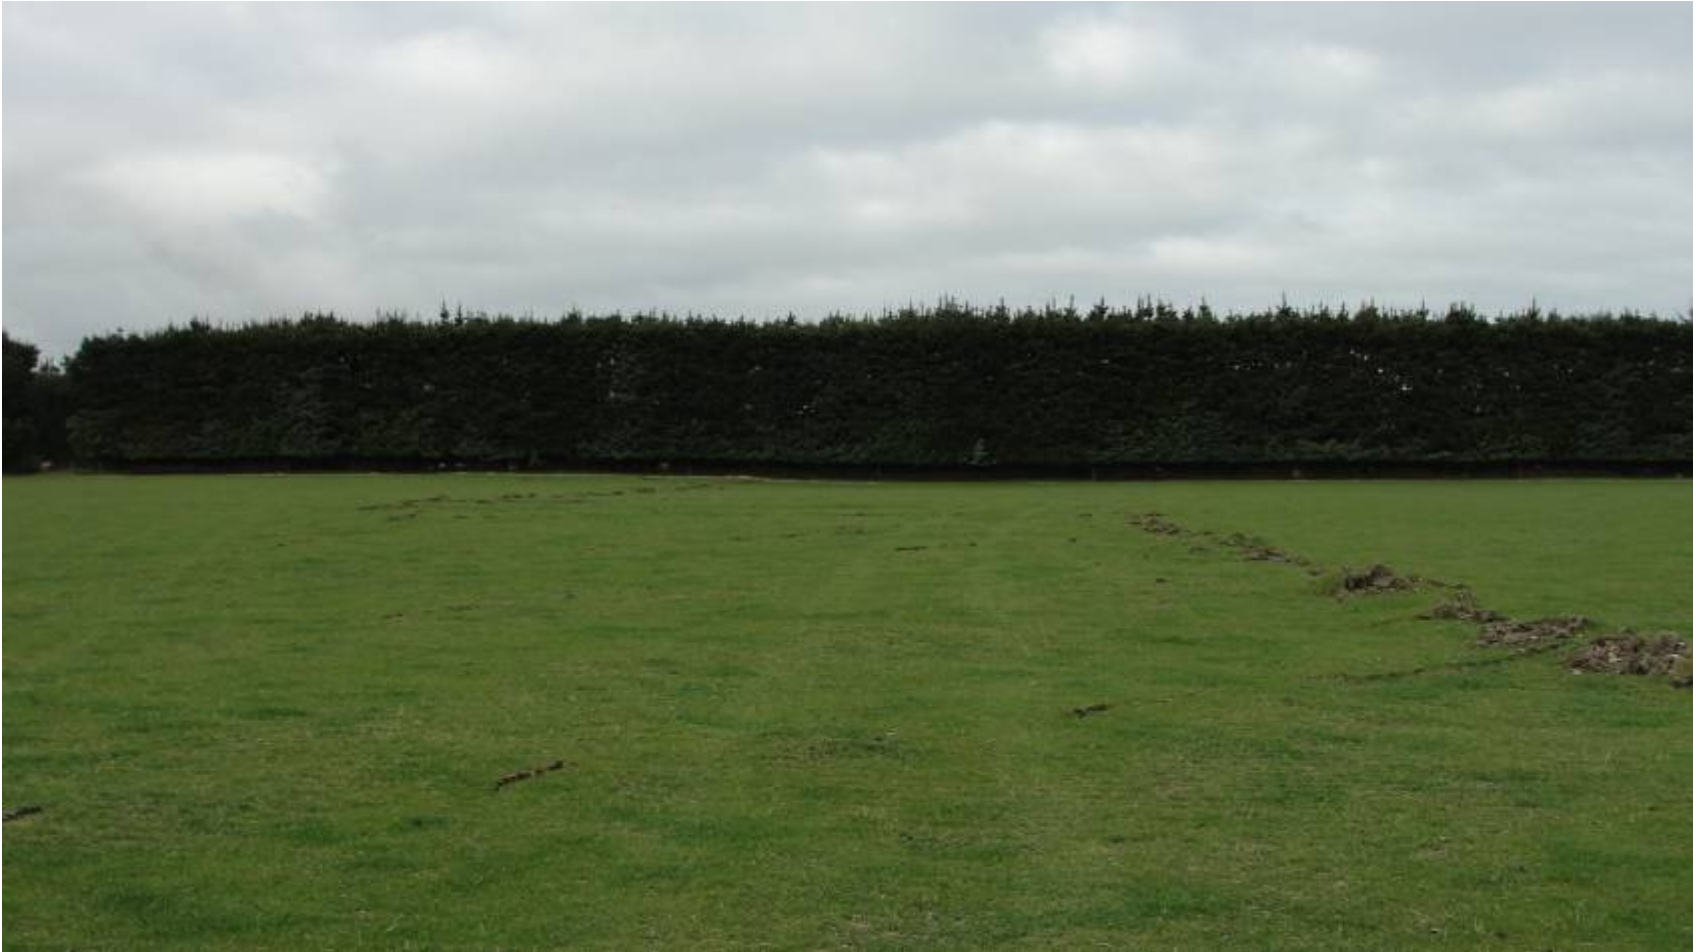
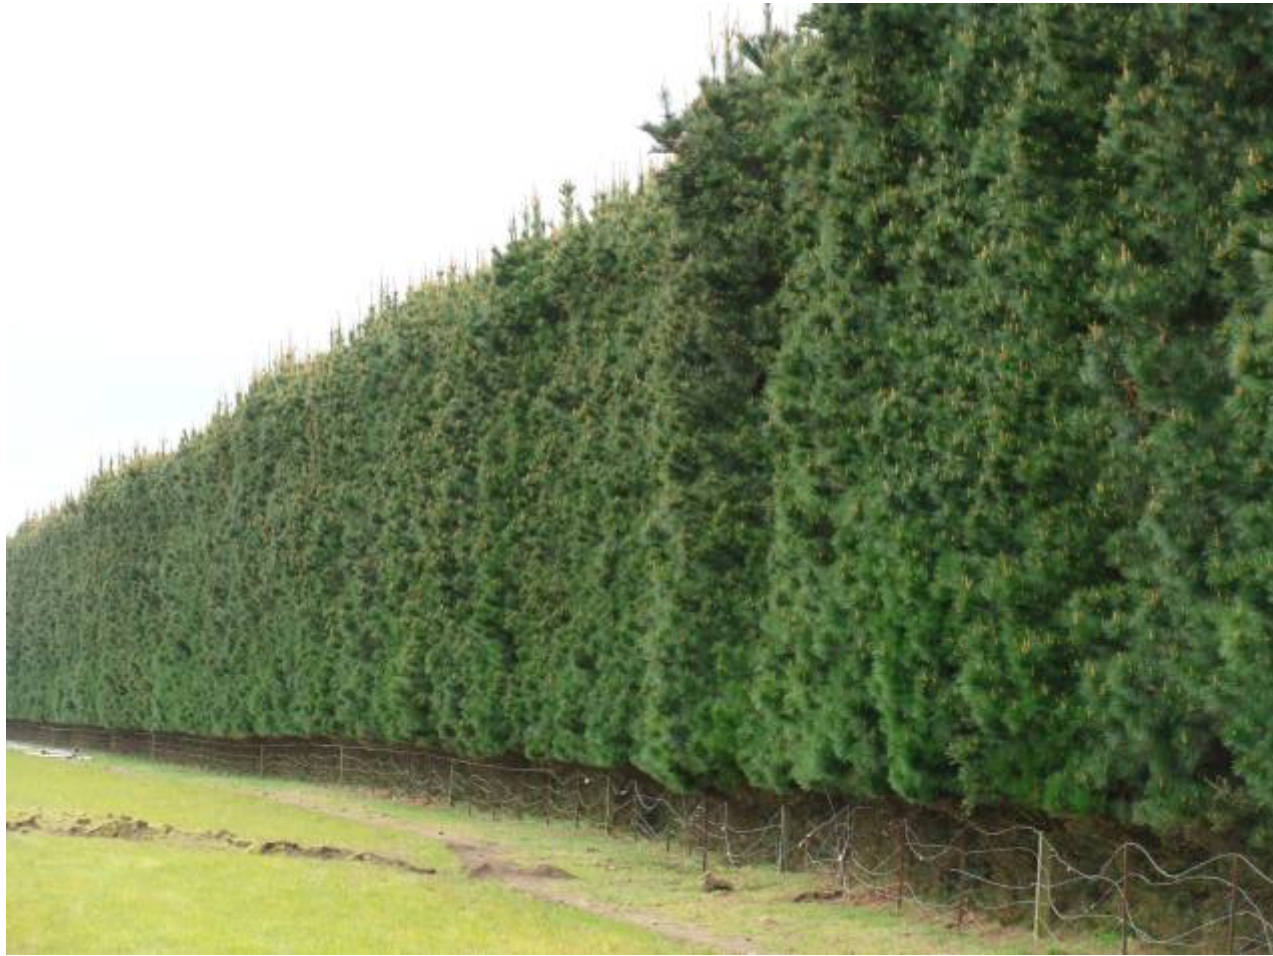
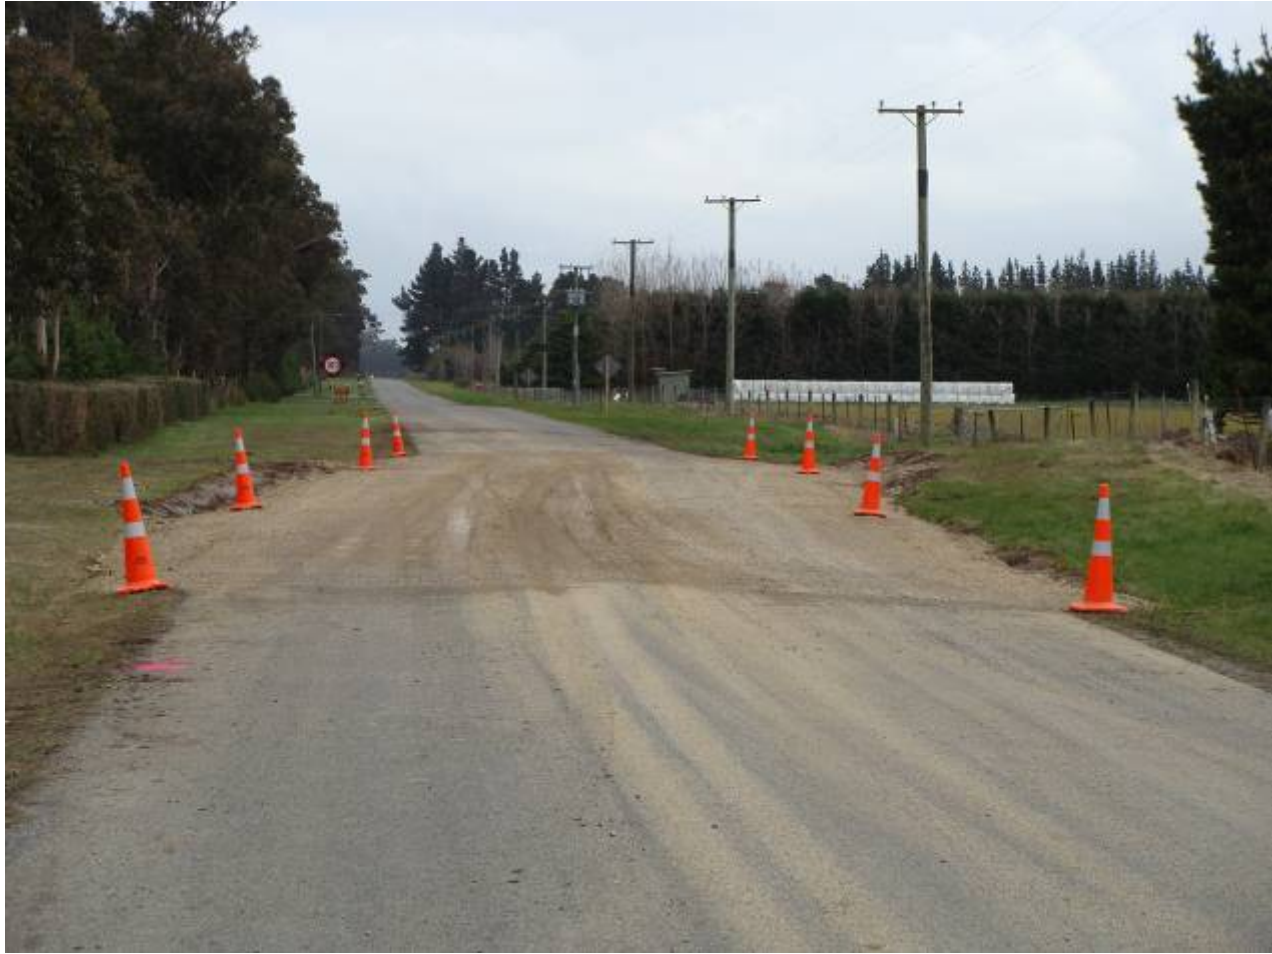
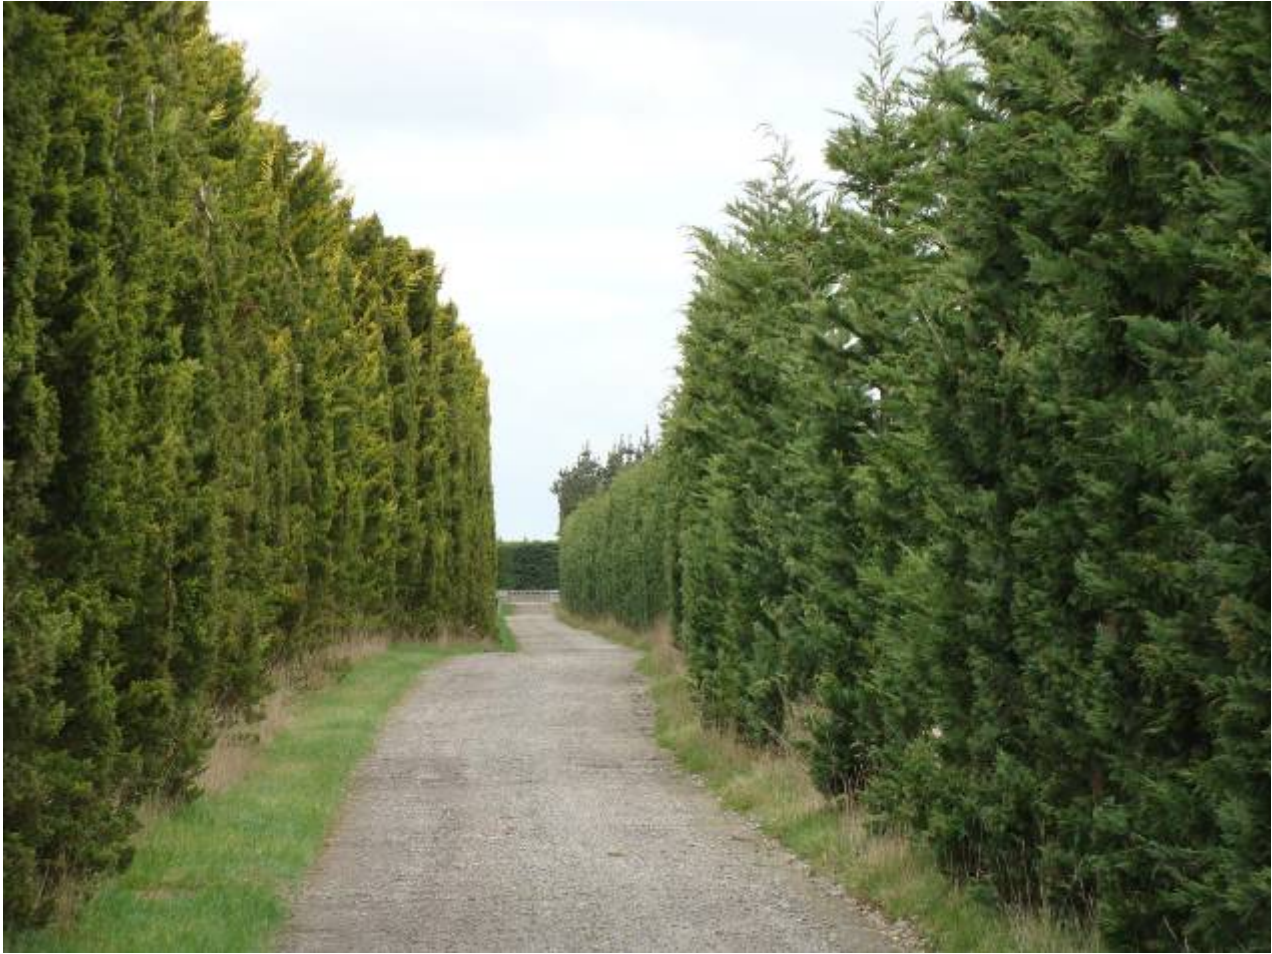
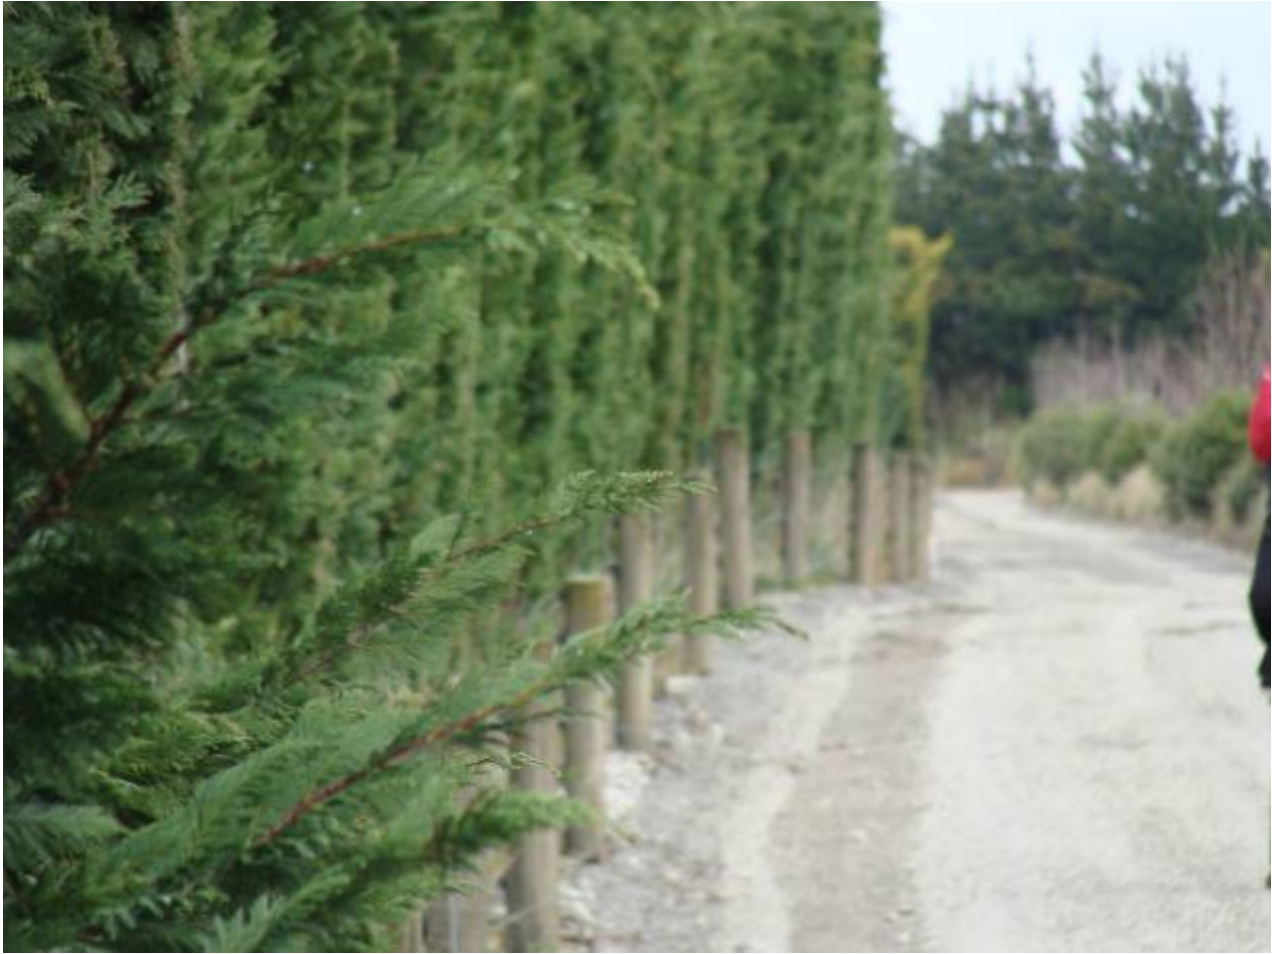
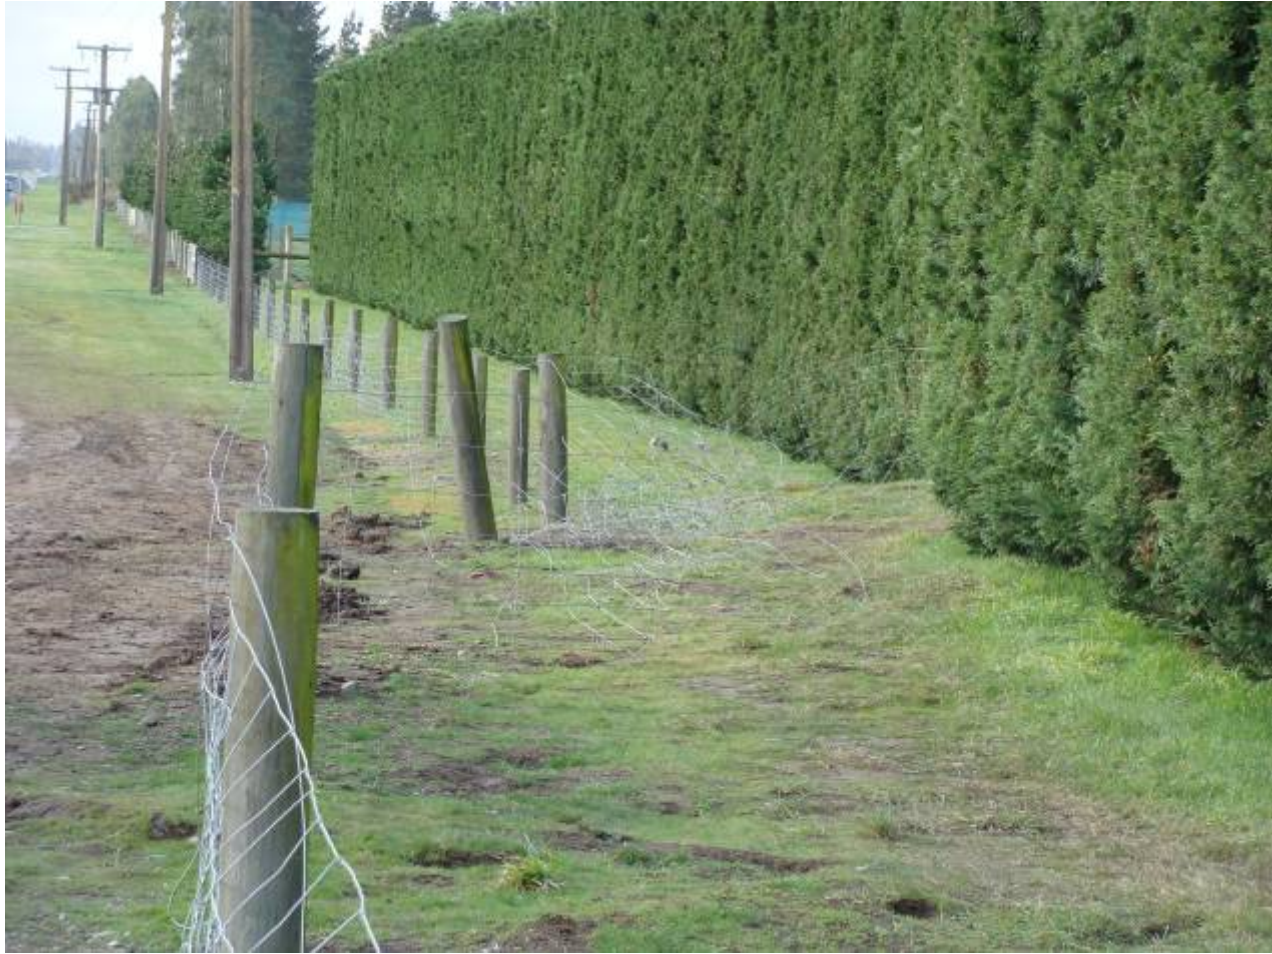
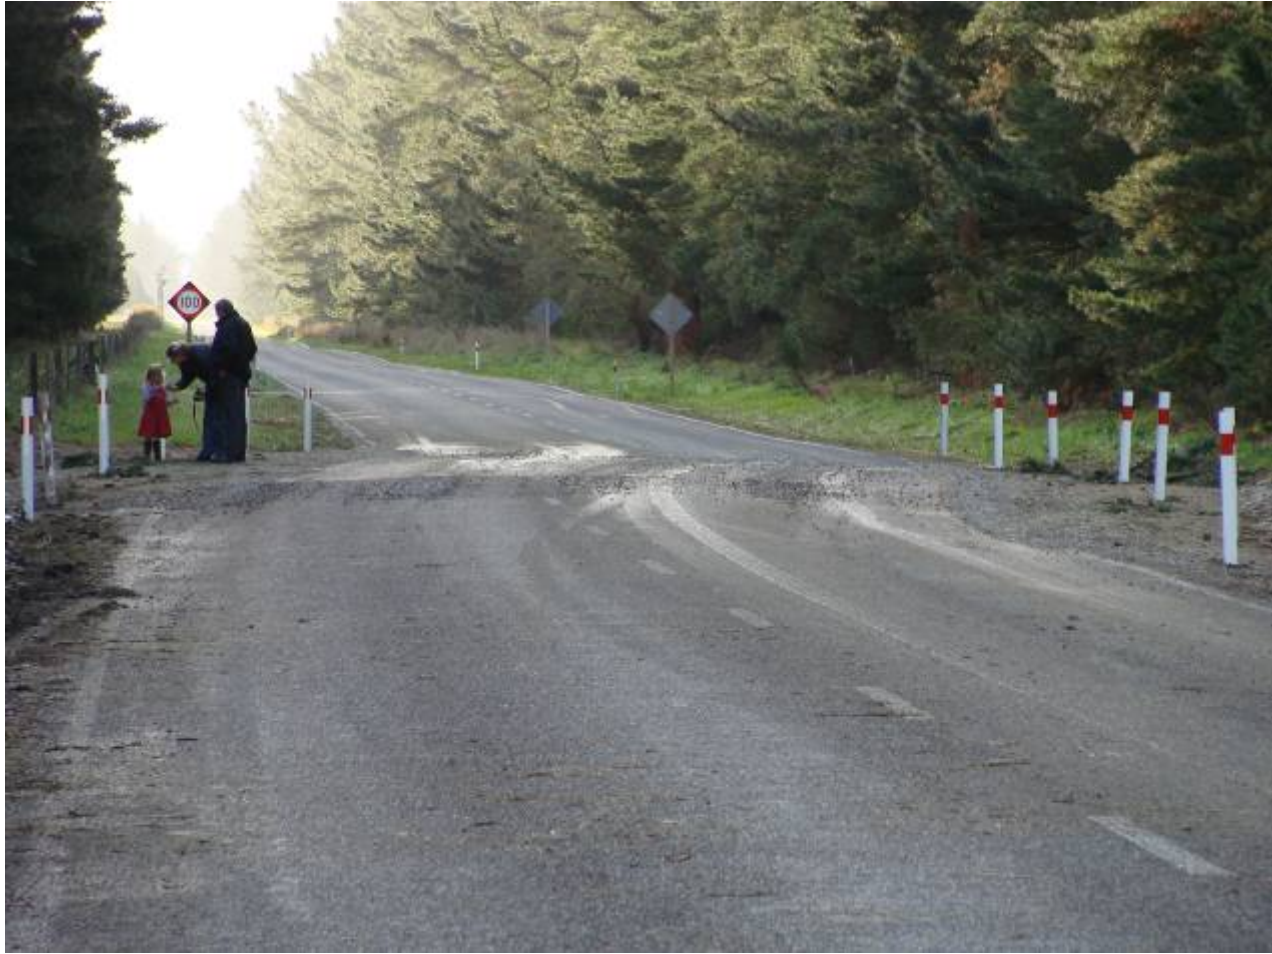
# En echelon features of the fault

The width of deformations associated with the en echelon development of the fault rupture

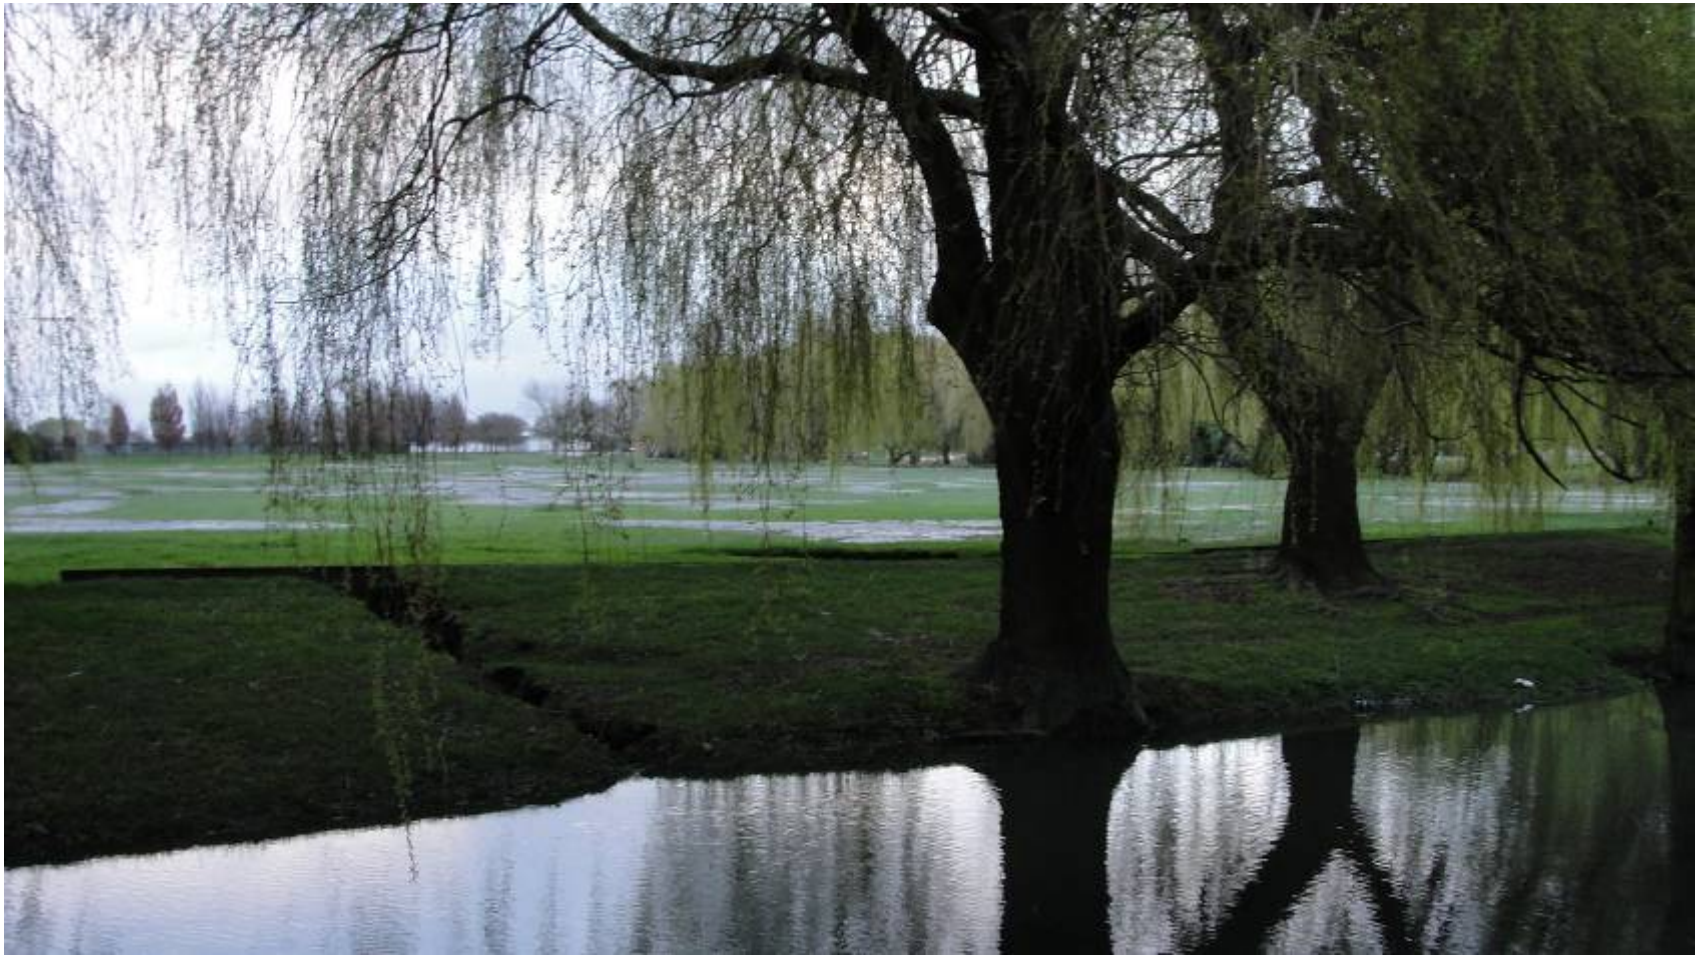
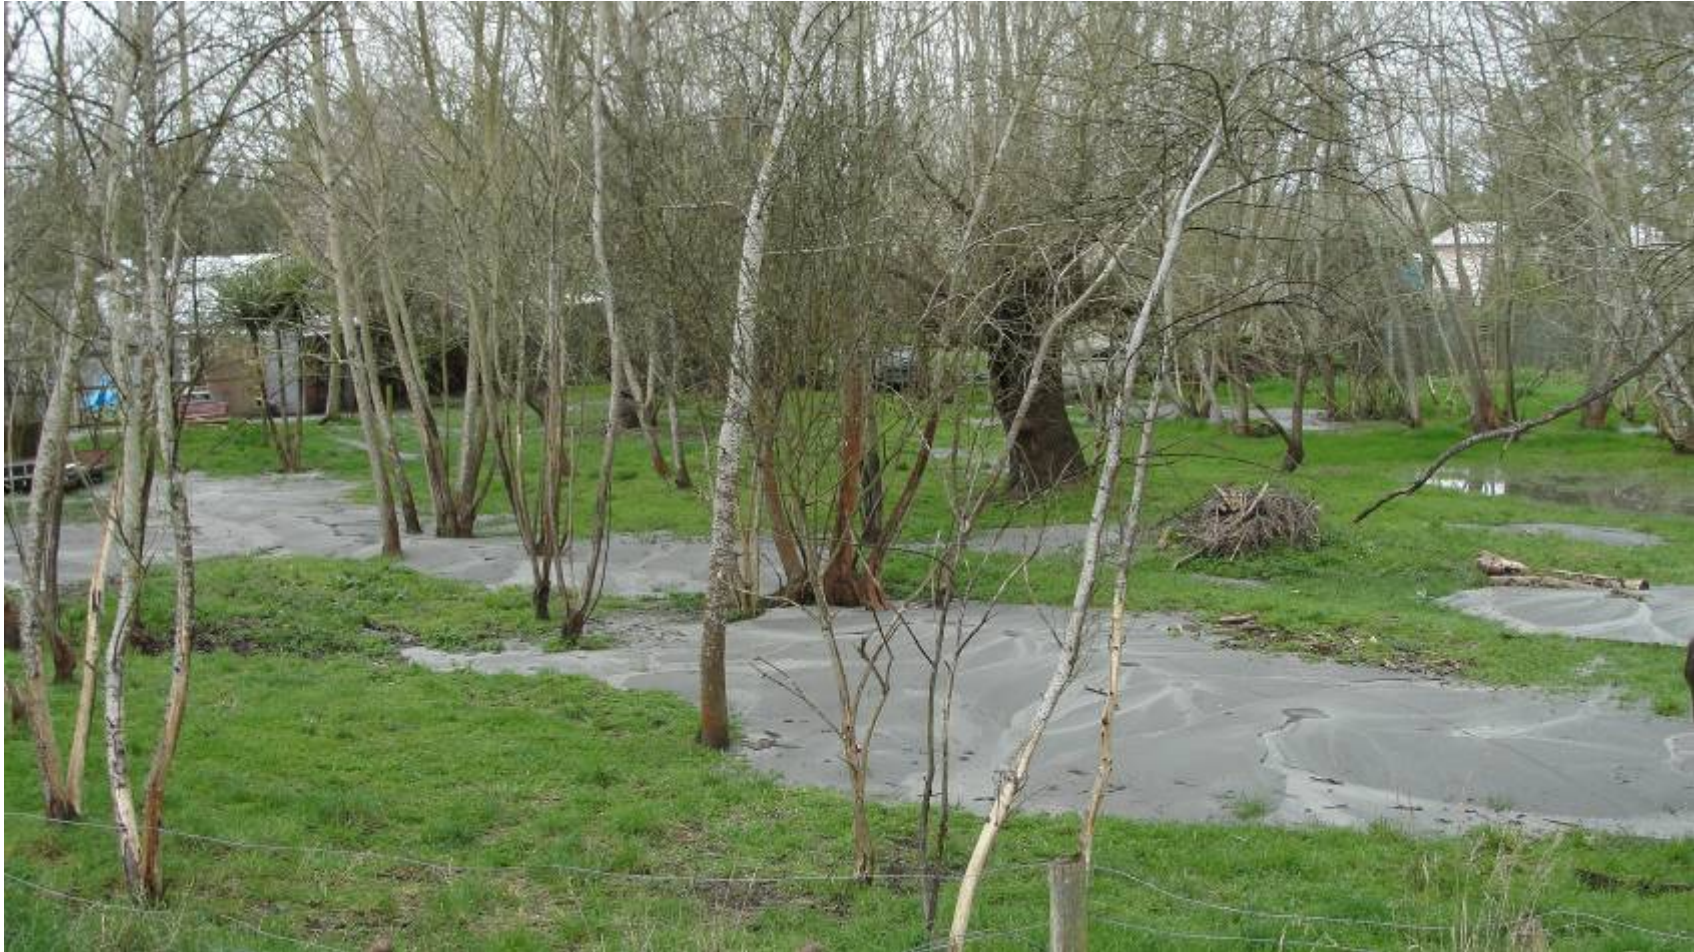
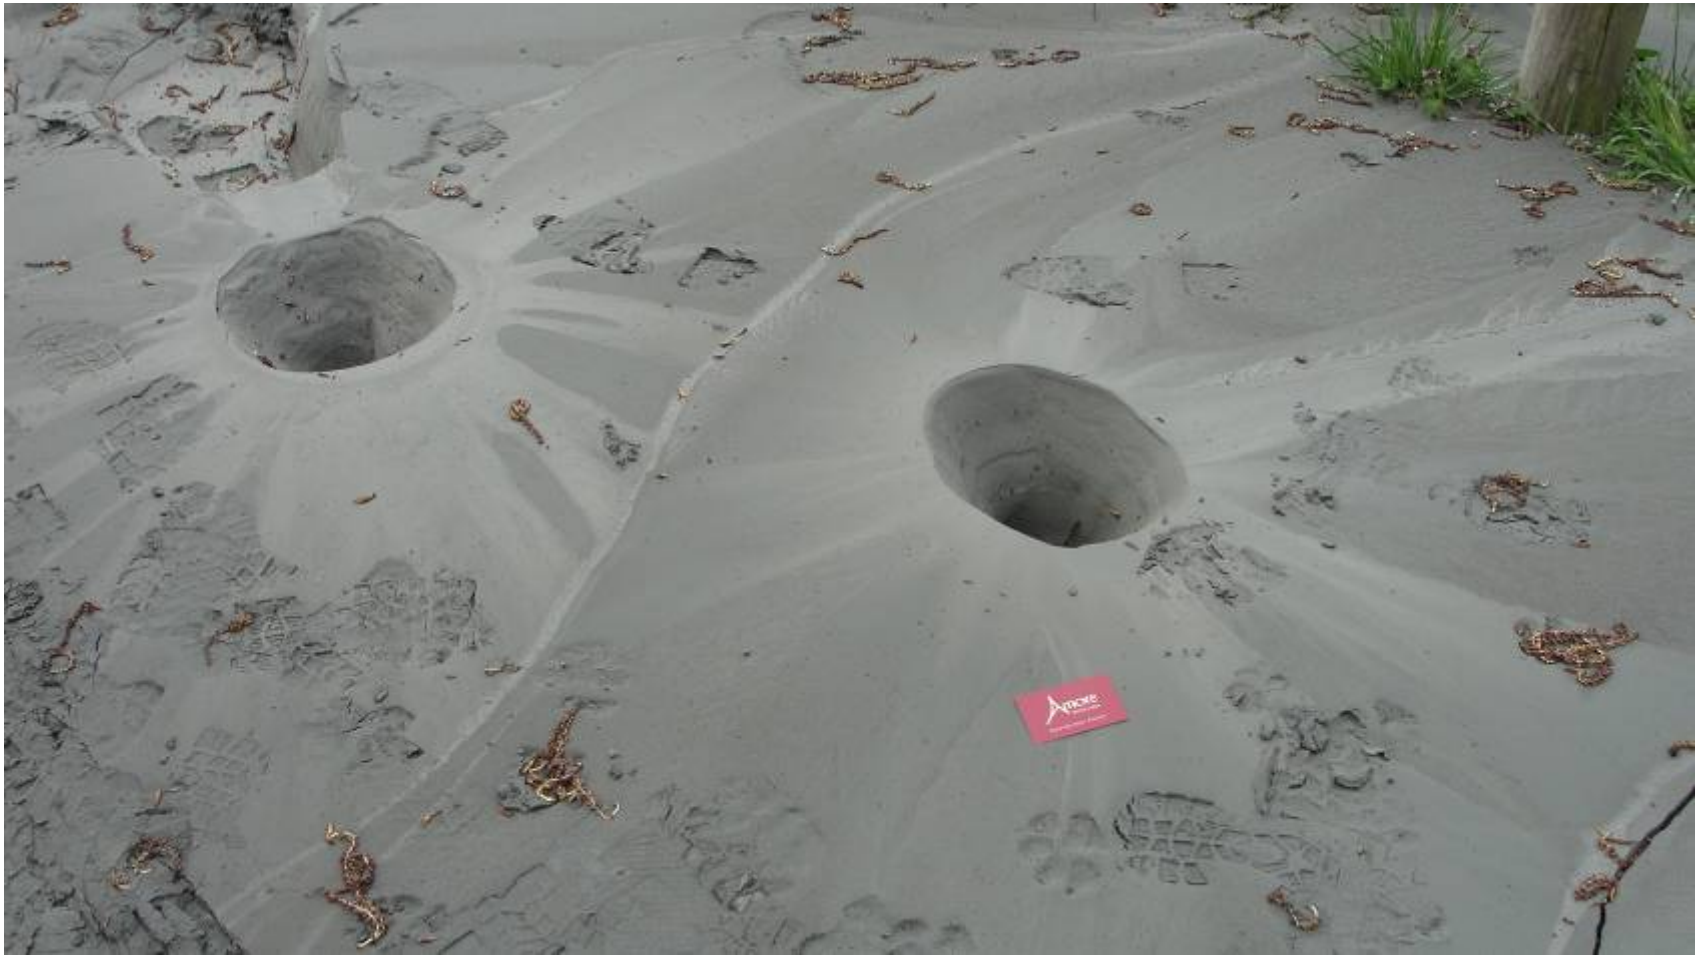
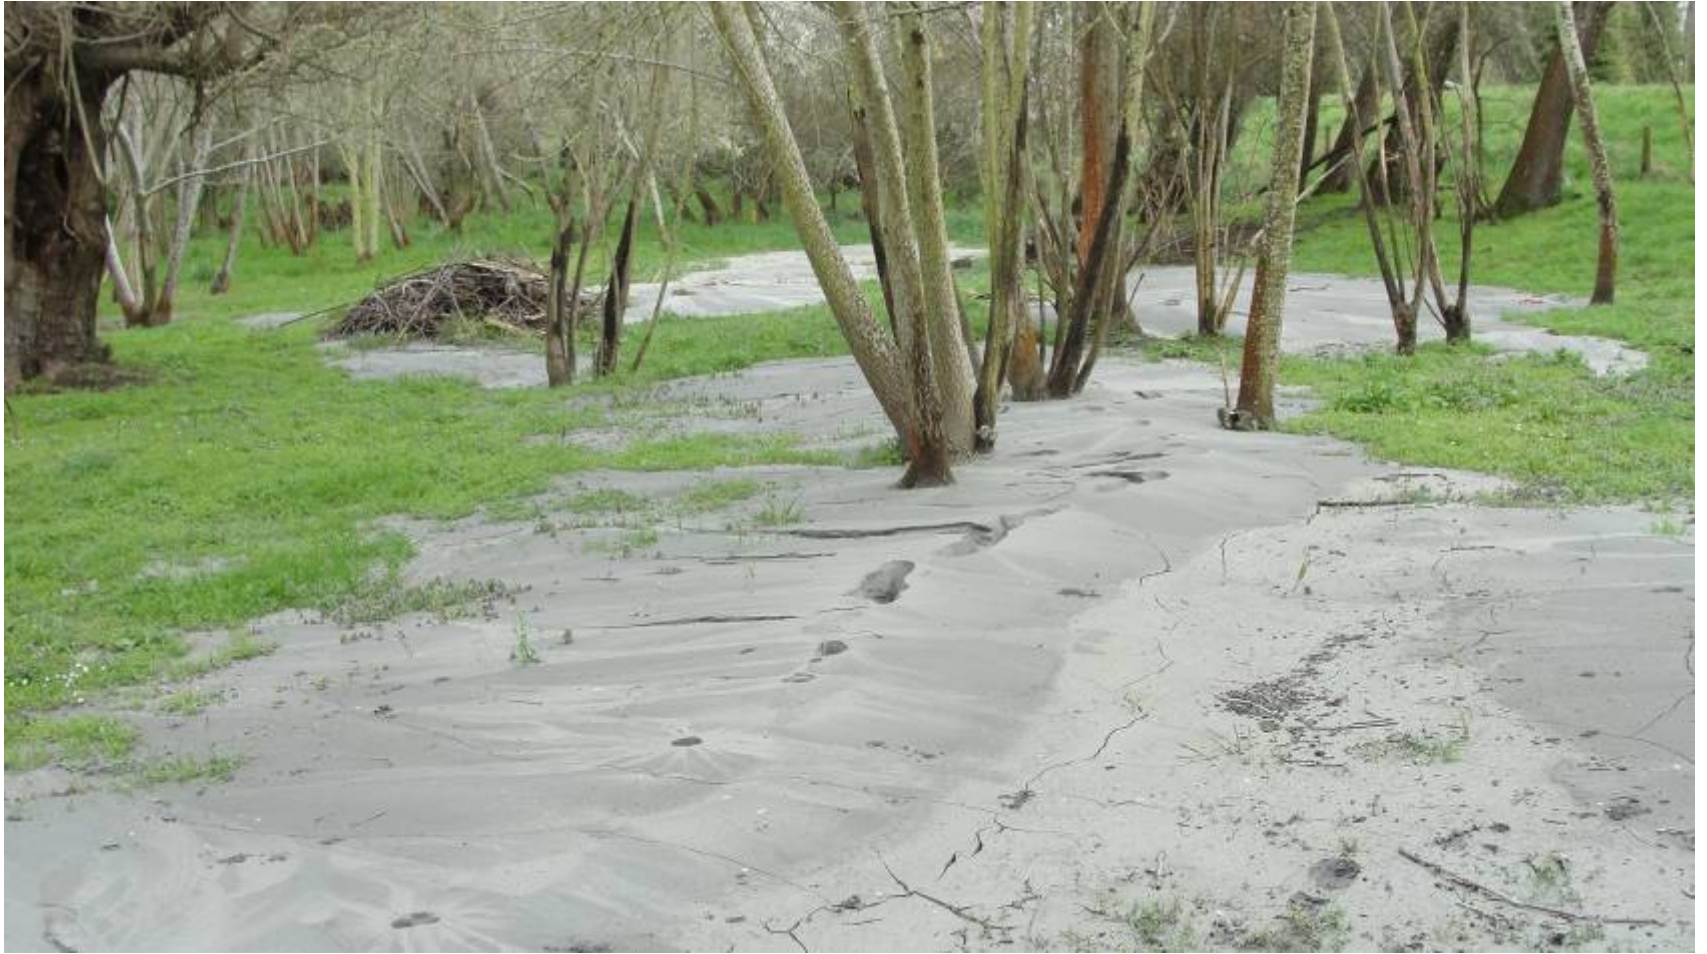
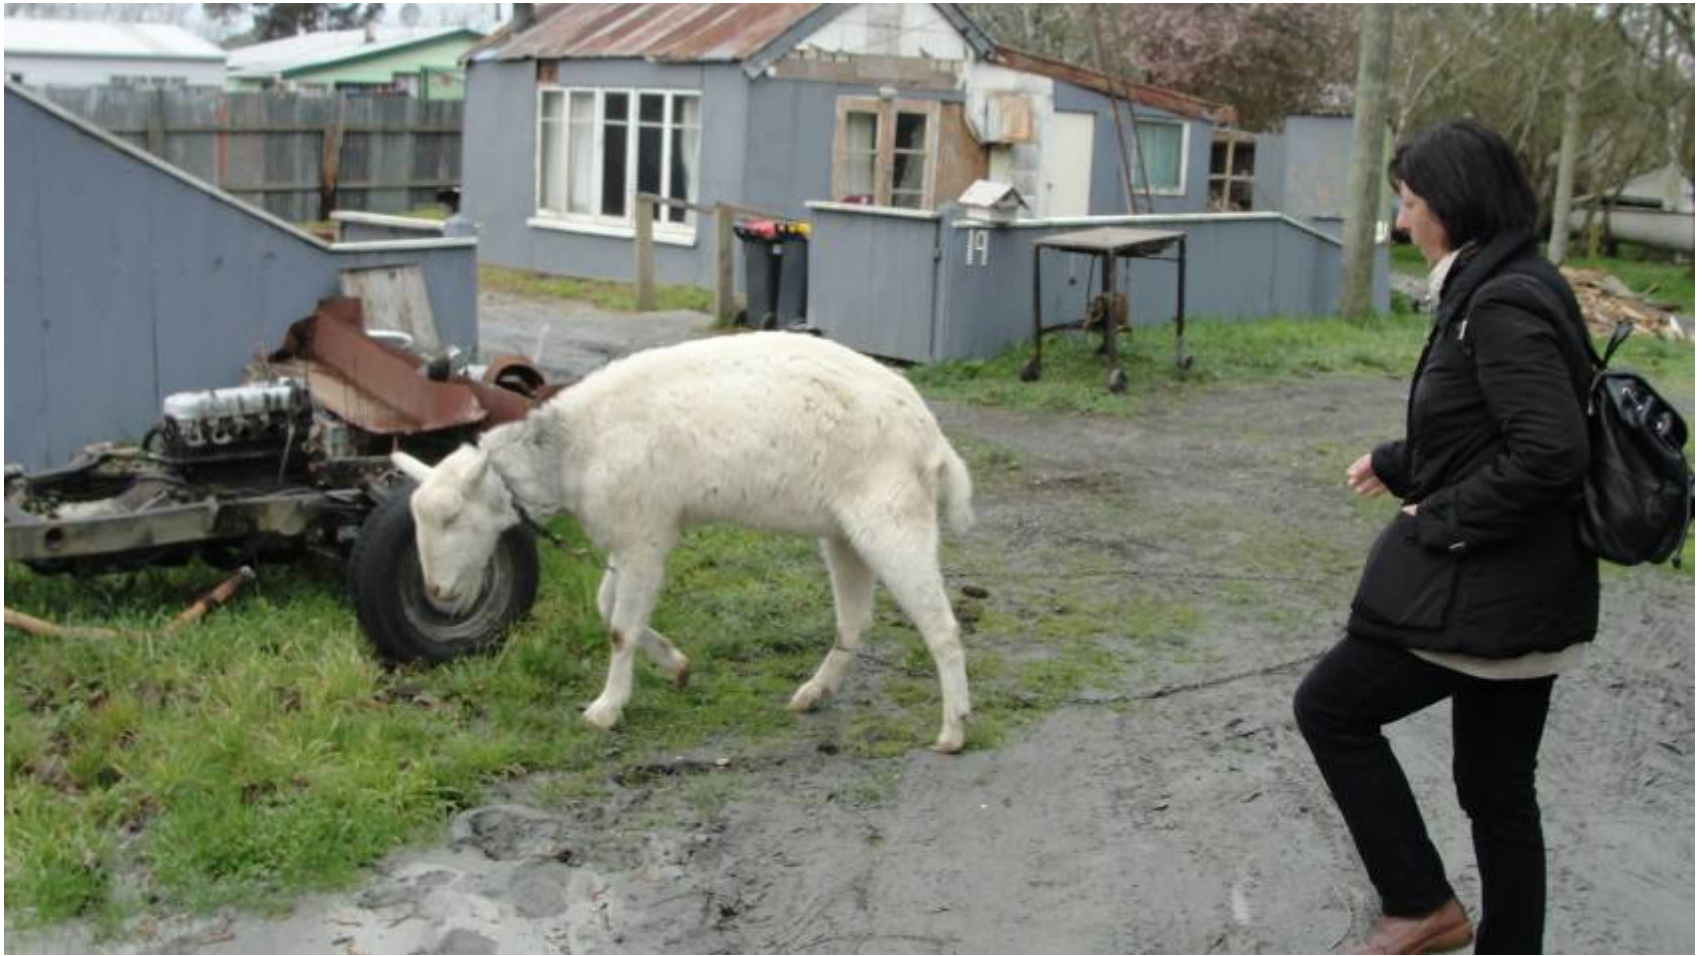
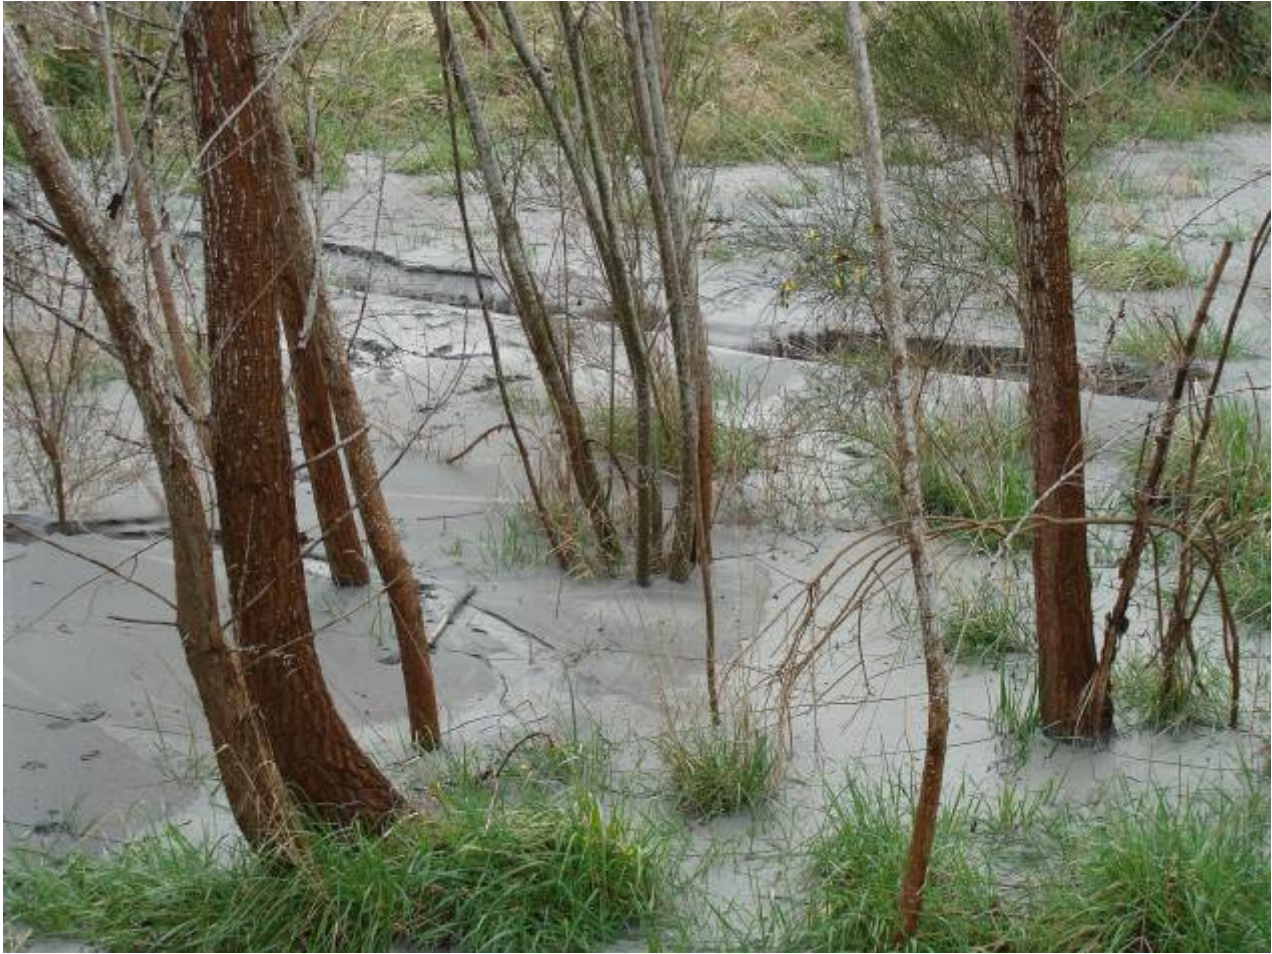
# The liquefaction

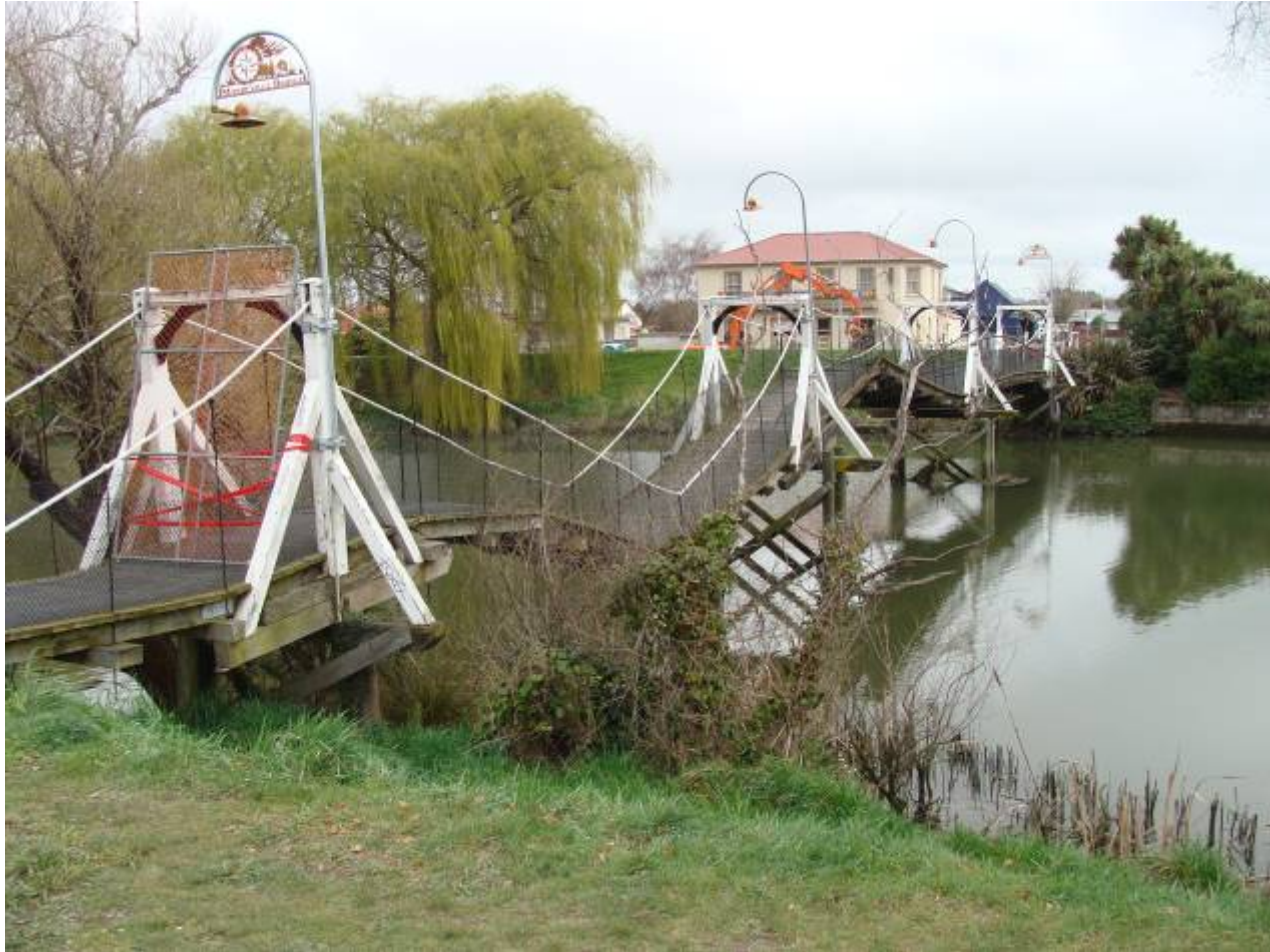
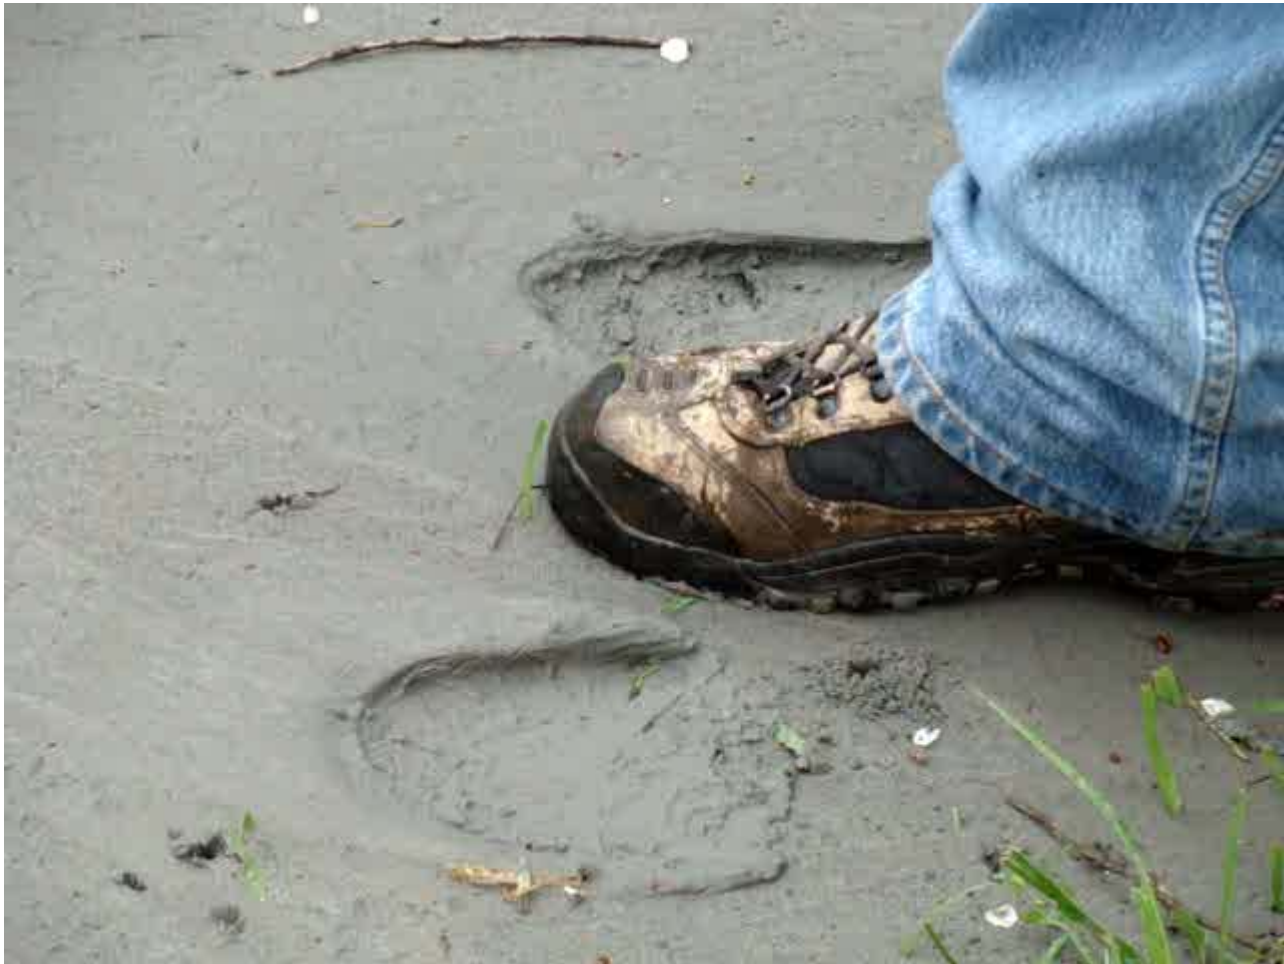
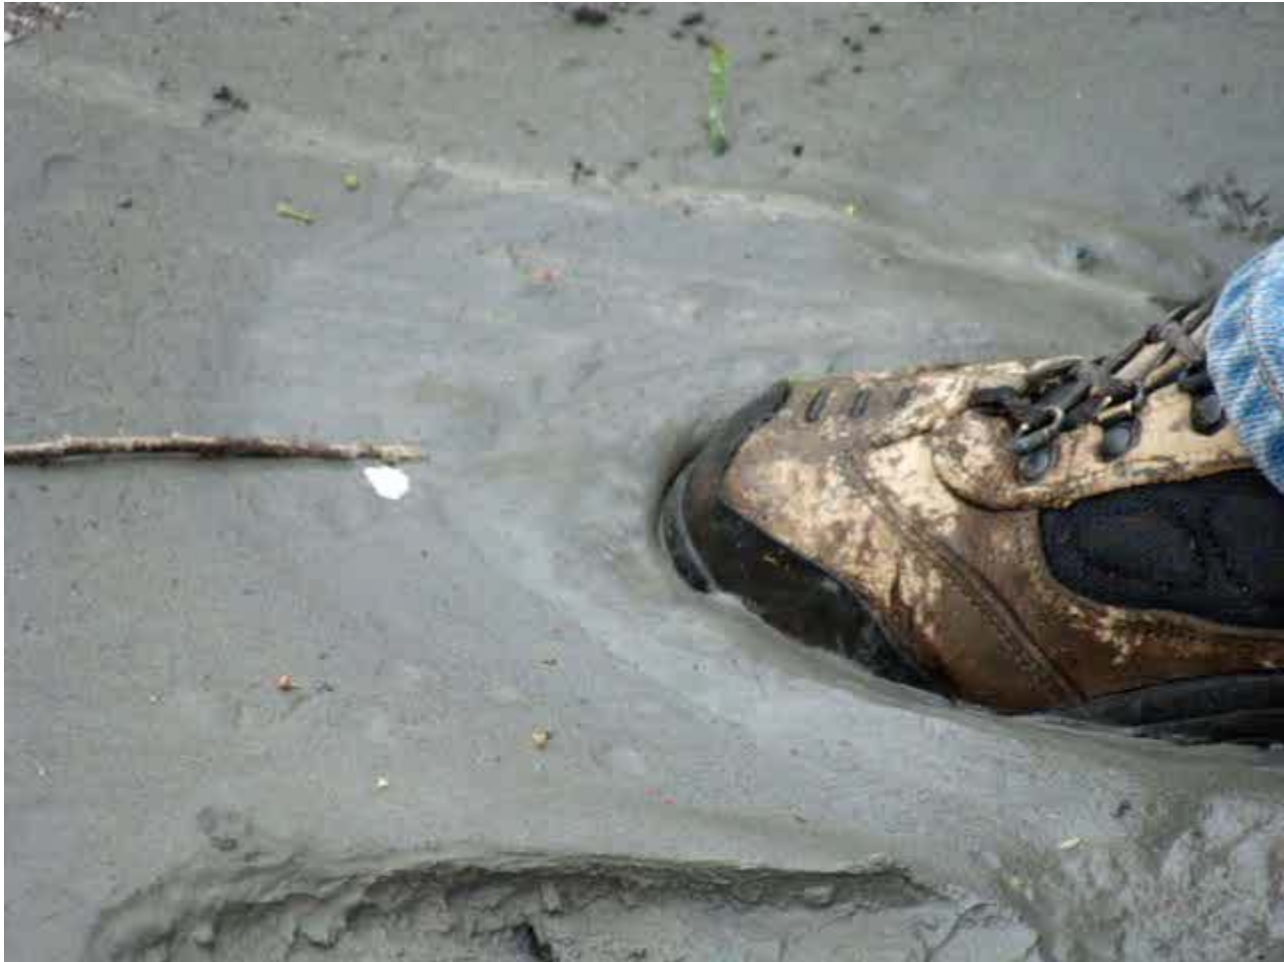
# Kaiapoi

Lateral spreading  
Mainly due to liquefaction
