# **Τα Νἑα** της Ε Ε Ε Γ Μ

# ΣΕΙΣΜΟΙ ΝΕΑΣ ΖΗΛΑΝΔΙΑΣ ΚΑΙ ΙΑΠΩΝΙΑΣ

Αρ. 37 – ΑΠΡΙΛΙΟΣ 2011 ΠΑΡΑΡΤΗΜΑ

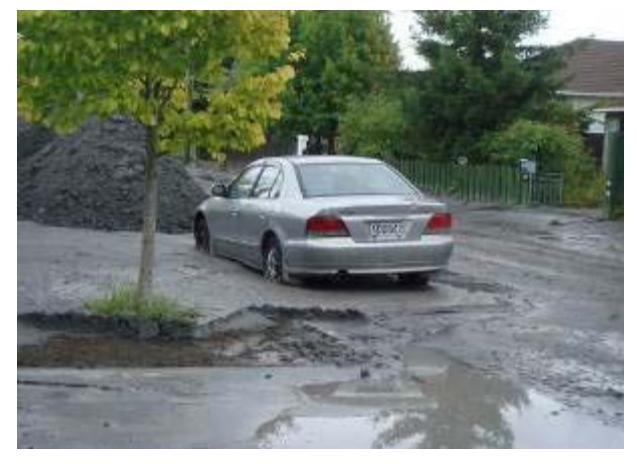
Photo 2 Liquefaction in residential area in Edgeware

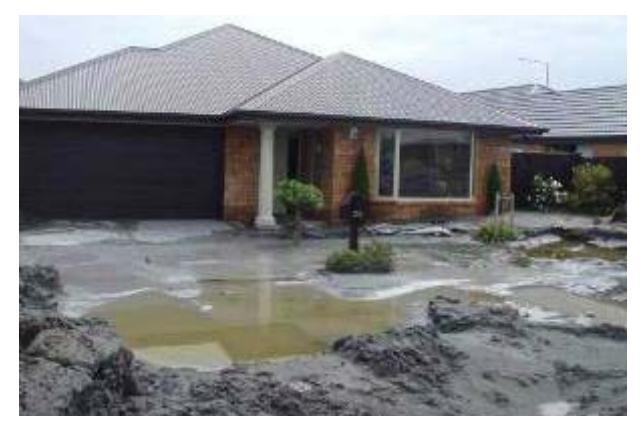
Photo 3 Repeated liquefaction near Bexley

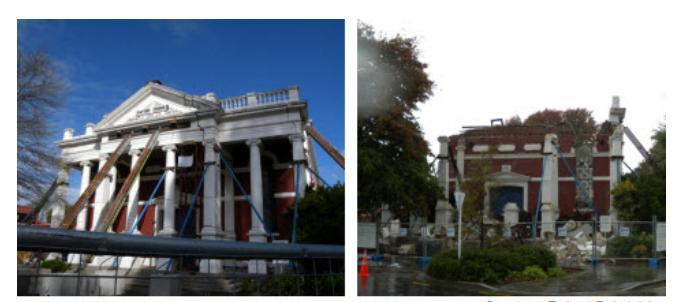
Oxford Terrace Baptist Church

Driving through the red zone, we came to the first building that we could do a September-February comparison of – The Oxford Terrace Baptist Church. It was a large, one story unreinforced masonry church. In September, the shanking had caused its front to begin to pull away. That was shored up by some steel braces when we got there in October. Today, however, the church was mostly a pile of rubble.

After September quake

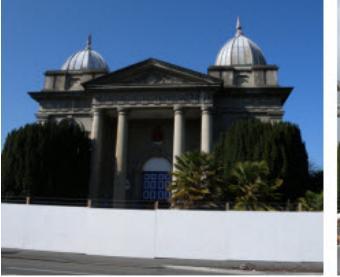
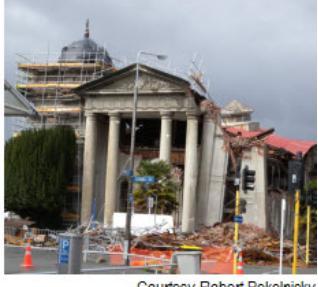
St Paul's church

We drove by another old church, St. Paul's. It is an 1880's unreinforced masonry church that suffered some damaged in September. That damage was some moderate cracking of the URM walls, but there was no threat of collapse. As with Oxford Terrace, unfortunately, this church has completely collapsed.

After September quake

Courtesy Robert Pekelnicky After February guake

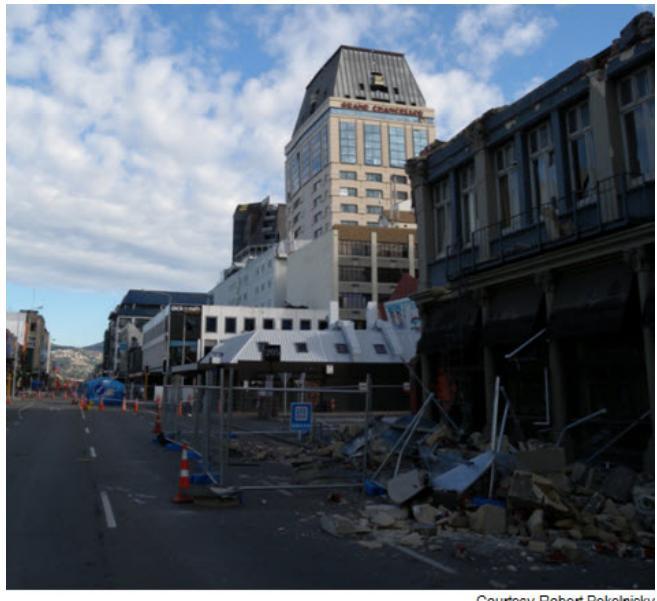
We came across two buildings that we had observed in October at 223 and 225 High Streets. It appeared 223 High had a minor upgrade done to it, presumably at one-third of code. On the other hand, 225 had a brand-new upgrade done to it at 100 percent of current code. The parapet in the rear of 223 High failed and there was some cracking in

the unreinforced masonry along the street-side face at the upper story. The 225 High building was undamaged. February's earthquake managed to knock down the parapet and large portions of the upper story wall in 223, while 225 again appeared undamaged. You could get up close to 223 and see how the bricks just pulled away from the adhesive anchors.

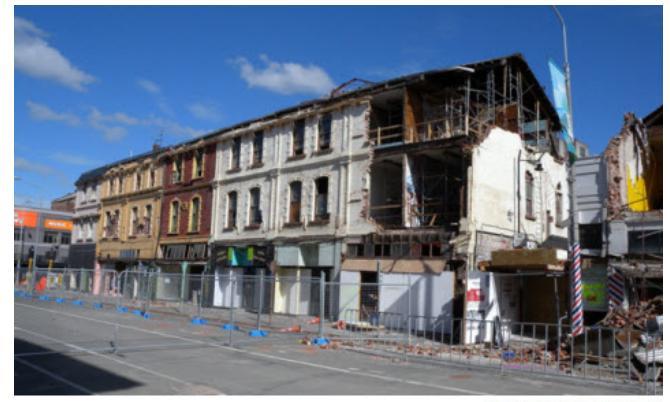
Continuing our walk, we came to a row of buildings along Manchester Street that had also previously been damaged. What appears to be a row of about six separate buildings is actually one building built in 1880, but divided into six separate shops by unreinforced masonry walls (URM). The building looks amazingly similar to what it looked like in October. It was at first a surprise, given how much more

intense the shaking had been in this more recent earthquake and how all the other buildings we'd looked at in both had performed. However when we got closer we could see that the building had been stabilized by adding some

out-of-plane through bolts and horizontal wood whaler beams along the façade. While this would not aesthetically qualify as a permanent upgrade, it appeared to do the trick to strengthen the building such that the walls did not fall out into the street as they did at 223 High.

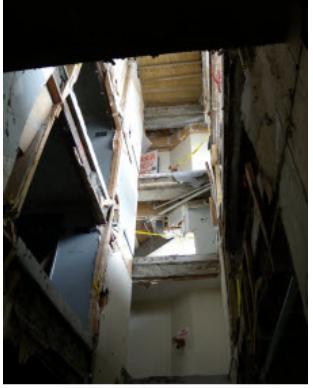
The first building we went to was the Forsythe Barr building. It is a tall building that structurally performed well. However, there was one verv serious issue with this building - the exit stairs collapsed! The exit stairs were precast concrete elements, meant to span from one floor to the next. They were situated on four-inch angles. That was not enough of a seat during the severe seismic shaking, and most of the stair elements unseated.

They had to break windows and lift people out of the building.

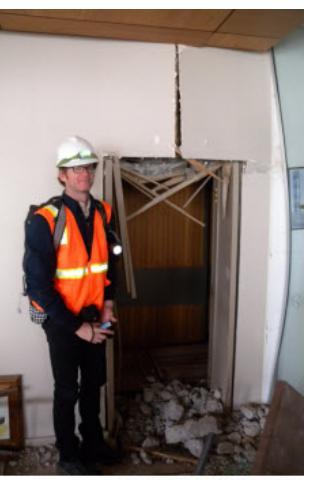
The next building we looked at was a concrete wall and frame building where the shear wall core settled differentially with respect to the rest of the building, due to the underlying soil liquefying. Here is Owen Rosenboom standing next to a door opening in the core wall that originally was probably about 7 feet tall, but has shrunk to less than 6 feet.

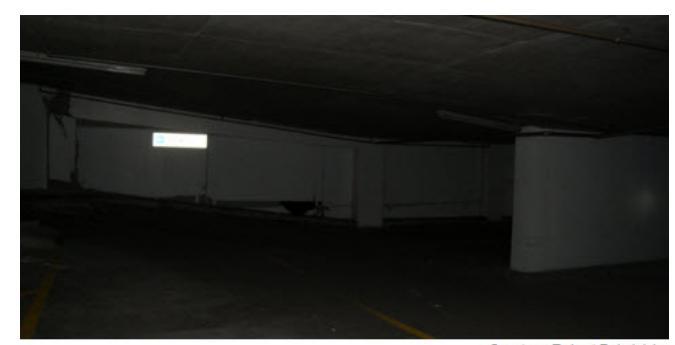
After leaving that building, we walked over to the tallest building in Christchurch – the Grand Chancellor. We were all excited to be able to go in and see the damage in this building. A load-bearing wall and two columns supporting a large transfer girder had failed, causing the southeast corner of the building to drop about 3 feet. The building was so noticeably leaning that emergency crews cordoned off a radius of about 4 blocks around the building. The

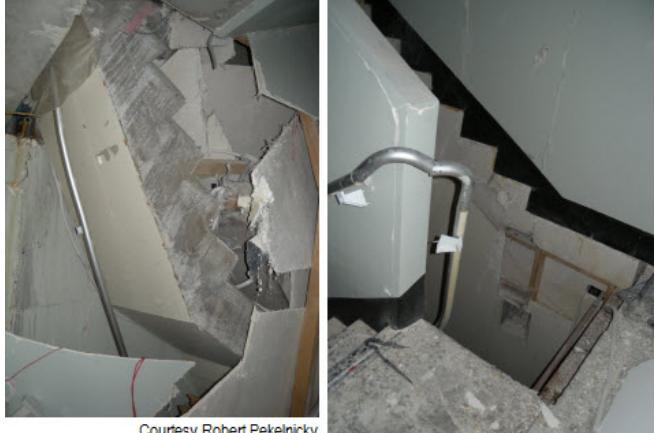
After lunch, we met up with another engineer from the Holmes group who was going to take us into three buildings this afternoon. We first headed to Clarendon Tower. It's a tall building in which the stairs had dislodged and there were some failures in the floor diaphragm. In fact, there was such a severe failure where the precast double-t sections actually dislodged from the beams and are being help up solely by adhesion to the 2-inch topping slab which is spanning like a catenary. Unfortunately, it was not safe for us to go up to the floor under that to observe. However, we did get some very sobering pictures of the failed stairs. Being in this building and the Grand Chancellor were probably the two most unnerving points of the trip.

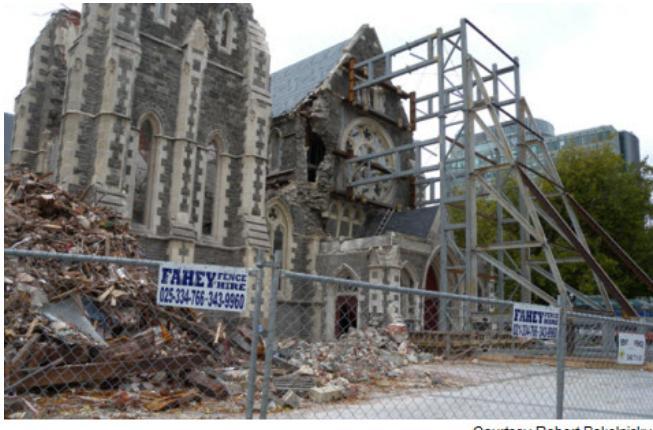
We then walked over to the Christchurch Cathedral. We were very lucky to find out that the engineer taking us around was going to be the one designing the repairs to the cathedral. They had previously upgraded the cathedral by adding some shotcrete to the front face and then strengthening the roof diaphragm.

At the time they were not permitted to do any work in the spire, which in my opinion was unfortunate, because that is what collapsed. The remainder of the cathedral was damaged, but according to that engineer, it was essentially what their complex nonlinear models had predicted would happen.

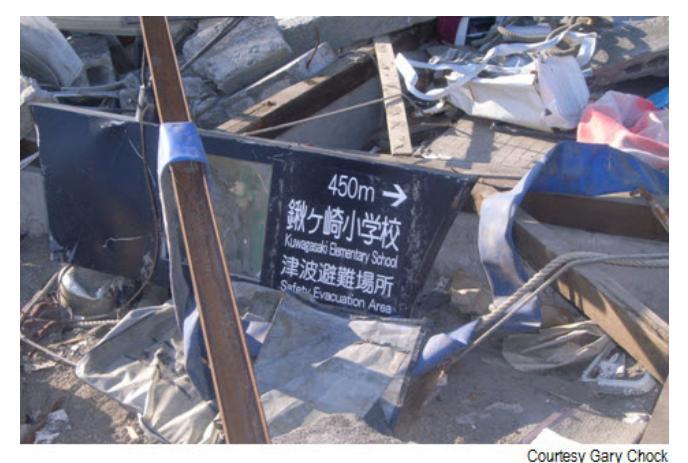
An evacuation sign lies among the debris of a Miyako City home, outside of the seawall.

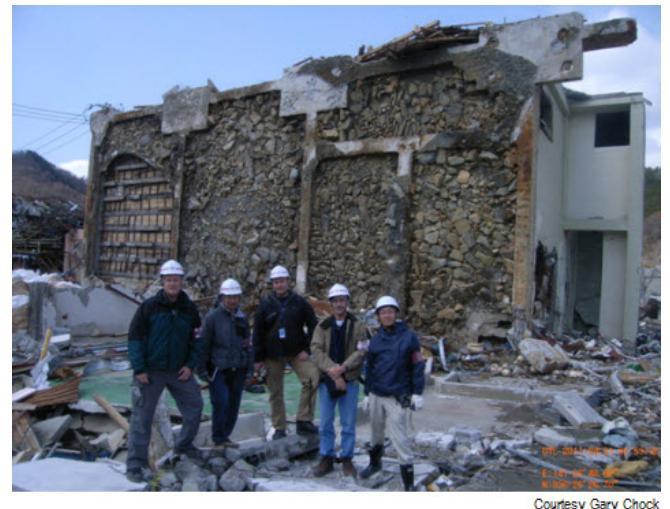
In front of the foundation of an overturned building in Onagawa are, from left to right, ASCE reconnaissance team members David Kriebel, Gary Chock, Ioan Nistor, Ian Robertson, and Dr. Hiroshi Takagi of the Tokyo Institute of Technology.

Within a minute of our arrival in Onagawa, we knew this would be an exciting day of investigative opportunities. There were half a dozen reinforced concrete buildings that had been overturned and laterally shifted by tens of meters. Some of these had pile foundations that had been sheared off. In viewing these along with other failed structures like pedestrian overpasses, overturned bridge spans, light poles, and massive stone tablets, we realized that the flow velocity had been high for both inflow and the *return* flow. We also found several cases of reinforced concrete walls and steel-framed walls that had been blown out by fluid pressure. A lot of our work consisted of taking detailed measurements of structural dimensions and reinforcing of elements and building structural system information for subsequent case study analysis.

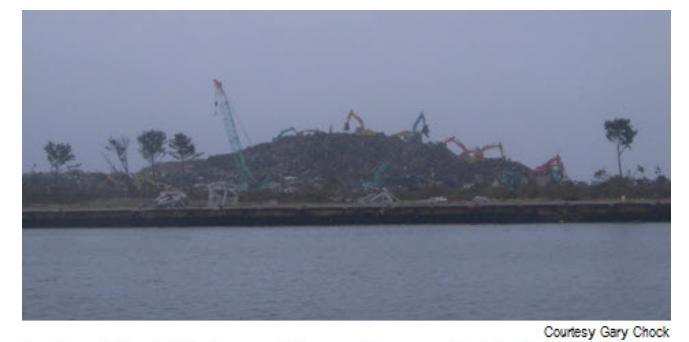
Seen from a distance, in Natori, cranes stack up a massive, ever-growing pile of trucked-in debris.

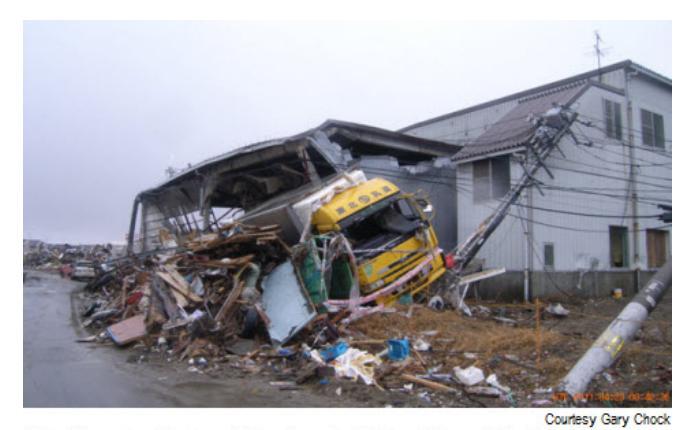
At Sendai's port area, the tsunami's force threw a truck into a steel-framed industrial building.

We started the day with a return to Sendai port to examine some trucks that had been swept against a one-story industrial building and a nearby reinforced concrete utility pole. We have an interest in tsunami-borne debris impacts on structures, as well as debris accumulation in increasing the effective projected solid area of a building for hydrodynamic forces. As case studies to quantify the force, we need to collect data on the debris object and its effect on a structure.

While measuring the dimensions of the first truck, the point of impact on the steel corner column of the roof, and the inundation mud line in the building, the company's manager appeared. People were busy with clearing up debris that impeded the road and their business. Mr. Shishido, the manager, explained that after the initial tsunami wave, he ran about a kilometer and a half to high ground at a construction site and watched as the larger second incoming surge swept into his company's area. The truck in question had been across the street in the neighboring building's parking area. Dr. Shusaku Inoue of Takenaka Corporation, another of our local collaborators, explained our purpose and Mr. Shishido was quite agreeable to our investigation. He will be finding out whether the security camera on his building captured anything useful from the tsunami. When we had finished, he brought a bag of iced coffee drinks (exactly two for each of us.) Noticing that he had been wearing a monogrammed golf cap that was a little old, we gave him a new ASCE-monogrammed navy blue baseball-style (basubaru) cap as a reciprocal gesture.

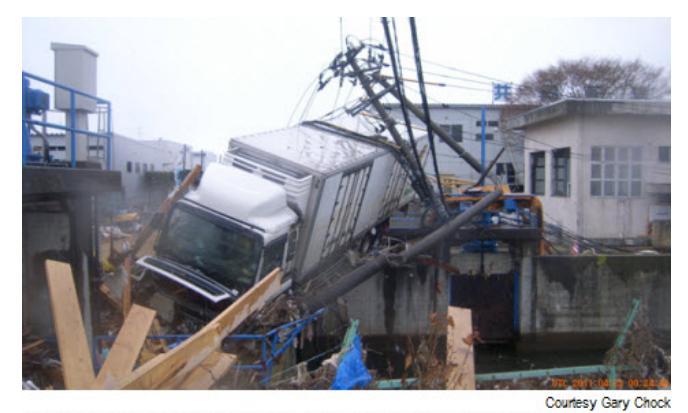
Another tossed truck at Sendai's port rests against a concrete utility pole it had snapped into pieces.

At truck number two, Dr. Mogi of Saitama University explained our mission to the debris clearing road crew. We then proceeded to take necessary measurements of the second lateral strike, which had shattered the power pole at the point of impact and yielded its base. The pole was of the spun-cast hollow concrete type with longitudinal reinforcing made of steel wires, which is typical in Japan. The pole had a diagonal strut of a reinforced concrete pipe as well. I would expect that this truck and the power pole will be removed within a matter of days.

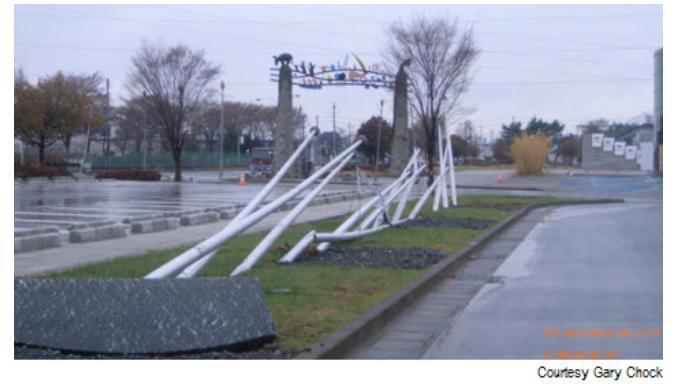
The tsunami's force bent and snapped a row of flagpoles at the entrance to a sports complex.

Tom Sawyer of ENR was very quick to pick up on what we were looking for, and he made a remarkable find of a series of flag poles that had been laid down by the tsunami, in front of the sports building that had an extremely clear mudline indicating maximum water depth. None of the poles had debris strike marks of any significance, and a few had been split open, permitting us to take wall thickness dimensions. This allowed us to acquire a nice data point with water depth, flow direction, with the information required to compute flow velocity.

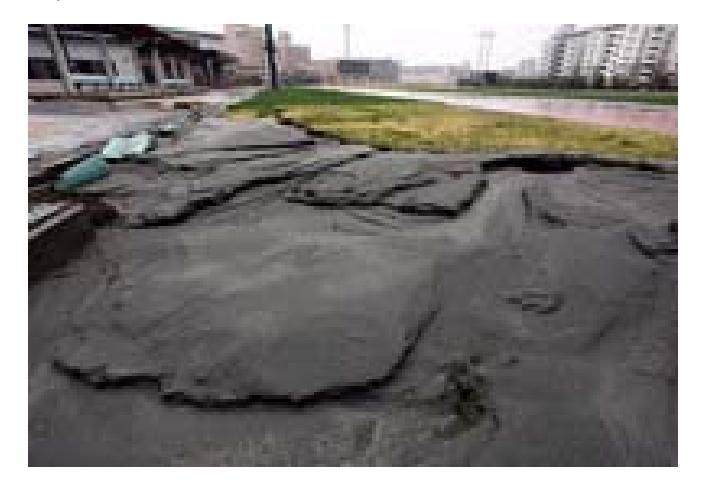
While most of Tokyo avoided major damage in the March 11 quake because of stringent building codes, in some parts of Tokyo Bay the magnitude-9 temblor triggered liquefaction, a phenomenon where soil loses its strength after violent shaking. The most affected suburb was Urayasu, one of only three residential areas in greater Tokyo where land prices rose last year, and the home of the Tokyo Disneyland resort.

Liquefaction, which causes soil to act like quicksand, was found across about 86 percent of Urayasu's surface land, said the local council's Sekine. About 112 kilometers (70 miles) of road in the 17 square-kilometer (7 square-mile) city were damaged, she said.

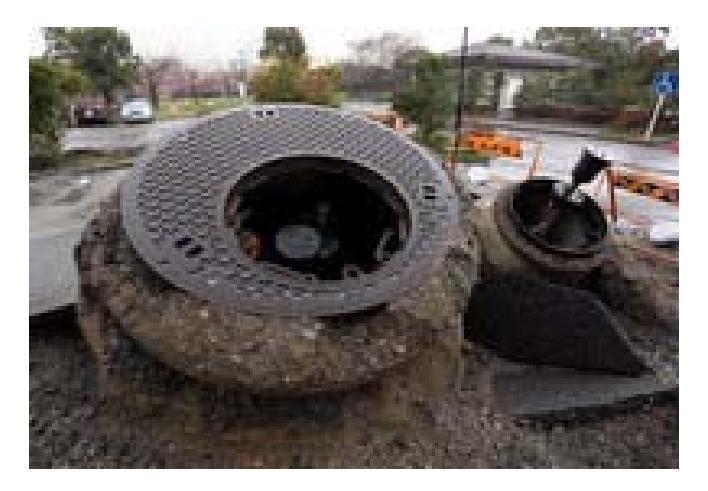
"I was very surprised there was land damage to an area like Urayasu, so far from the seismic center of the quake," said Yasuo Tanaka, a professor of geotechnical engineering at Kobe University. "They should have been prepared for earthquakes, but given the damage, it clearly wasn't enough."

Urayasu may consider reinforcing the reclaimed land, which makes up about three-quarters of its surface area, once it has finished dealing with emergency repairs following the March 11 earthquake.
