Contribution of geotechnical engineering in the rehabilitation of buildings and infrastructures

Christos Tsatsanifos

Managing Director, PANGAEA CONSULTING ENGINEERS LTD, Athens, Greece

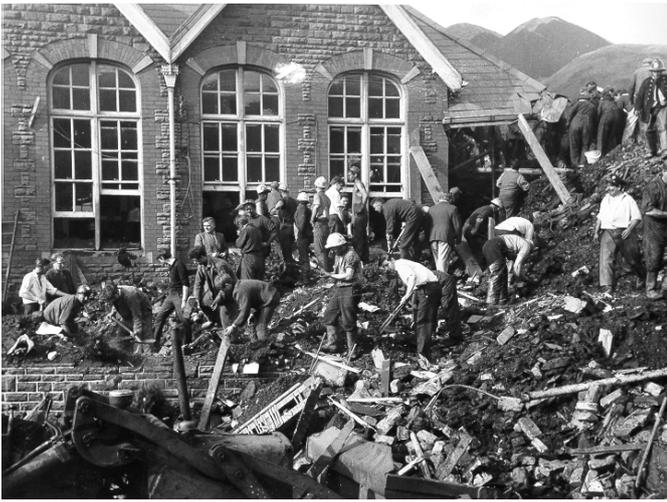
Figure 1. The Pantglas Junior School, Aberfan, South Wales engulfed by the debris of the flowslide.

At 9:15 am on Friday, October 21, 1966 a waste tip slid down a mountainside into the mining village of Aberfan, near Merthyr Tydfil in South Wales. It first destroyed a farm cottage in its path, killing all the occupants. The slide engulfed the Pantglas Junior School, just below (Figure 1), and about 20 houses in the village before coming to rest. 144 people died in the Aberfan disaster: 116 of them were school children.

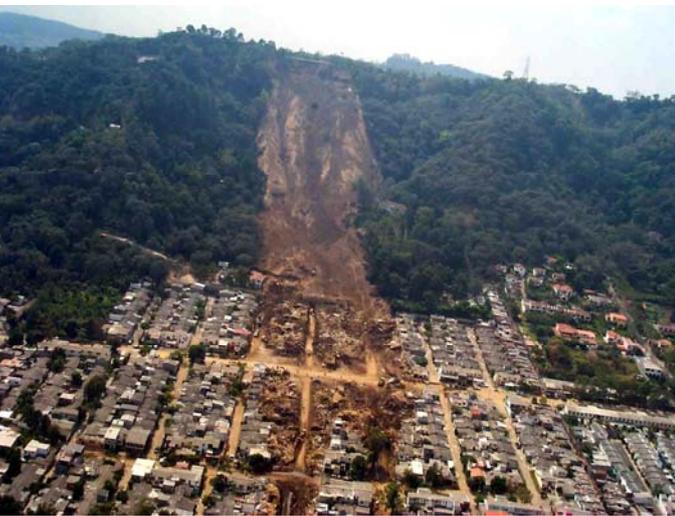
Figure 2. Oblique aerial view of landslide that buried Colonia Las Colinas, El Salvador.

in the neighbourhood under tons of earth (Figure 2), leaving as many as 1,200 people dead.

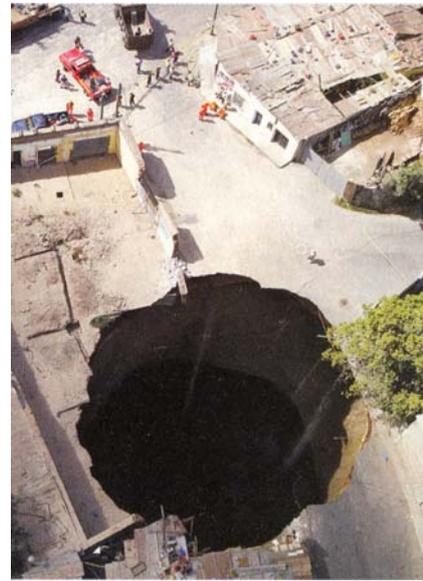
Figure 3. Leakage of a sewer pipe created a hole of 30.5 m diameter and 49 m depth in Guatemala City.

A clogged sewer line caused a sink hole in Portland, Oregon, USA on December 2006, which swallowed a truck – which had been sent to clean the sewer. Natural gas and water lines were also ruptured in the accident. A similar accident happened in Guatemala City, Guatemala on 22nd February 2007. A hole of 30.5 m diameter and 49 m depth opened (Figure 3), swallowing five houses and killing 3 persons. The accident was the result of the leakage of a deep buried sewer pipe in tuffs (pyroclastic deposits).

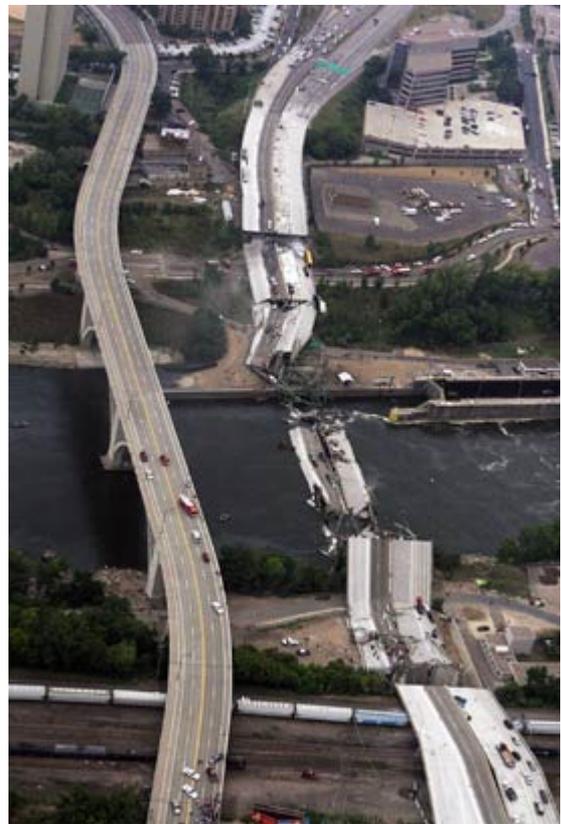
Figure 4. Aerial view of the collapsed bridge in Minneapolis (2nd August 2007).

A 120-ton concrete beam collapsed onto Interstate 70 in Washington County, Pennsylvania, USA, barely missing passing motorists on December 2005, while recently (2nd August 2007) the catastrophic collapse of the I-35W highway bridge over the Mississippi river in Minneapolis, Minnesota, USA, left 5 dead persons and 111 injured (Figure 4).

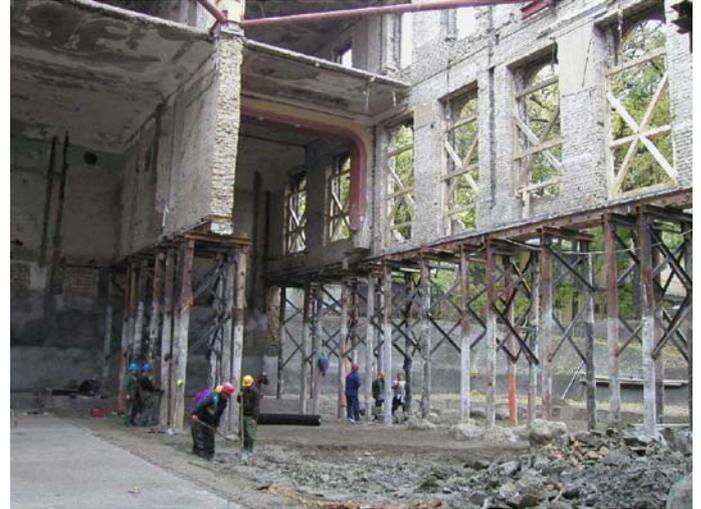
Figure 12. The AEB Bank building “in the air”

The loads of the internal walls were between 100 and 300 kN per meter and were transferred to the ground, temporarily, through micropiles (Figure 12).

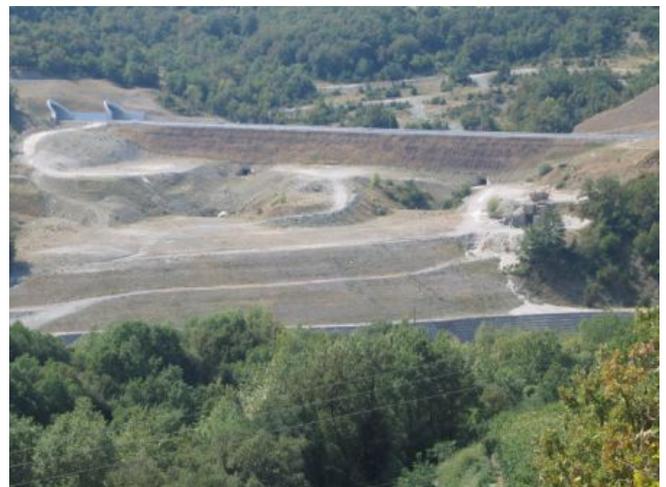
Figure 18. The Anthochori Embankment on the Landslide Area after the Construction of the Remedial Measures.

The stabilization measures selected comprised the construction of a berm at the toe of the landslide - a large retaining structure constructed by gabions along the bank of the Metsovitikos River - combined with a net of drainage ditches behind the embankment and a drainage blanket under the embankment. Also, on two ravine beds, passing through the area of the landslide, Armco tubes, able to accept differential settlements without being cracked, were placed under the stabilization

fill. Finally, the slopes of the toe weight were vegetated for preventing their erosion. Figure 18 shows a general view of the landslide area after the construction of the embankment and of the remedial measures.

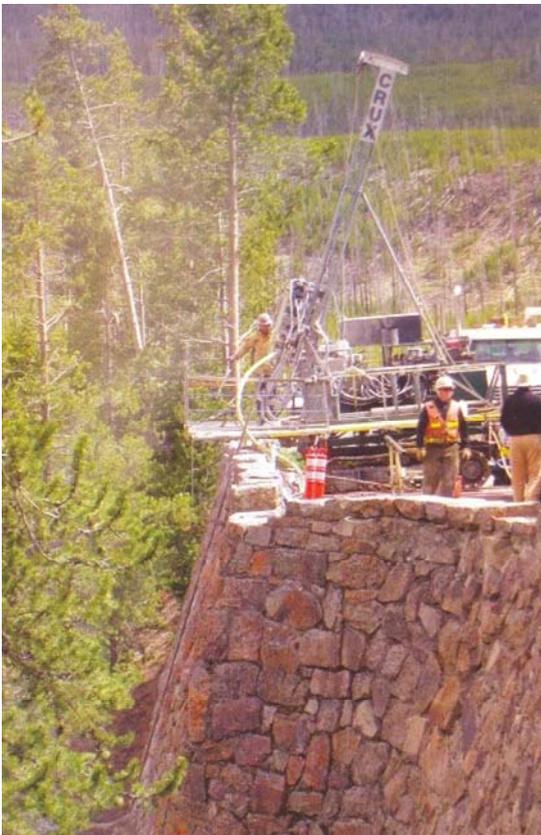
Figure 19. Micropile installation at Gibbon Falls Retaining Wall (Barrows et al., 2005).

The contractor drilled the micropile on the same batter as the wall face using high rotational speed (1,000 rpm), and low down pressure to help maintain the batter (Figure 19). Drilling progressed without problems through the 8.5 m wall, through 5 m of gravel and cobbles, and through 3 m of

highly to moderately weathered rhyolitic tuff. Casing was installed and a 25 mm threadbar was grouted into the hole through perforations in the casing below the toe of the wall, under 3 MPa of pressure. When the work was completed, there were no visible signs to indicate that any significant disturbance had occurred. The pilea added reinforcement and bearing capacity and preserved the historic structure without impacting the natural resources around the wall (Barrows et al., 2005).

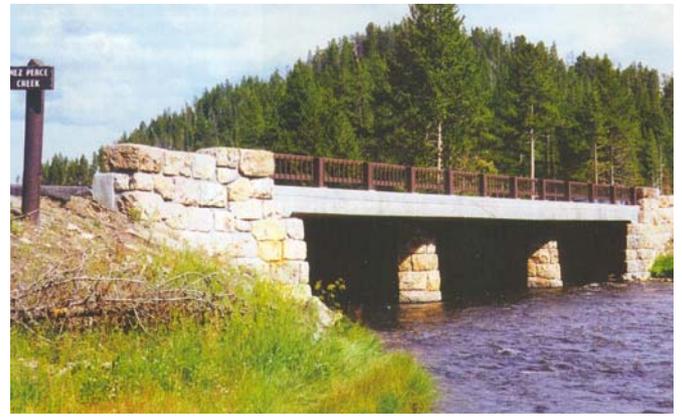
Figure 22. Nez Perce Creek Bridge at the Yellowstone National Park, USA (Barrows et al., 2005).

Nez Perce Creek Bridge in Yellowstone National Park USA (see Figure 22) was widened in 1996 to allow for increased traffic and larger vehicles, and to comply with current safety standards. It has been determined that the stone masonry piers would not sustain the design seismic loads but it was important to retain the look of the original work. One of the steps taken to accommodate these new design loads was to add steel reinforcement to the piers to make them more ductile and self-stable, and to isolate them from the bridge deck. This technique involved placing micropiles through each pier at 1.5 m spacing, and extending them 3 m into bedrock. The deck isolation was

achieved by elastomeric/steel bearing pads which allowed the pier masonry to remain untouched. The bridge abutments were widened by deconstruction of the stone masonry and constructing new concrete core walls for the additional width. To retain the same masonry look, the walls were faced with original stones as well as stones conserved from roadway excavation. (Barrows et al., 2005).

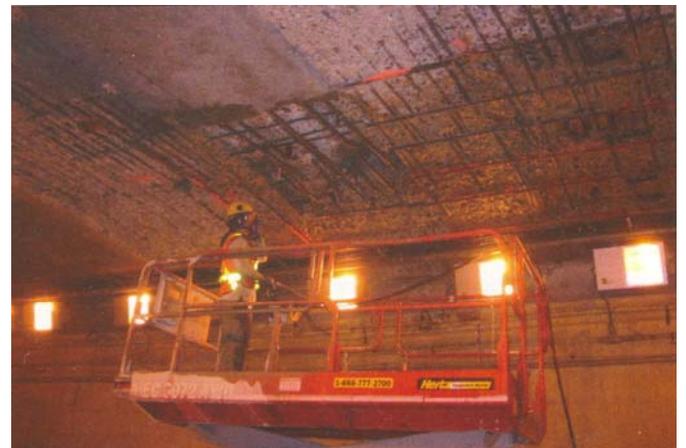
Figure 25. Crews prepare the main joint between tunnel sections for structural repair and strengthening of George Massey Tunnel.

Structural upgrade involved adding reinforcement to ensure that an earthquake would induce many well distributed cracks as opposed to a few large ones. The biggest challenge was finding space where to add steel. Trucks already "scrape" the ceiling so only the ceiling corners, the floors and the walls were reinforced, as well as the wind tubes and the air ducts (see Figure 25).

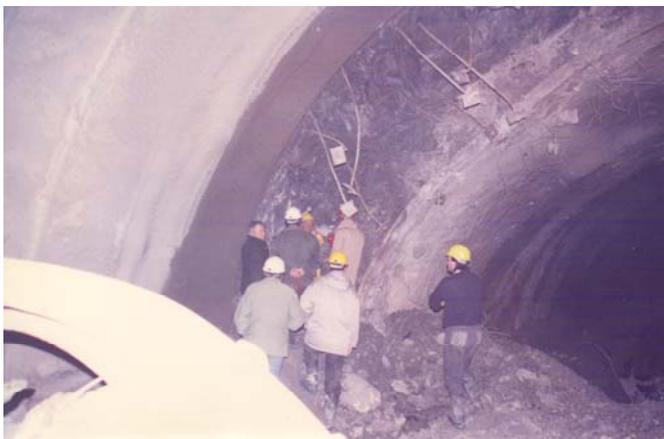
Figure 26. The maximum squeezing deformation of the Tymfristos Tunnel was as much as of 2 m.

Due to contractual problems and lack of funding the project has proceeded intermittently in three different contracts, with a halt of more than two years (from September 1995 to October 1997) between the second and third contract. During this period a 531 m long section of the top head, already excavated along the whole length of the tunnel, in an area with a rock mass of poor strength and deformation characteristics, suffered from excessive deformations, which destroyed the primary support and led to substantial closure of the opening (see Figure 26).

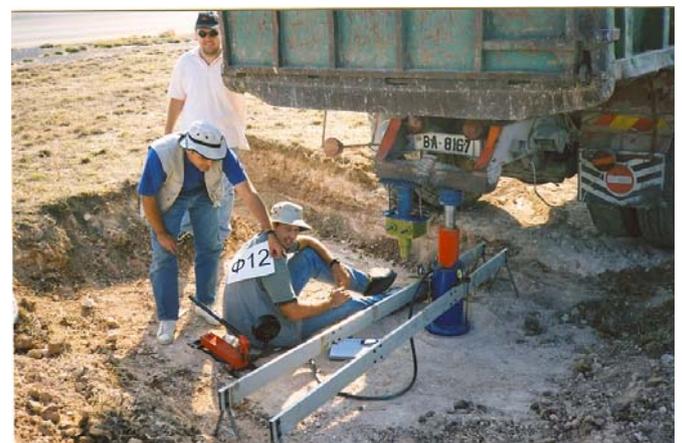
Figure 27. Geotechnical investigations for the rehabilitation of Tanagra airport runway pavement.

Figure 27 shows a location of the geotechnical investigations performed for the design of the rehabilitation of the Tanagra Airport Runway Pavement. The results of the investigations and the sub-

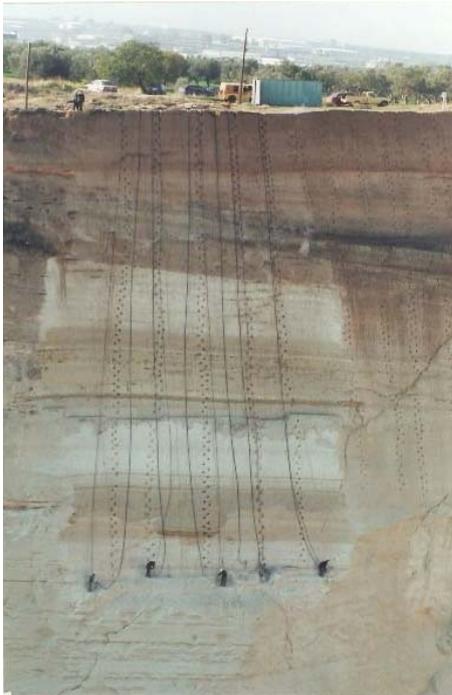
Figure 29. Rehabilitation works on the slopes of the Corinth Canal

In all these cases major rehabilitation works had been required for the re-opening of the Canal. Currently, in order to safeguard the passage of the ships through the Canal, continuous rehabilitation of the slopes is required, as shown in Figure 29.

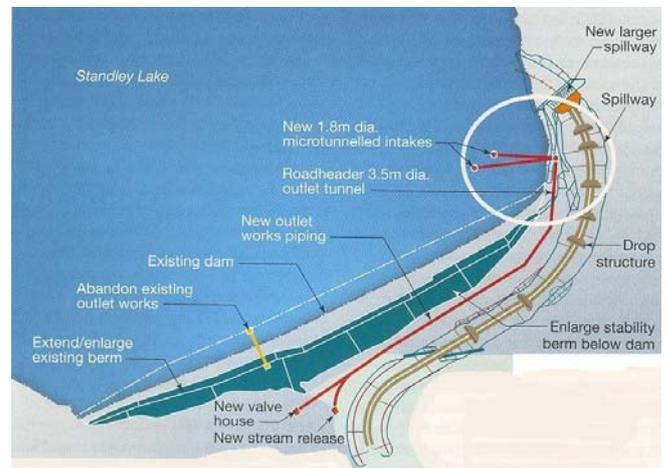
Figure 31. The Standley Dam Rehabilitation project (Coss, 2006).

The rehabilitation of the dam included constructing outlet works tunneled, using microtunneling techniques, in the abutment (separate from the embankment), a new spillway, and placement of additional stability berms (see Figure 31).

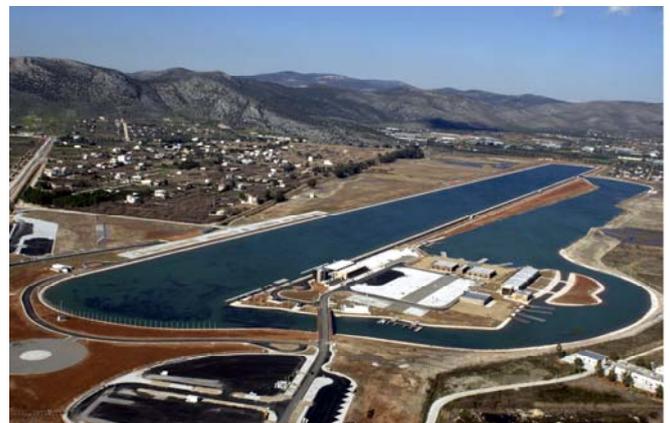
Figure 33. The Athens 2004 Olympic Games Rowing and Canoe Centre at Shinias, Marathon.

The design of the Olympic Centre (see Figure 33) presented some very interesting geotechnical problems to deal with and provided all the necessary works in order to reinstate the old marshland through the water overflow from the rowing ponds to the marshland (Tsatsanifos, 2004).
