# The Nicoll Highway Collapse

D. W. Hight  
T.O. Henderson + A.R. Pickles  
S. Marchand

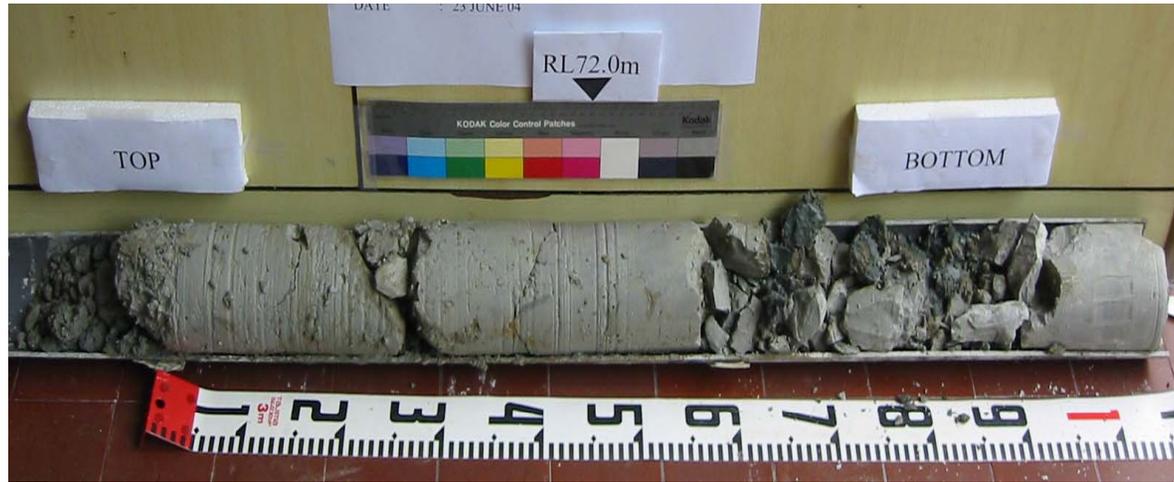
*JGP quality in 100mm cores from borehole M1 in Type K*

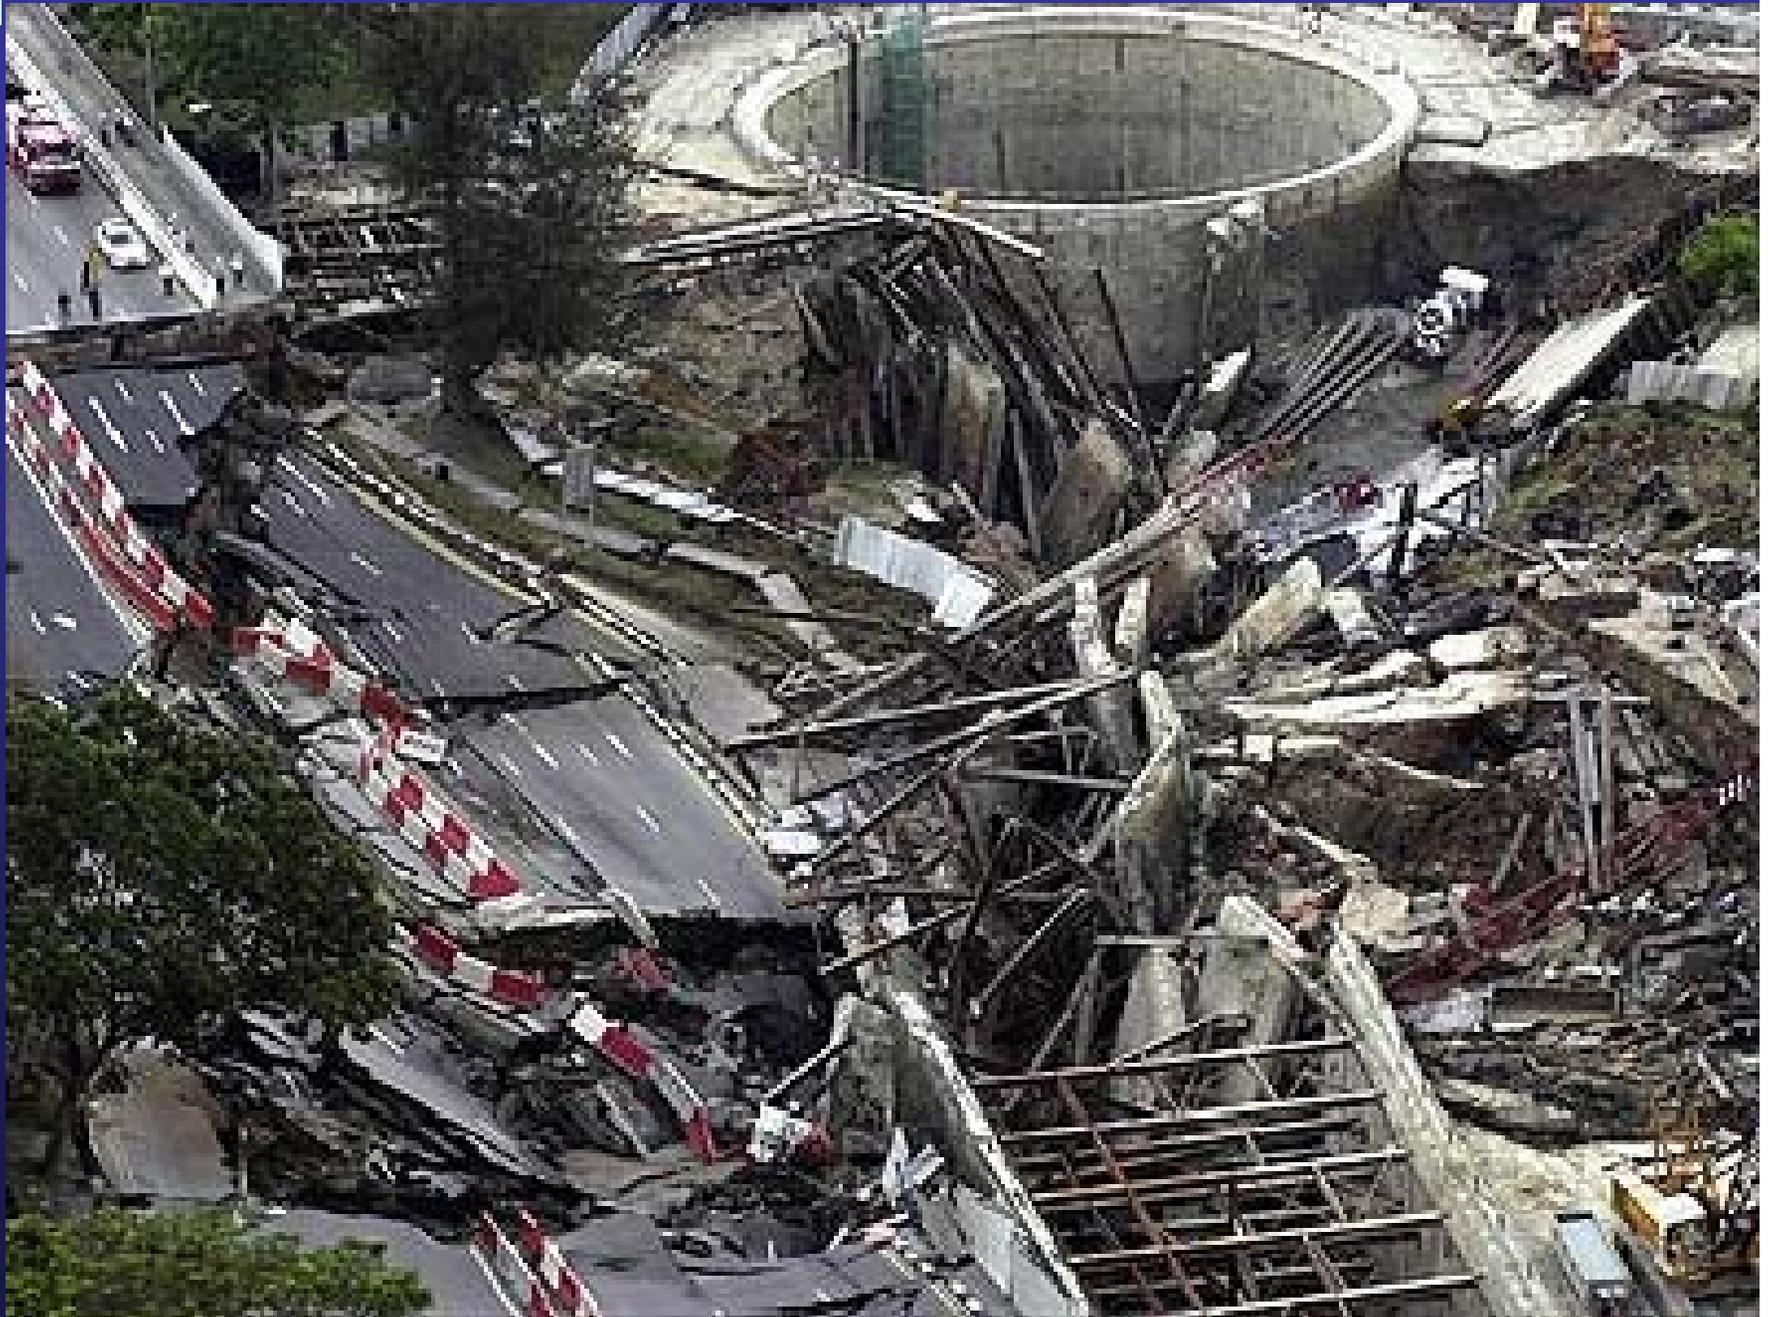
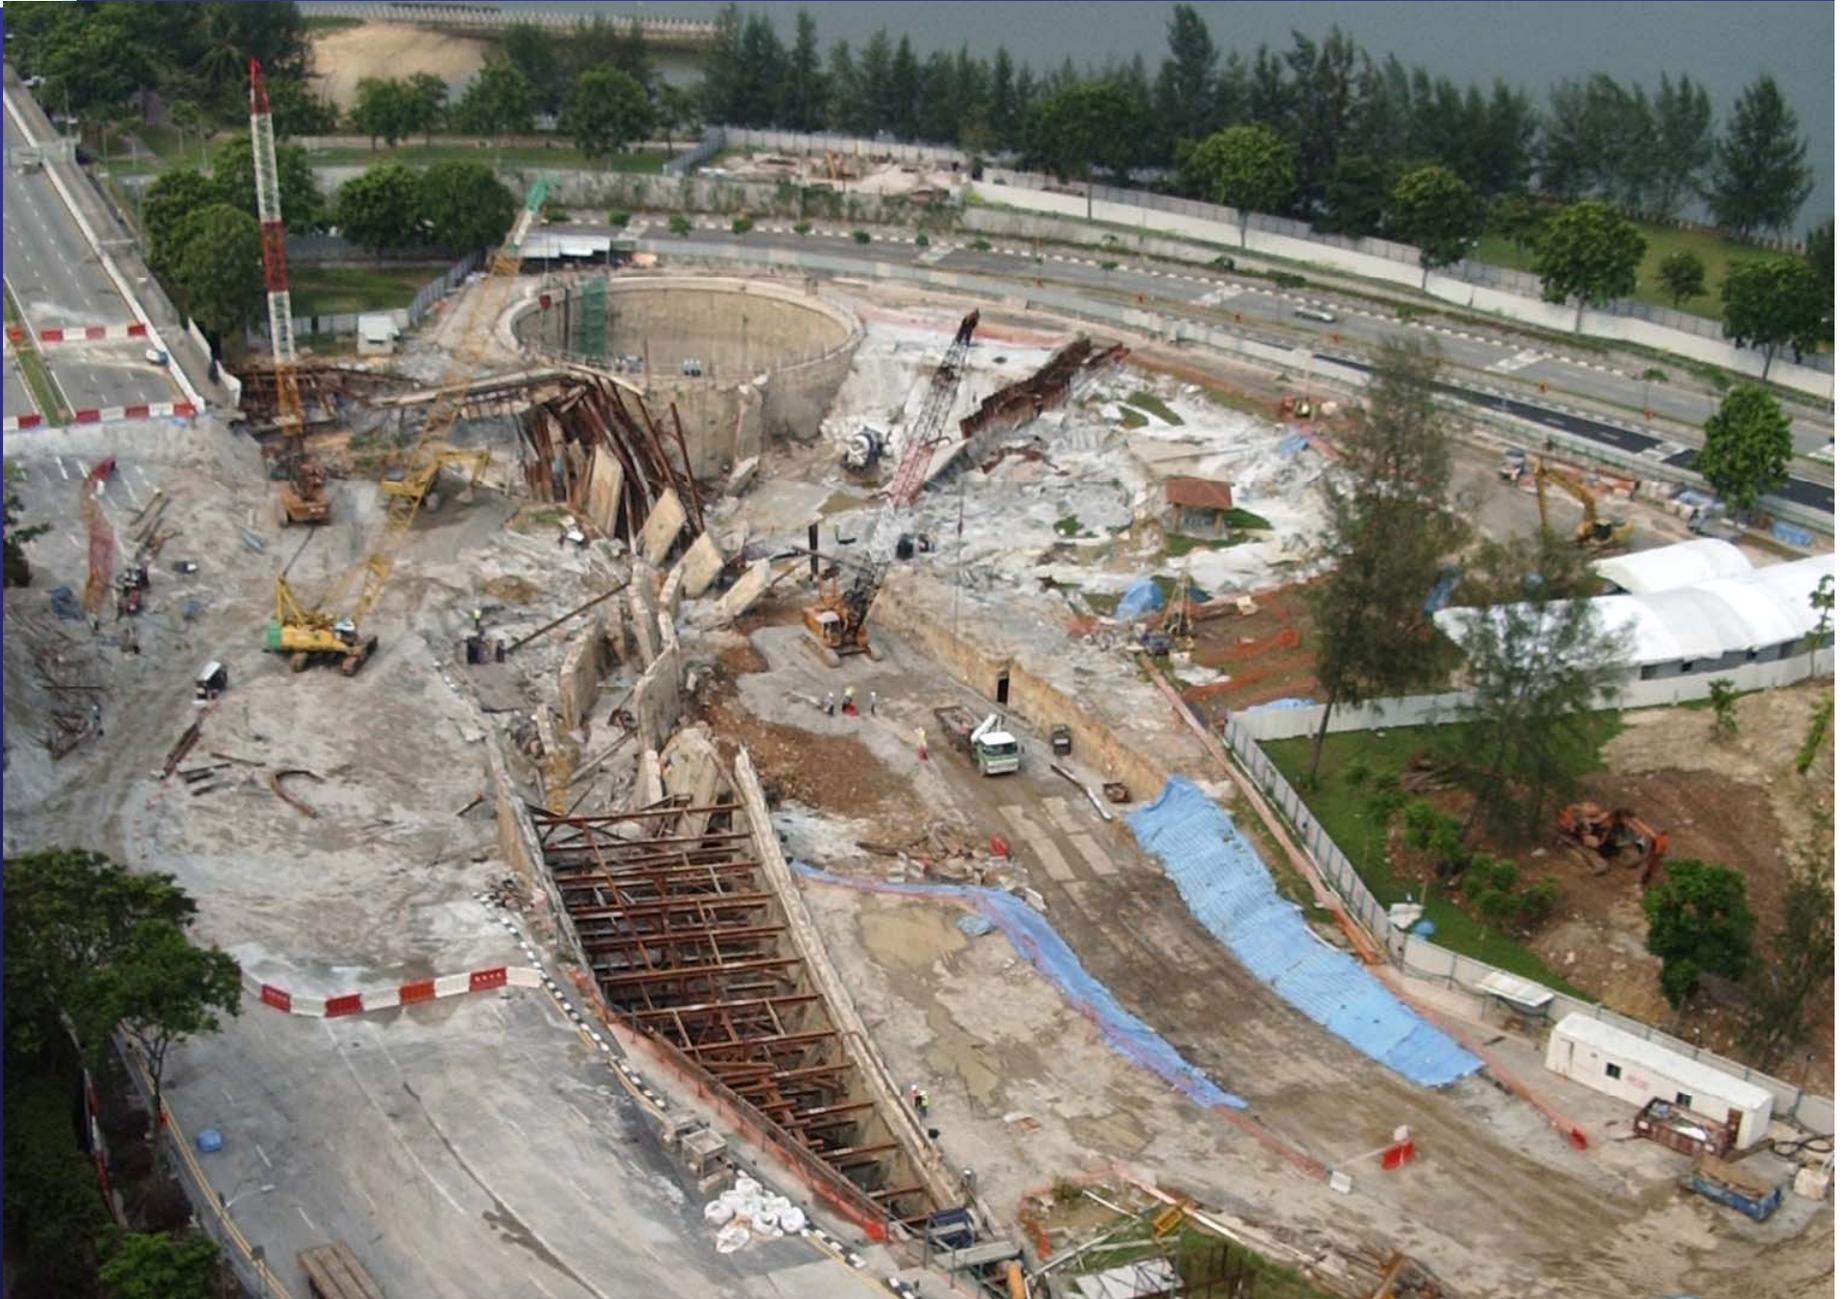
*Post-collapse geometry superimposed on buried valley*

Post-collapse positions of the Dwall  
panels
